## **VALIDATION REPORT**

### **Block B**

### **5 to 9 Berkeley Avenue, Reading, Berkshire, RG1 6EL**

CON01-READ-052

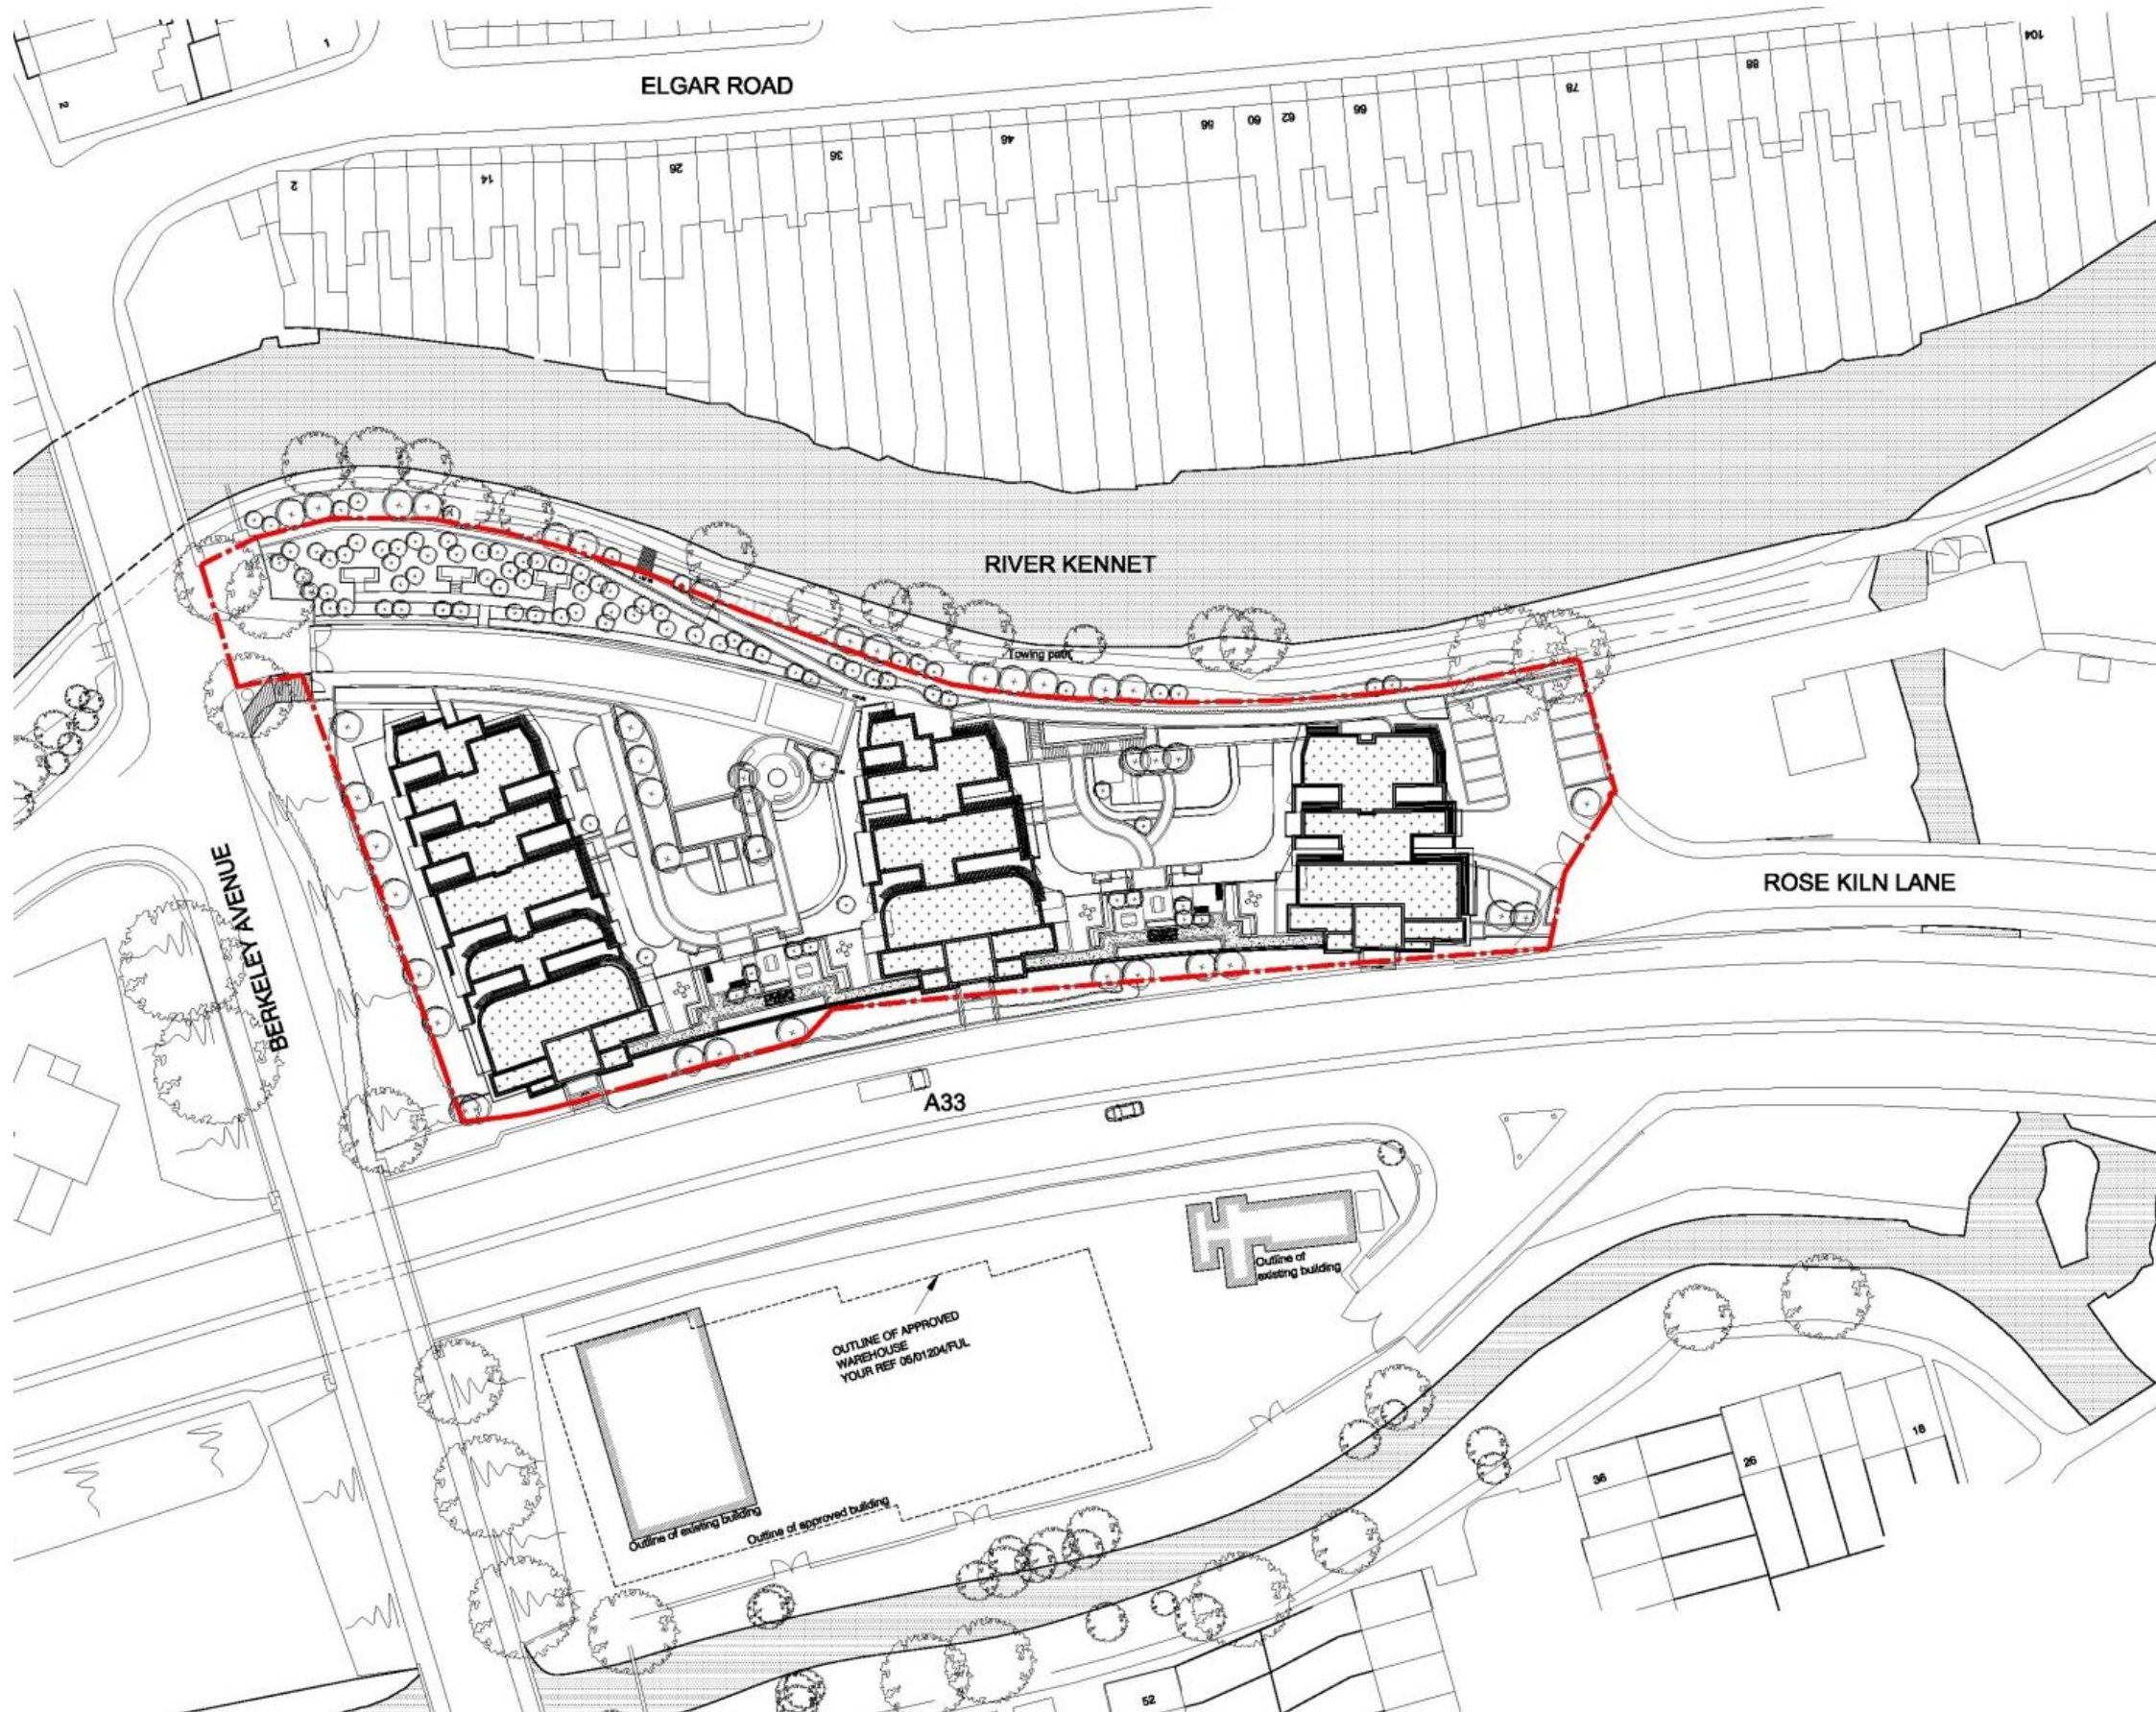
| Originator | WGG | <b>BERKELEY AVENUE, READING</b><br><b>CON01-READ-052</b><br><br><b>PROPOSED LAYOUT</b> | |

Stansted Environmental Services Limited (SES) has been commissioned by Weston Homes plc to prepare a Validation Report for a multi-storey development at the former 'Lok 'n' Store' site at 5 to 9 Berkeley Avenue, Reading, RG1 6EL, comprising 112 residential units, with an undercroft car park and areas of communal soft landscaping. A proposed development plan is included as Appendix A.
