Project: Kenavon Drive,  
Reading

Title: Internal ADF Results  
Proposed Scheme 12/01/17  
West Block

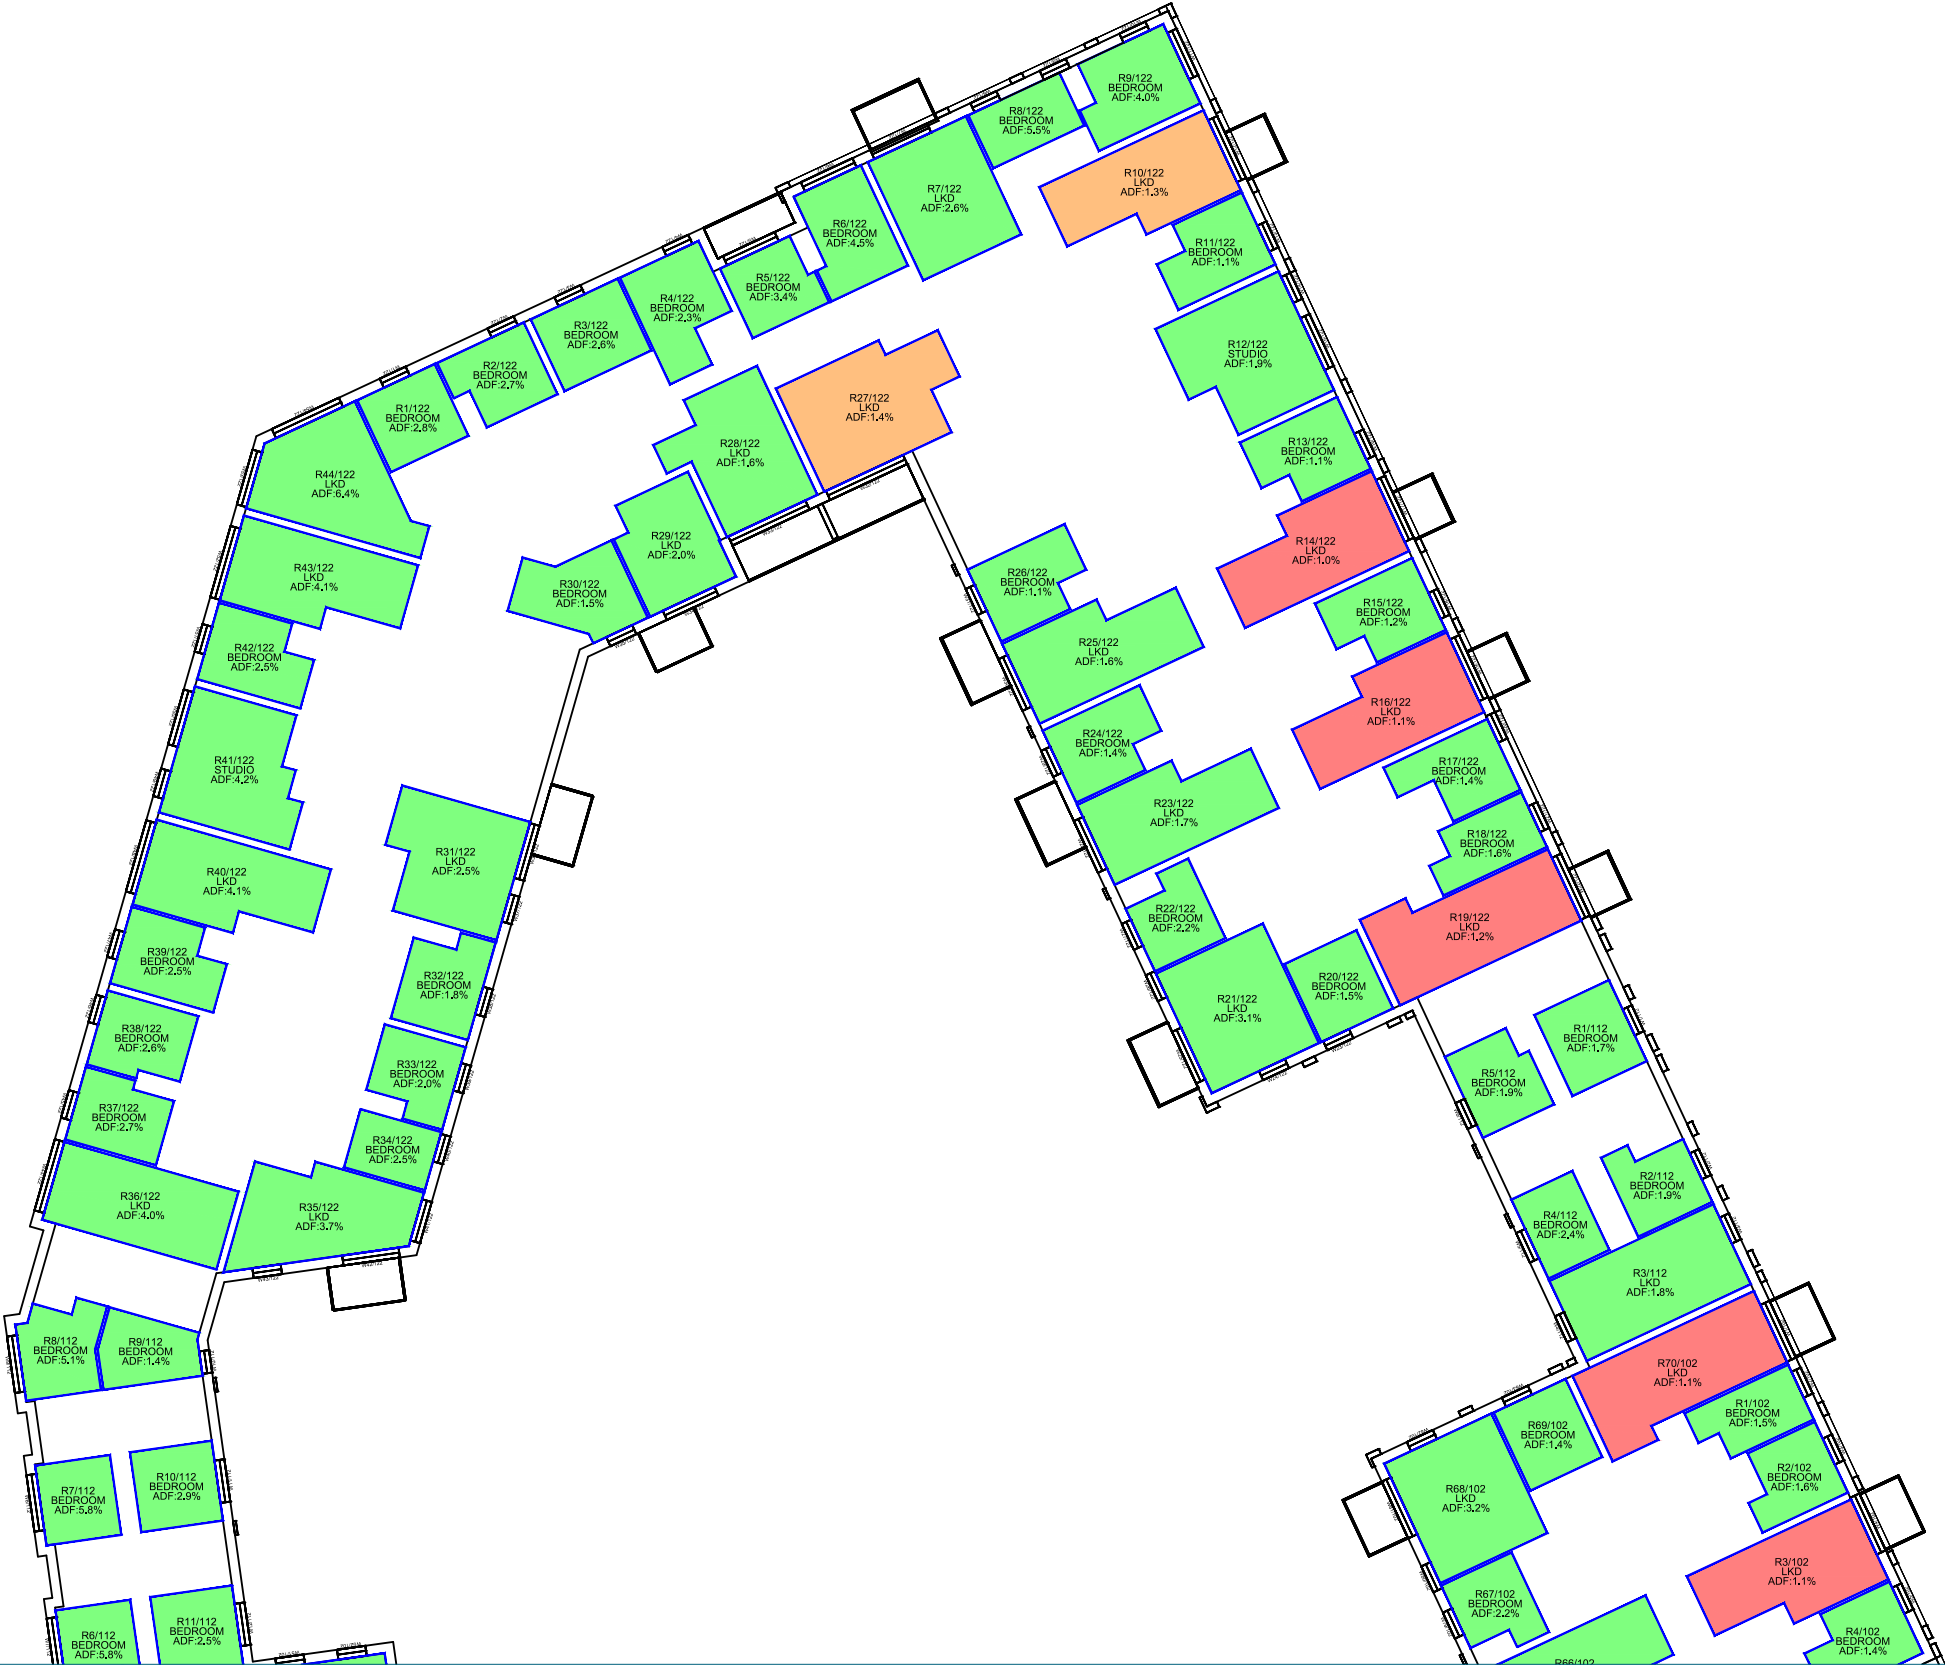
Dwg No: **P915/I/143**

SECOND FLOOR

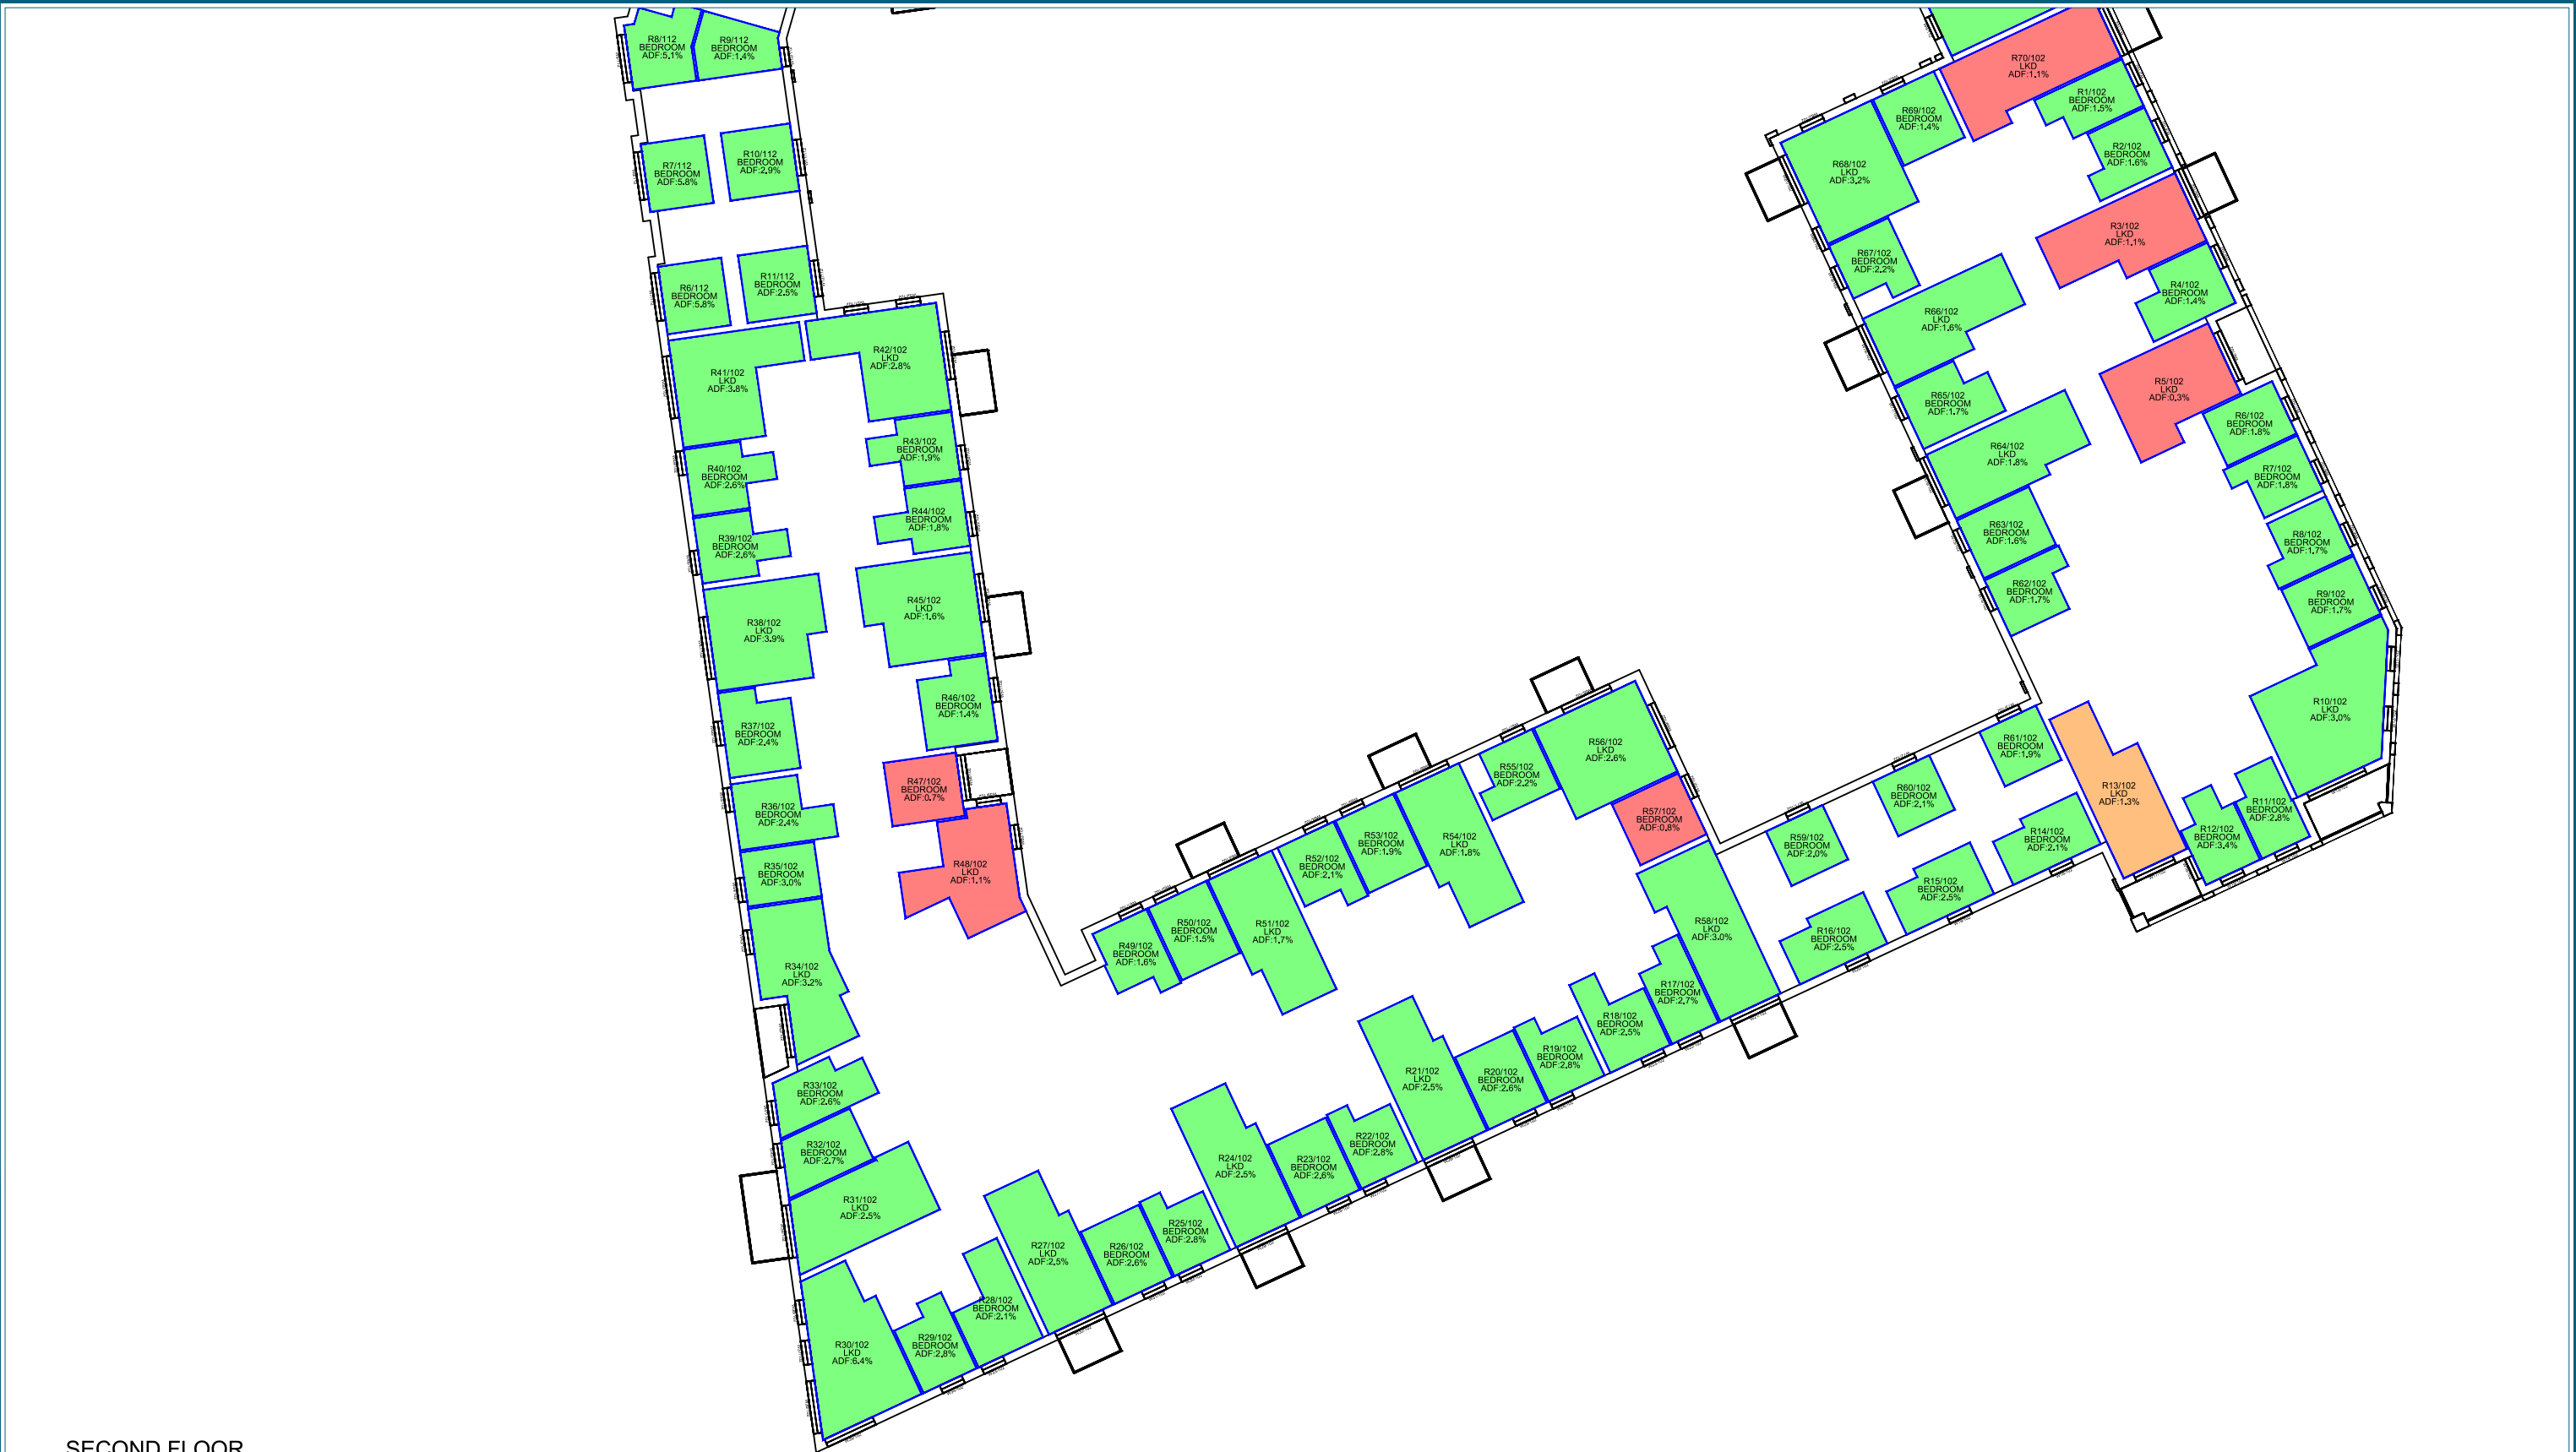
Dwg No: **P915/I/144**

SECOND FLOOR

Title: Internal ADF Results  
Proposed Scheme 12/01/17  
West Block

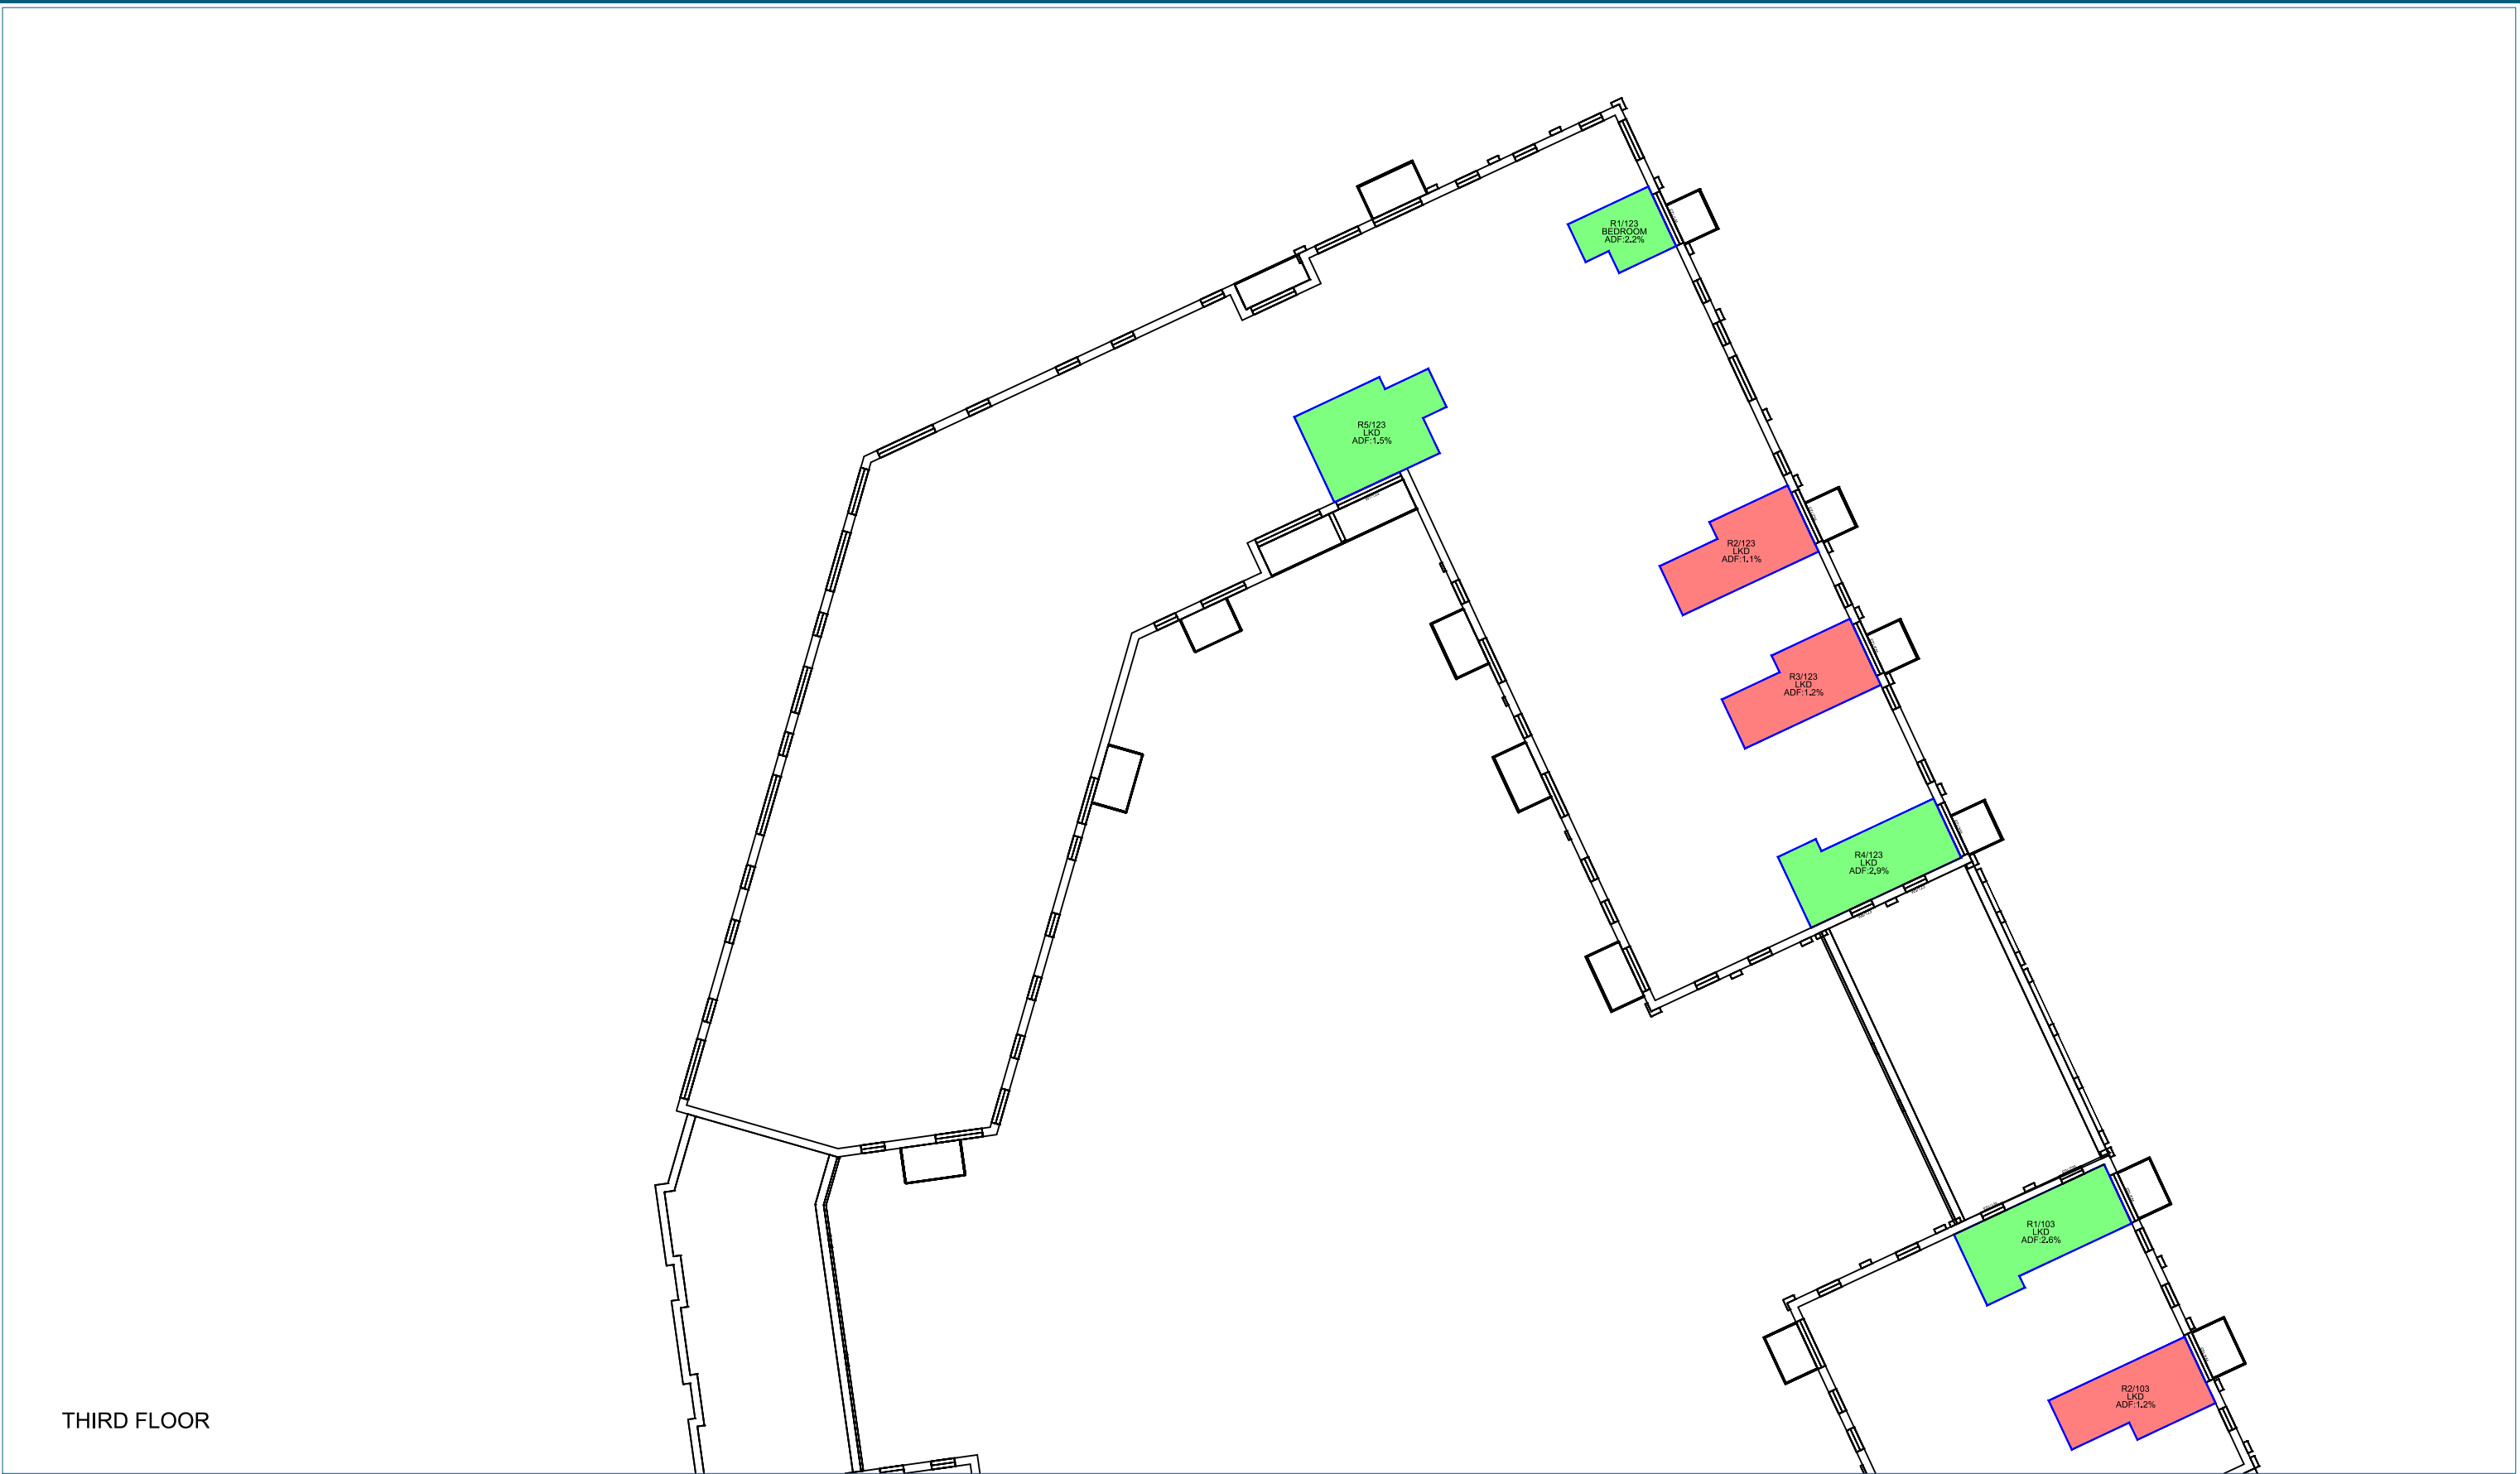
Dwg No: **P915/I/145**

Title: Internal ADF Results  
Proposed Scheme 12/01/17  
West Block

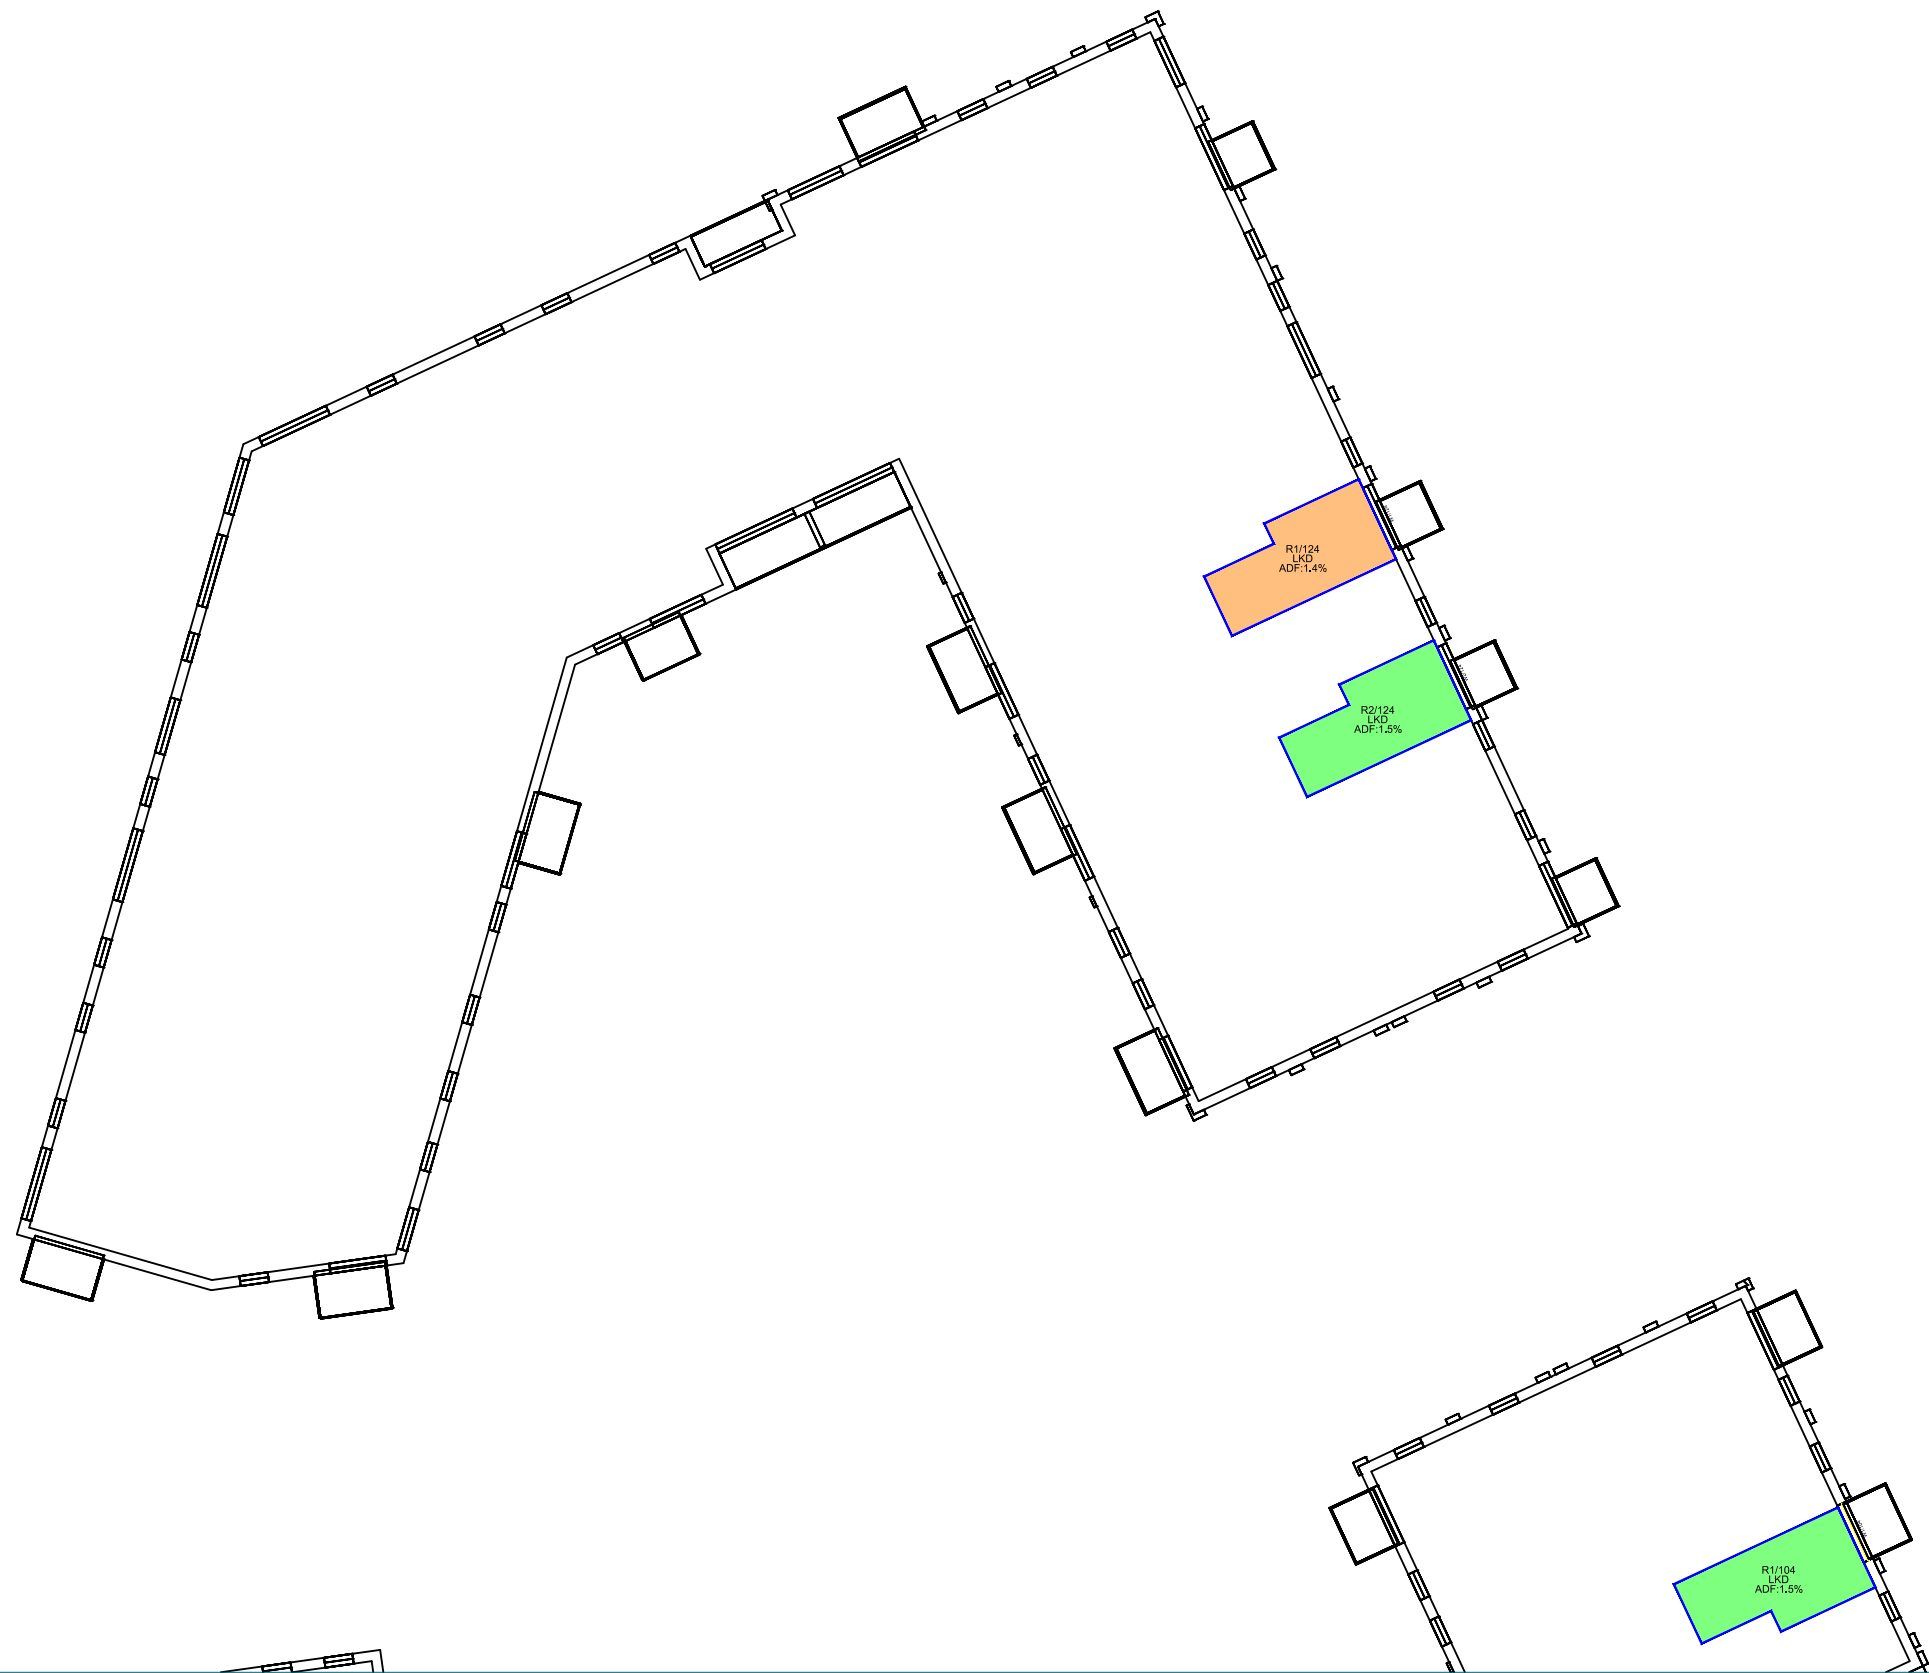
Dwg No: P915/I/147

FOURTH FLOOR

Title: Internal ADF Results  
Proposed Scheme 12/01/17  
West Block

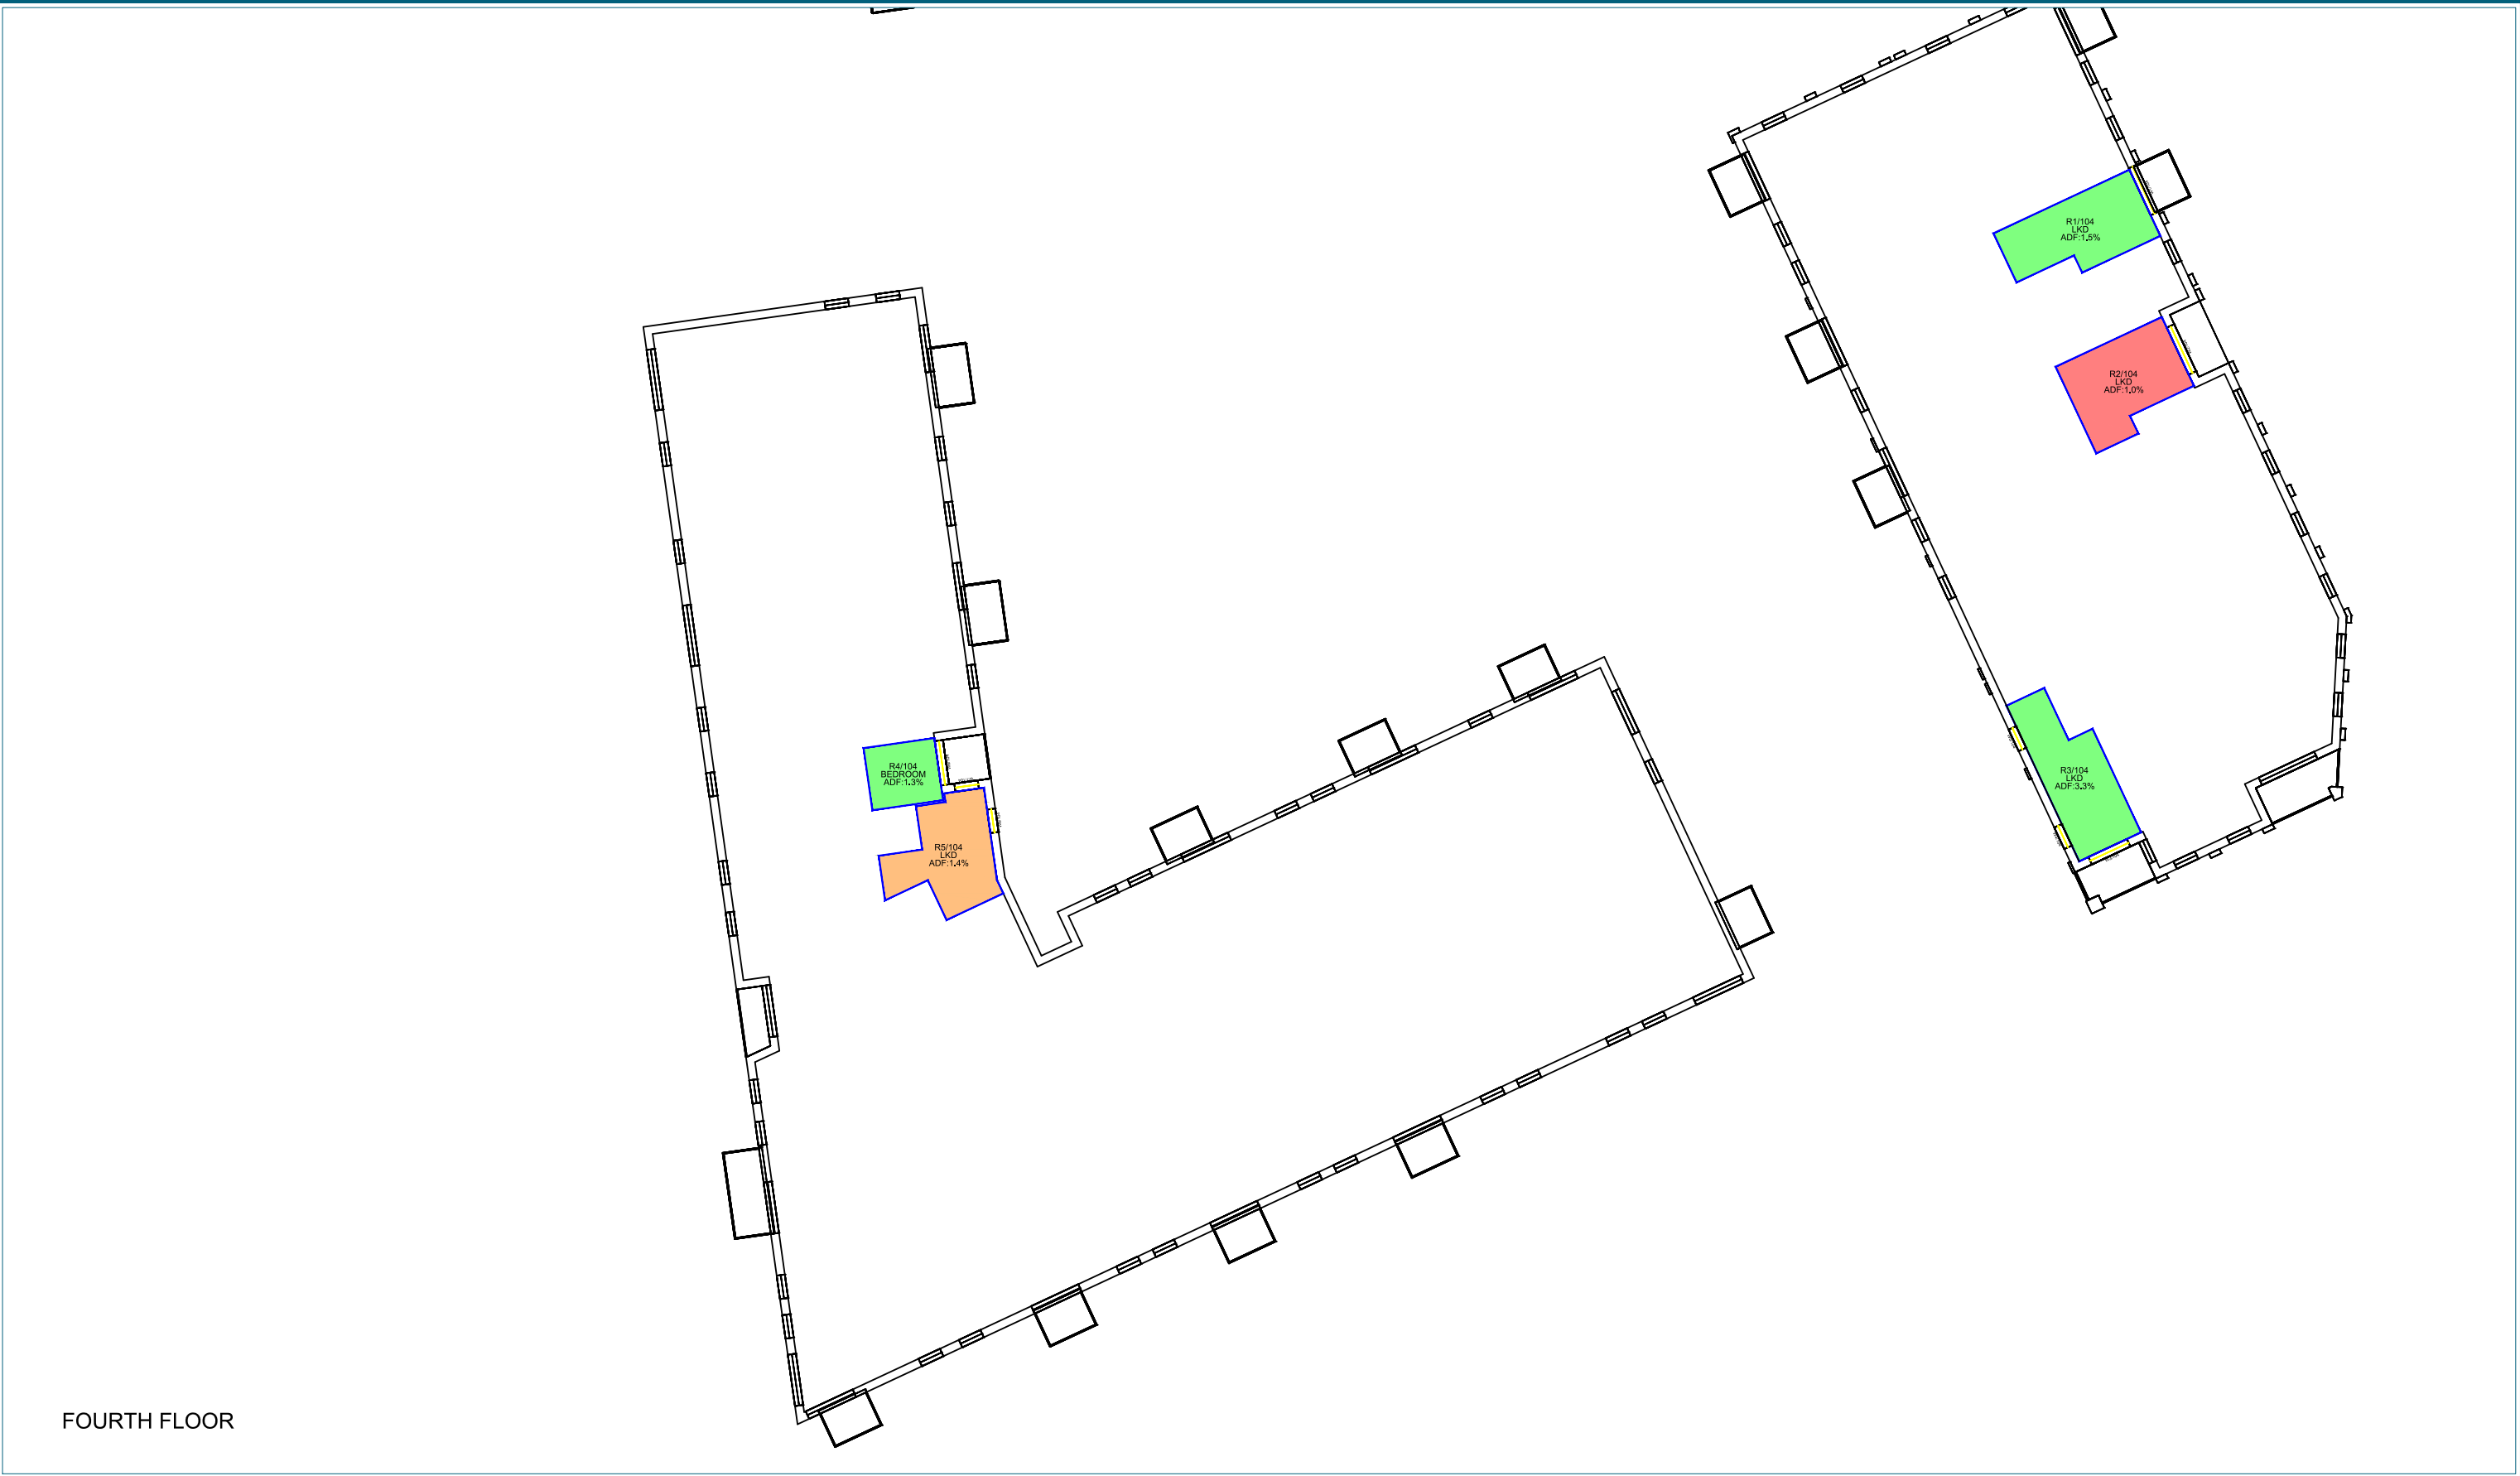
P915/I/148

Title: Internal ADF Results  
Proposed Scheme 12/01/17  
West Block
