# Reading Greyfriars

## Heritage Impact Assessment

Replacement of west end rooms and associated link building

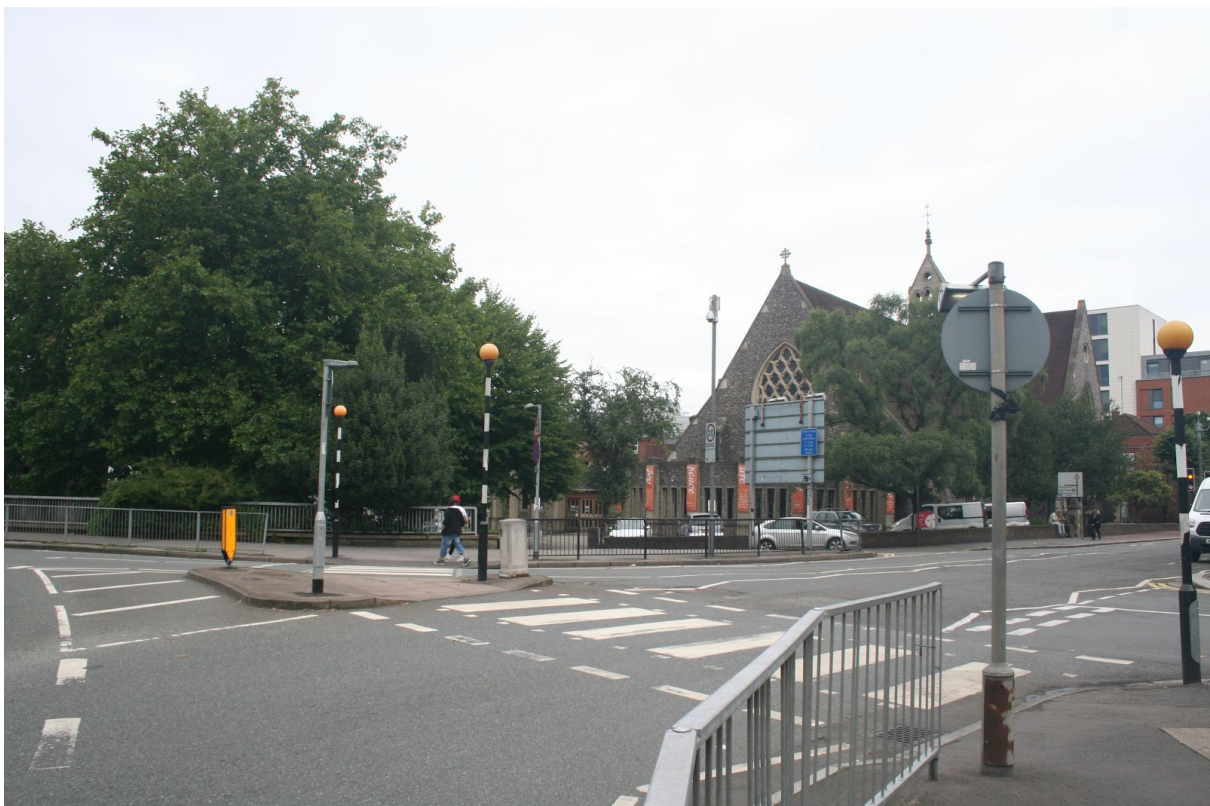
Above: Greyfriars from the south west, on the junction between Friar Street and the Caversham road

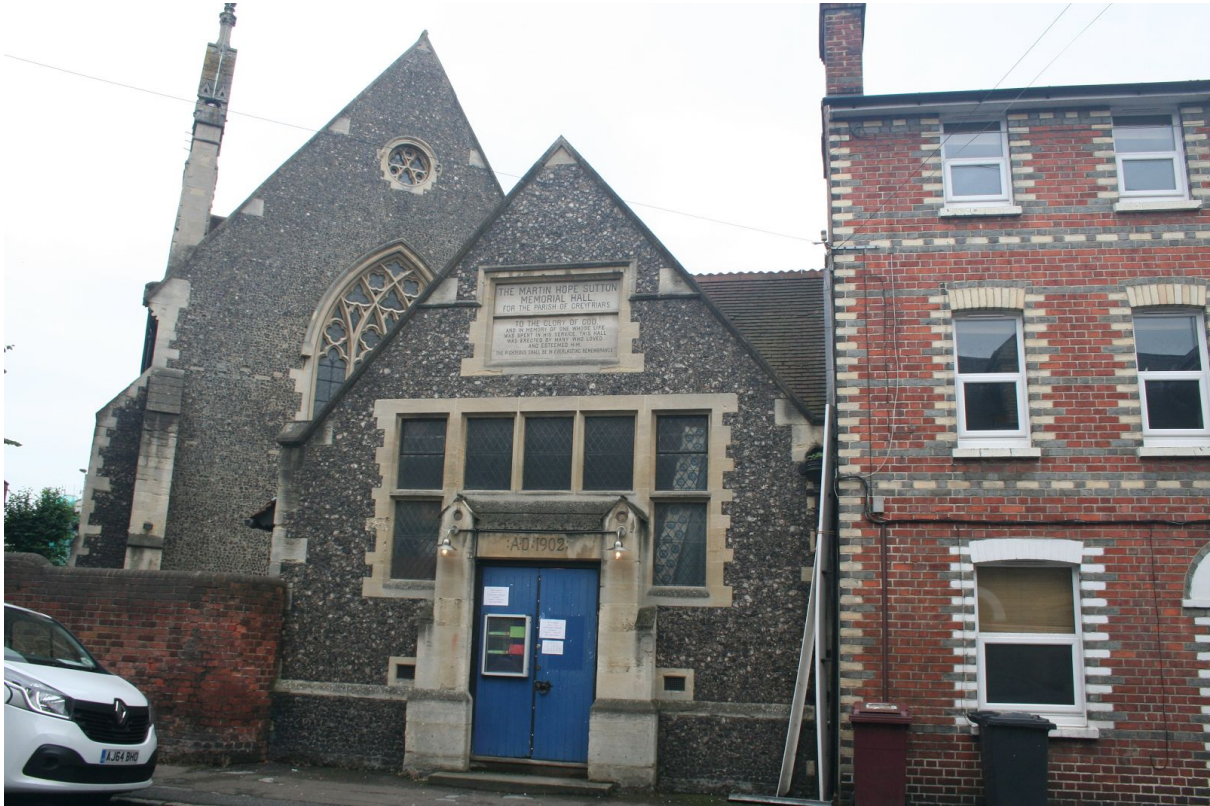
Above: north elevation of north transept, with the remainder of the elevation obscured by the memorial hall and houses of Sackville Street

The north elevation of the original church building is largely invisible, obscured by the old rectory wall, the memorial hall, and the houses of Sackville Street. The entire north wall of the north aisle is now within the 1972 extension linking the hall and the church, which runs almost up to the site boundary at the against the back garden walls of the Sackville Street terraces. This means that the north elevation is characterised as much by the 1902 and 1881 church properties on Sackville Street (the hall and numbers 2-4, the latter recently purchased) as much as it is by the north transept visible beyond them. Sackville Street itself remains much as it was c.1890, unlike Friar Street and the areas to the south of it which have been heavily regenerated. Overall though, this elevation is of **moderate-low significance**; it is of evidential and historic importance as surviving testimony to the 19th century character of the area, character that has already been lost on the other side of the church site along Friar Street, but it is not of great aesthetic merit.

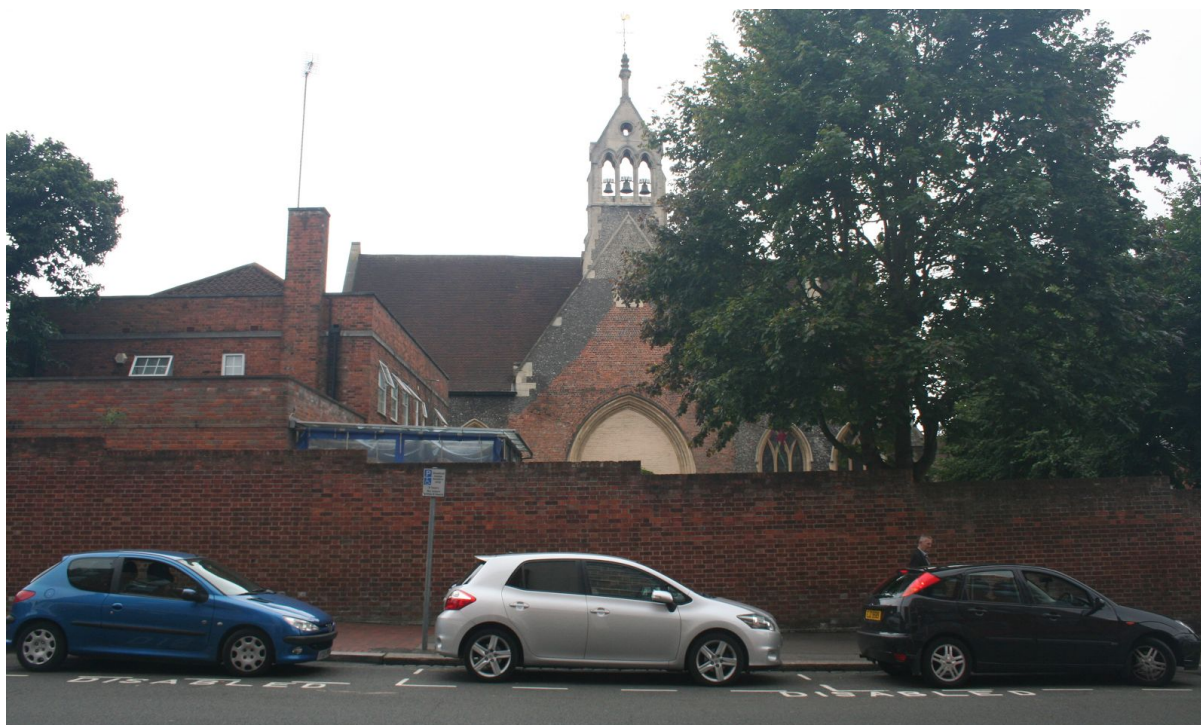
Above: east elevation from Greyfriars Road; 64 Friar Street, the old rectory and current church owned nursery, is on the left. The bell turret is Woodman's.

The east elevation of the church has not been built against, but is wrapped by the grounds of 64 Friar street and is therefore not directly visible from public roads or footpaths. As with the south elevation, most of the building here dates to Woodman's restoration; he built (or perhaps rebuilt) both transepts and the bell turret. The brick infill around the chancel arch is curious. At the time of the restoration many in the parish hoped that the chancel could be rebuilt, and Woodman's original sketch shows it; it may therefore have been his decision to infill in cheaper brick pending that work. On the other hand, the bricks could be 18th century, there are records of building against the east wall in the 18th century and the outline of the bricked up section is lower at the eaves and generally much smaller than the Woodman sketches indicate was his intention for the chancel. It is therefore most likely that this is the ghost of the demolished medieval chancel, bricked up post-reformation, refinished as part of the 18th century Haycock building works, and left untouched by Woodman who must have hoped he would be demolishing it in a later phase of work.

Overall this elevation is of **high significance**; though not much medieval fabric remains the elevation is the only one that shows traces of the building's post-reformation and pre-Woodman history, and the ghost building outline, whether of the former chancel or an 18th century building, is of considerable evidential, historical and archaeological importance.

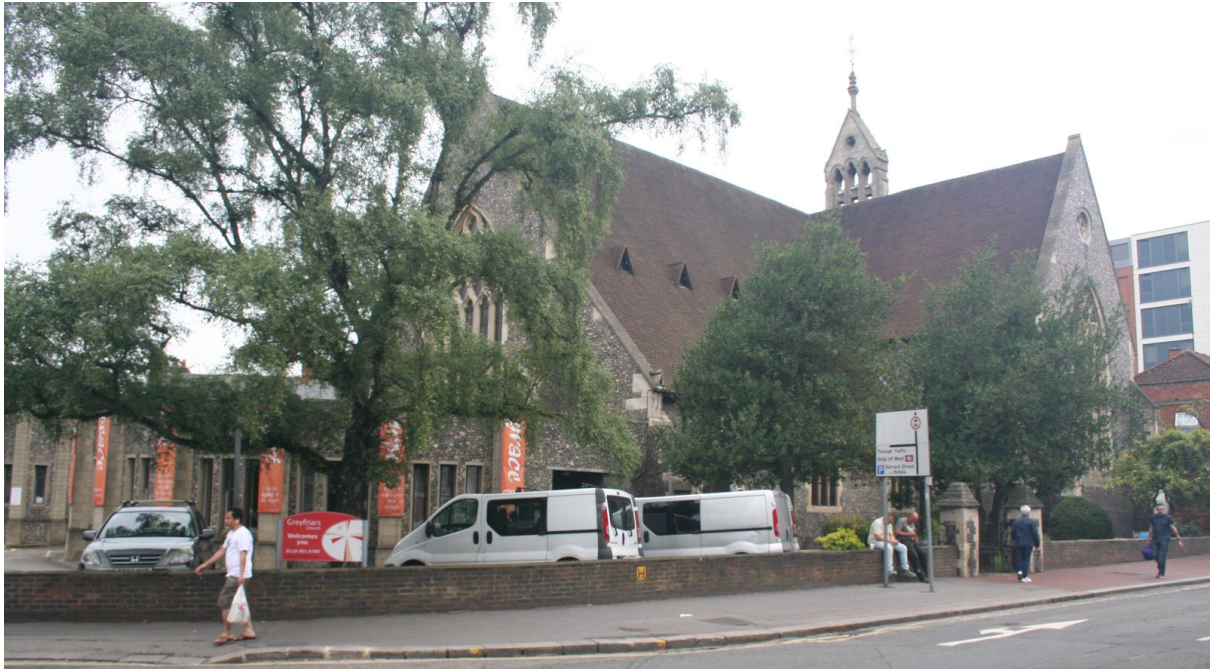
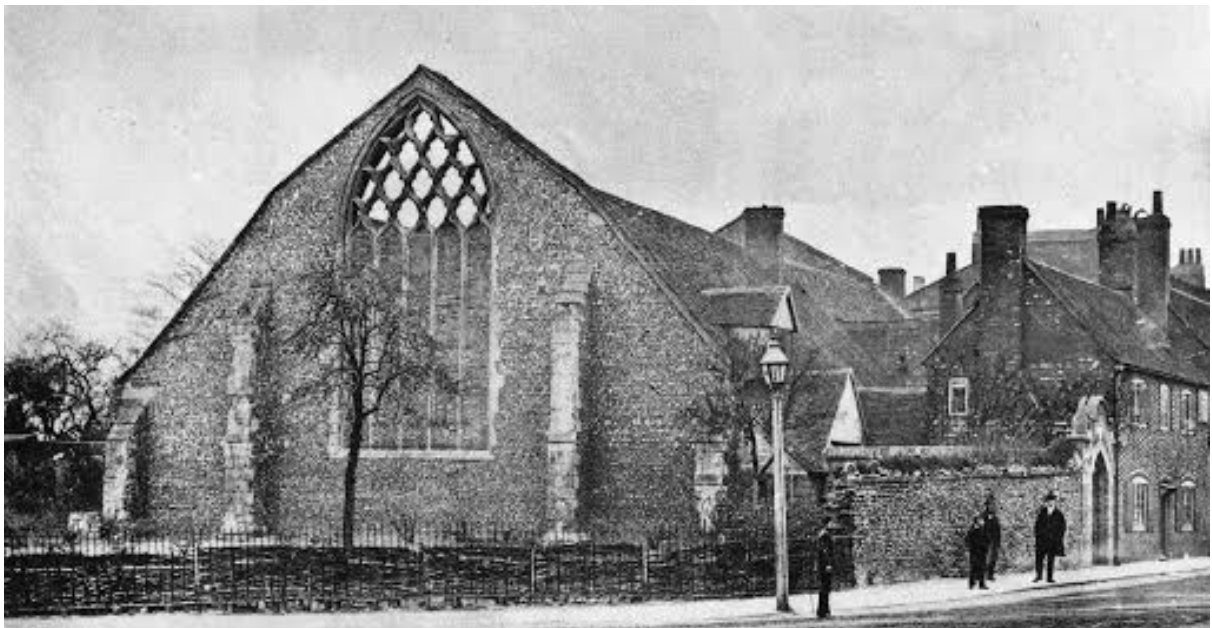
Above: Greyfriars south elevation, from Friar Street looking north east. Note the 1972 extension to west end of the church, on the left hand side of the image. Below: the same view c.1860, prior to the restoration works.

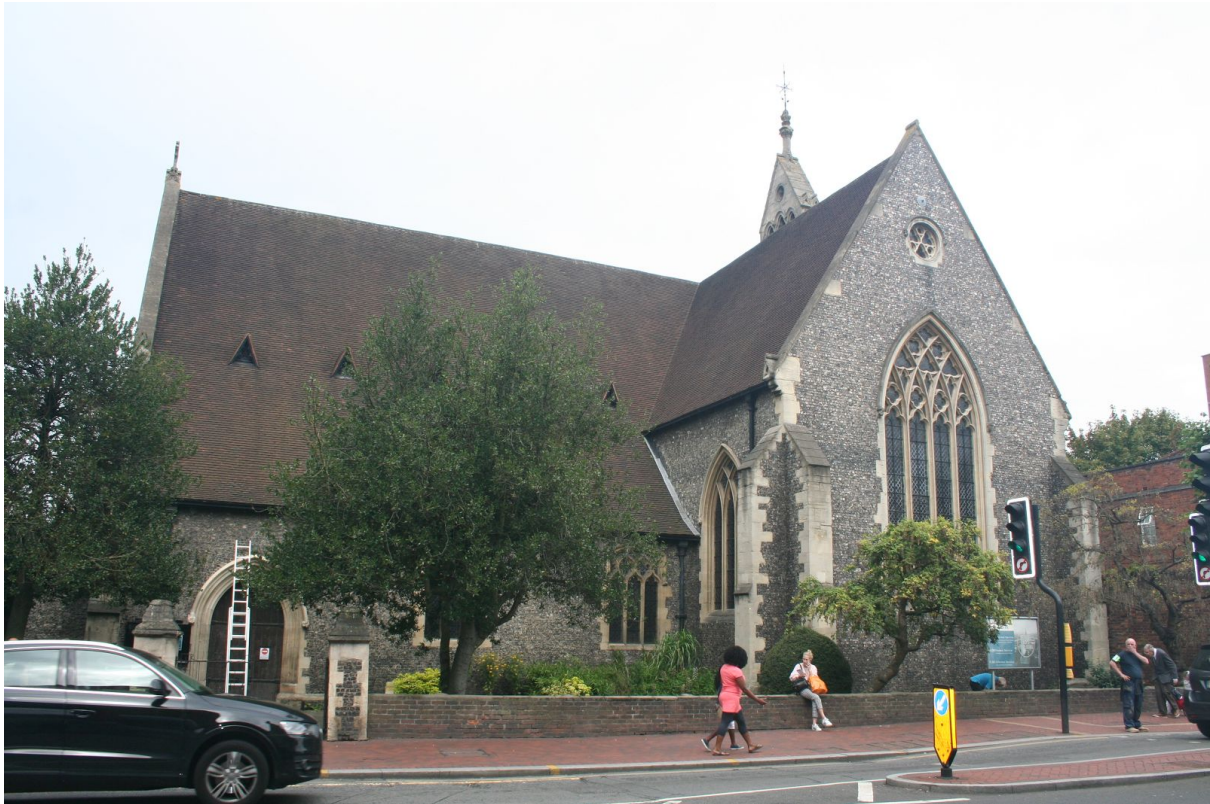
Above: south elevation of the friary church, looking north

The south is the principal elevation, and the one on which the church, as restored by W H Woodman in 1862-3, is most visible. It is dominated by the lofty south transept, and by Woodman's catslide clay tile roofs, in comparison to which the south aisle wall seems low

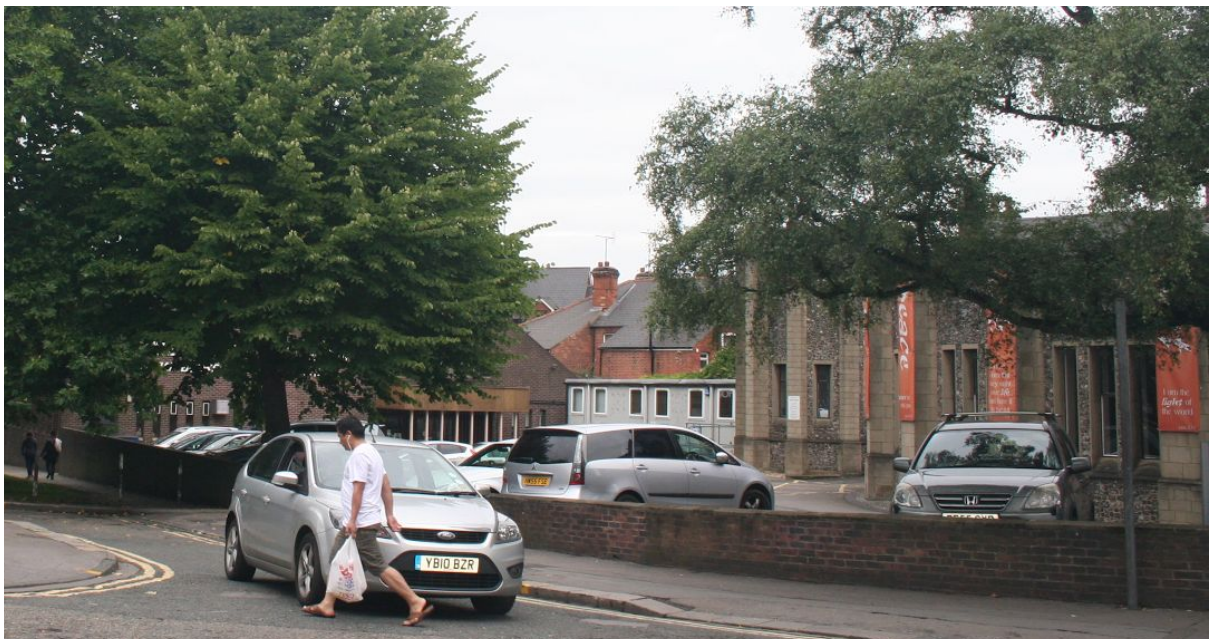
Below: south elevations of the west end of the site, with Greyfriars centre (left, through trees) and temporary building (centre). The backs of the Sackville Street terraces are visible over the temporary building.

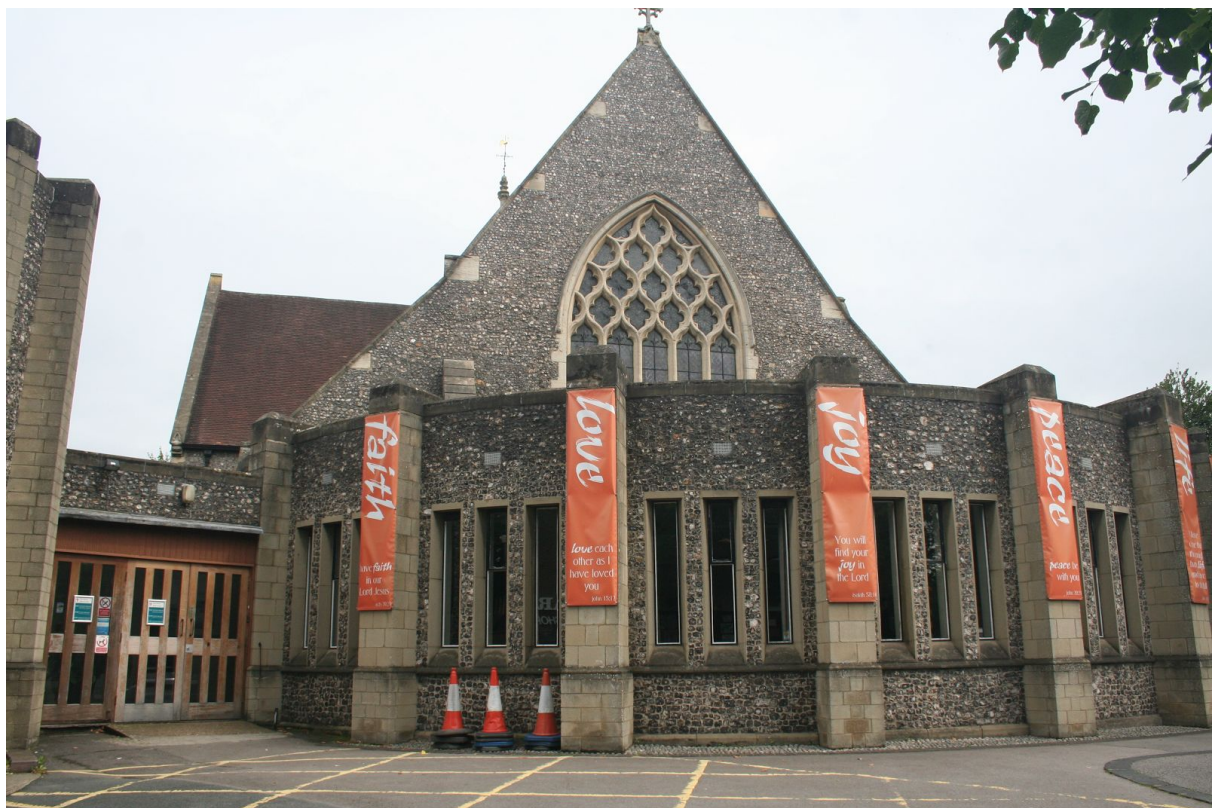
Above: west elevation from church car park

The west elevation is best known for its early 14th century west window, sensitively renewed by Woodman. This is the most familiar view of the building and is the one that appears most often in historic images of it before the restoration works; the window itself is a remarkably complete and rare example of early 14th century Franciscan tracery of national importance. The curved west extension was added by K C White in 1972, obscuring the lower part of the

original west end and of the window itself; this extension work also provided a new main entrance, as can be seen on the left hand side of the image above.

White's extension, in flint with concrete dressings, is sensitive in form, with a curved wall that reduces its perceived mass but unfortunately also reduces the usefulness of the interior space and places a visual barrier between the main road (Friar Street) and the main entrance. The selection of flint was clearly intended to complement the historic building but the effect is rather the opposite; the flint of the original church is lost against that of the extension (particularly in diffuse light), making it seem like a backdrop rather than the most important architectural feature on the site. Overall the significance of the west elevation of the 1863 building is **high**, but that of the White extension **low**.

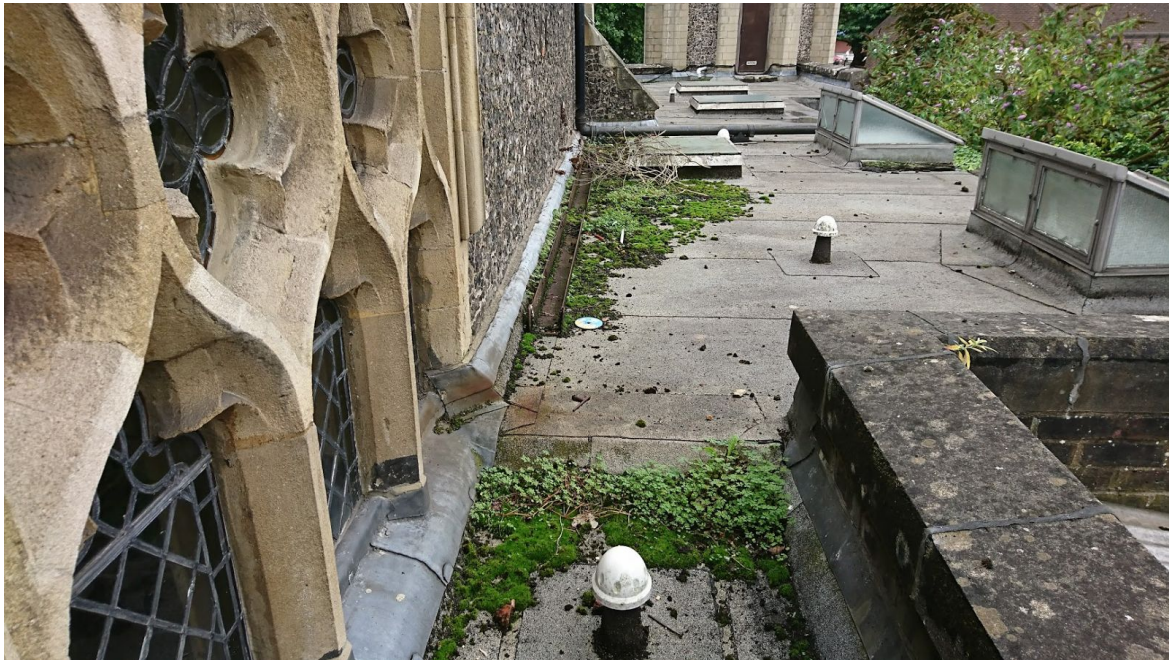
Above: flat roof to 1972 north link and west end extension

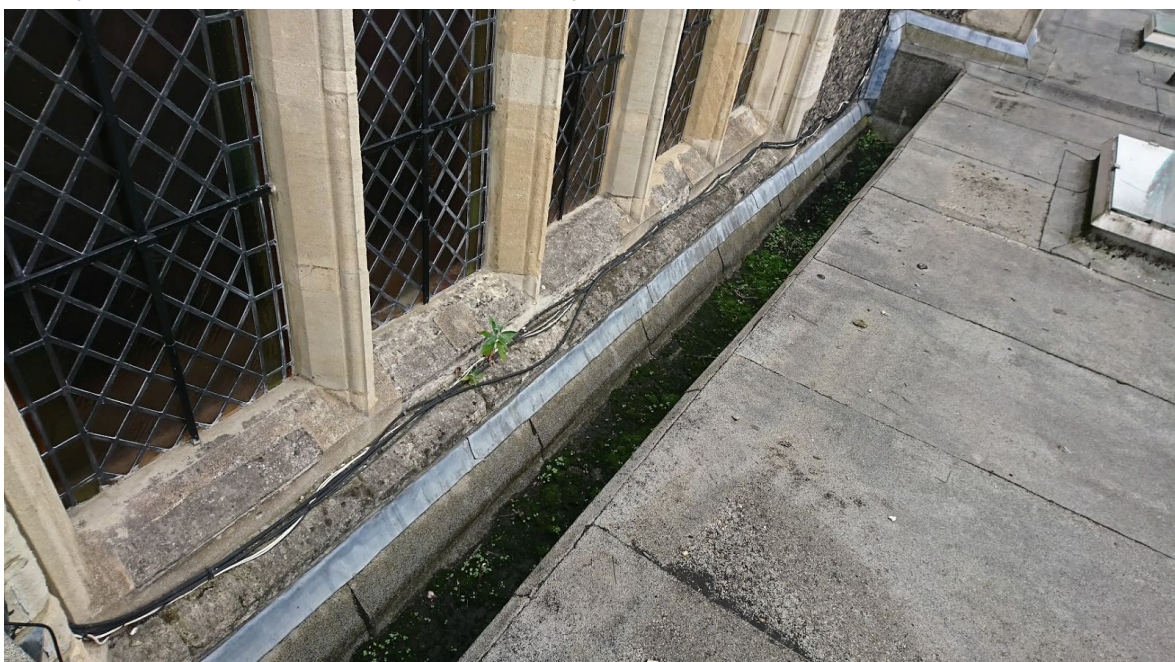
Below: junction of 1972 roof with renewed 14th century west window

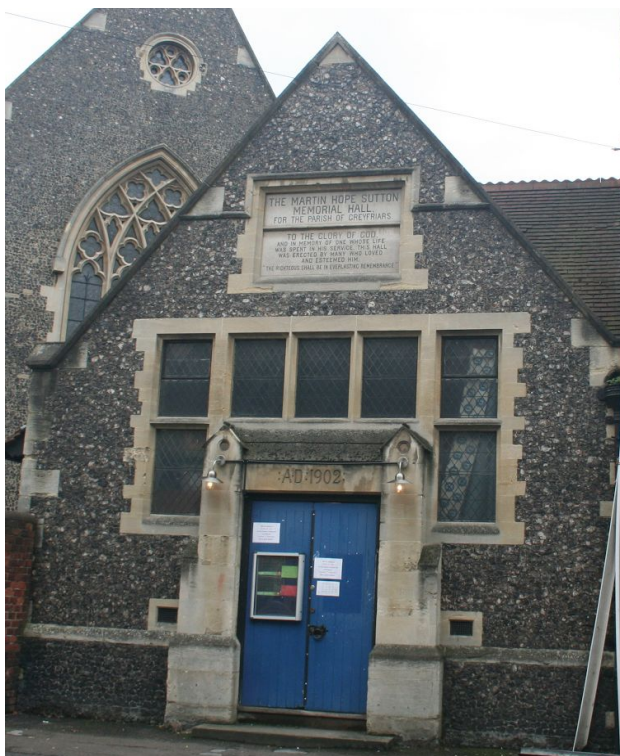
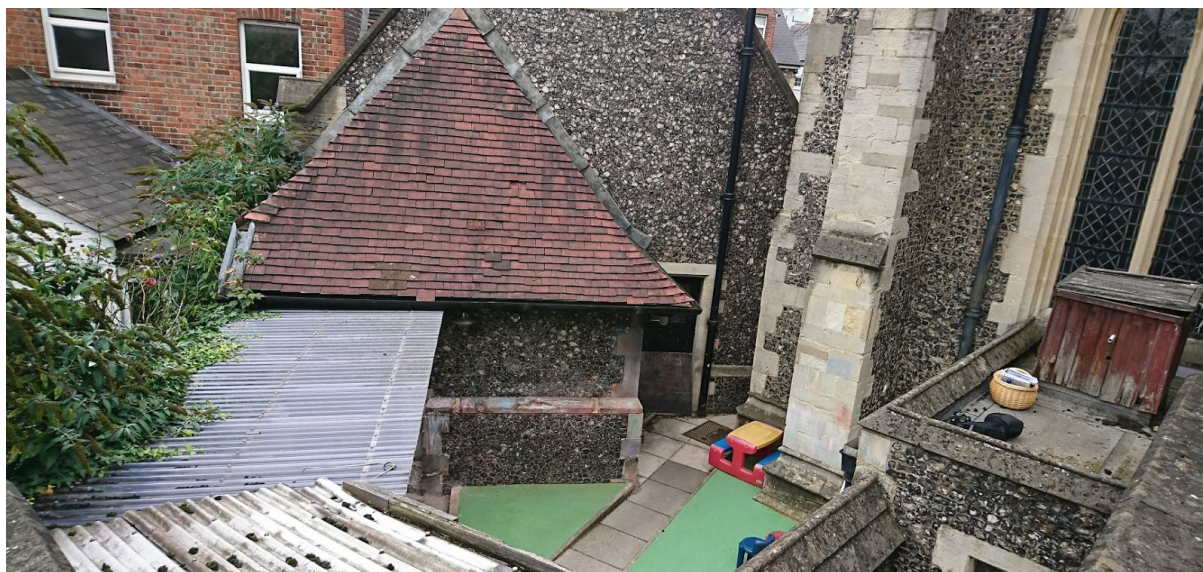
1902 by Ravenscroft, Son & Morris of the Forbury, Reading. Principal elevation and entrance to Sackville Street, though functionally it is accessed most through a small rear entrance from the 1972 link between it and the north side of the church. Flint with limestone dressings and clay tile roof. The main contractors for the build were Messrs Wheeler of Caversham Road, Reading, and the original building cost £750. Apart from the road facing elevation this is a plain building; on the road elevation the door surround crashes awkwardly into the large 10 light square window. A memorial plaque over the window commemorates the commissioning of the hall in memory of Martin Hope Sutton, who is commemorated within the church. To the rear of the hall is a small extension which

accommodated the original WC provision, and a small yard that is used as an outdoor play space by the nursery. Overall the hall is fairly standard Edwardian work, competent but not remarkable. **Moderate significance.**

Top: Sackville Street elevation of Memorial Hall. Above: Hall rear extension and nursery yard adjoining north transept.

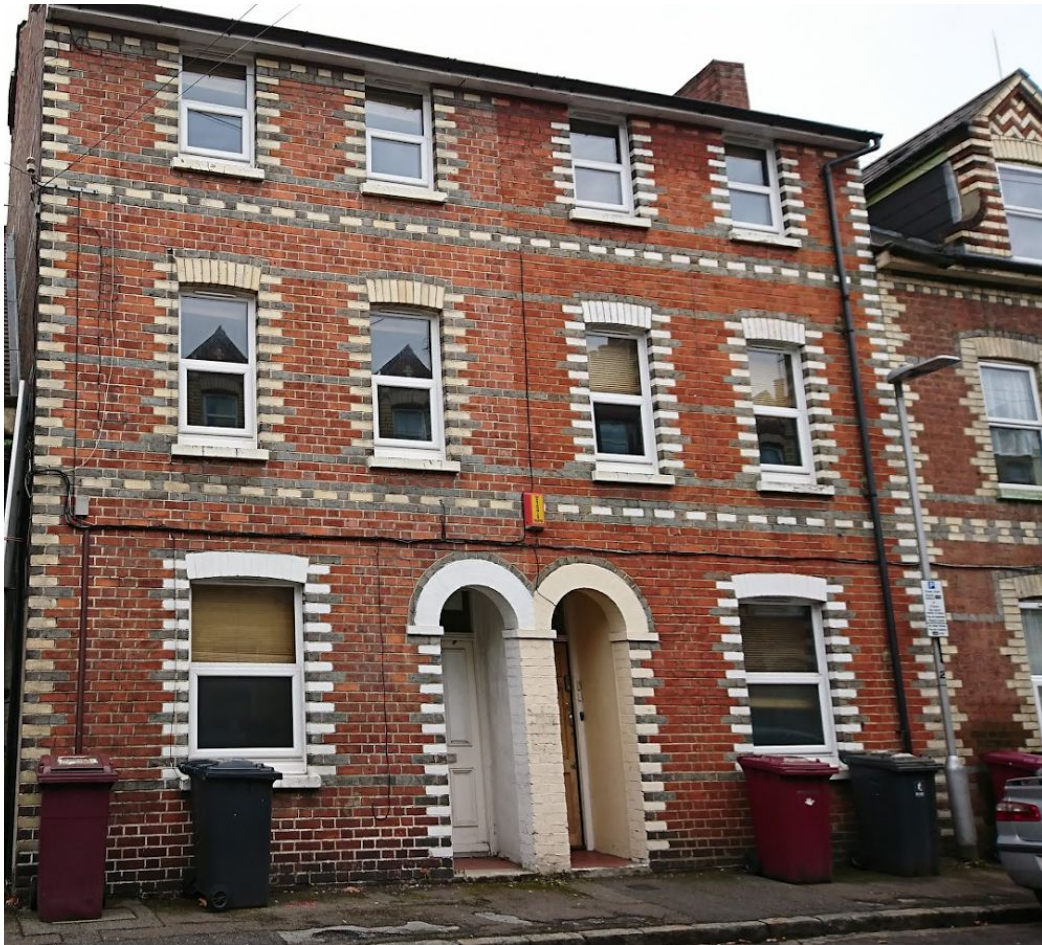
Victorian terraces c. 1881. Bold polychrome brickwork facade with black and cream bricks to string courses, quoins, and windows, narrow arched doorways. Modern double glazing. Built as accommodation for town's industrial workers, but in recent times used as offices by No5 counselling services, a local charity. The facade is an important element of the streetscape but the rear extension and interior refurbishments have removed most of the original character of the building itself. **Low significance** as a whole, the facade **moderate significance** as a part of the streetscape.

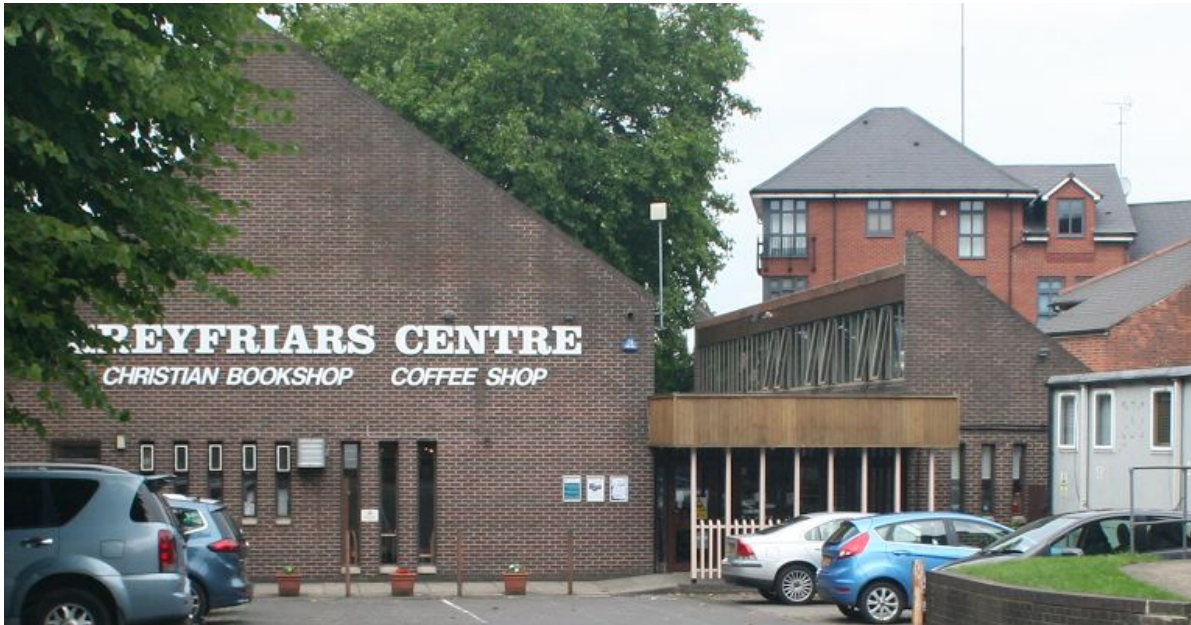
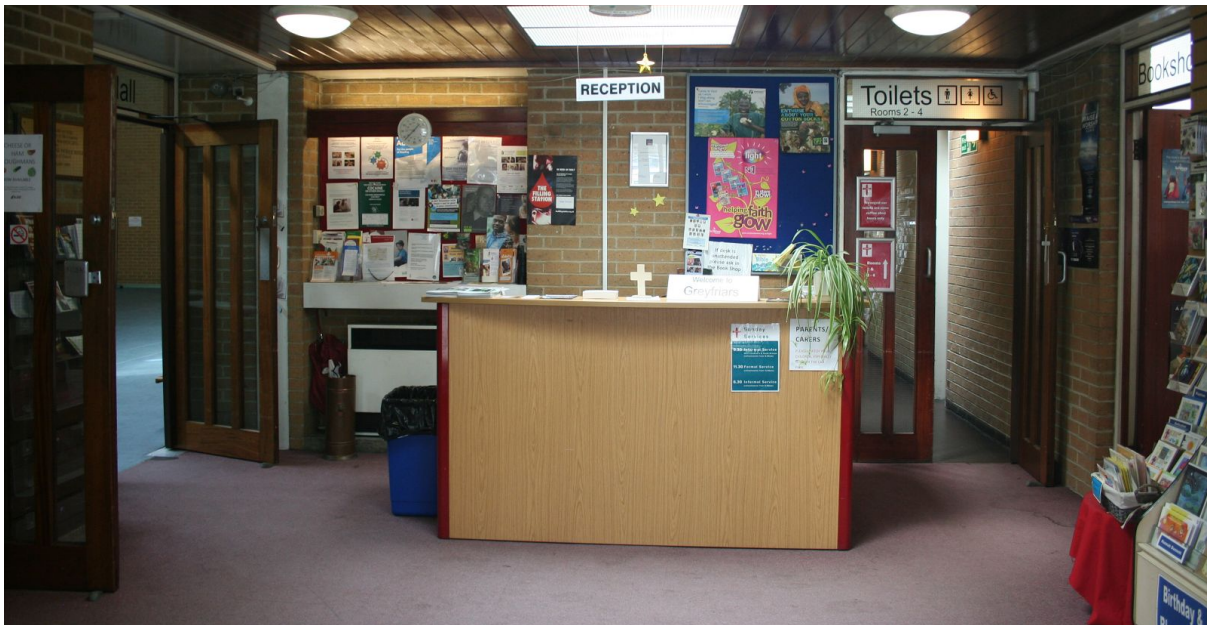
1981-3 by J Alan Bristow in dark brick with tiled roofs. Composed of two linked parts; a large hall, kitchen and cafe to the south, and a smaller series of meeting rooms with a bookshop to the north. Functional but of limited architectural merit and no historic importance. **No significance.**

Above: east elevation of centre; below: main reception area
