**PHASE 2 ENVIRONMENTAL**

**GEOTECHNICAL INVESTIGATION**

**NO 4008/18**

**28 WOKINGHAM ROAD, READING RG6 1JQ**

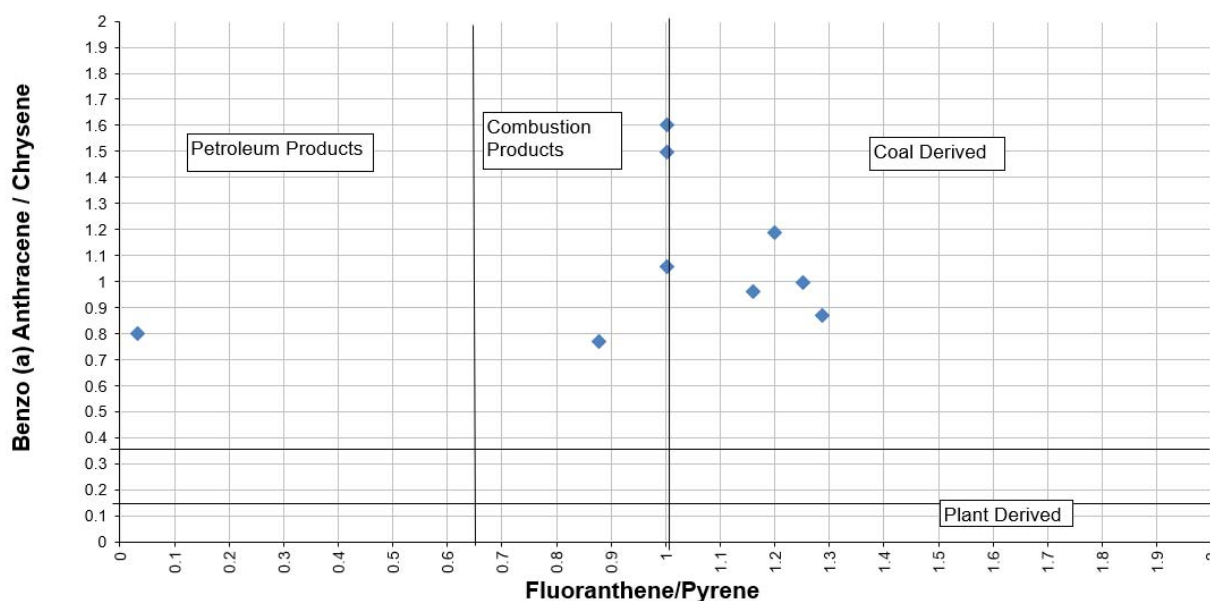
*Above a plot of the ratios of Benzo Anthracene / Chrysene vs the ratio of Fluoranthene / Pyrene*

5.34 In order to identify the source of these hydrocarbons (i.e. petroleum products combustion by-products, plant derived or coal derived) we have looked at the proportions of particular individuals (by plotting concentration ratios – see plot above)

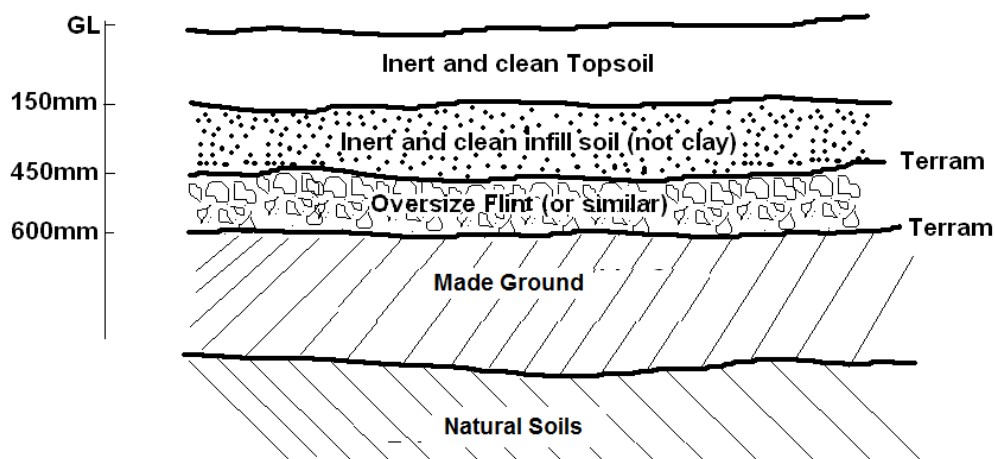
- 8.30 Capping should include a granular break layer at a depth of 0.6m sandwiched by a woven geotextile, top and bottom. The granular material would be oversize flint or a similar non porous stone. Crushed brick and concrete will not be suitable.

- 8.31 The granular layer would then be covered by suitable clean inert soils. This layer should not be clay due to potential waterlogging however, the materials should be able to retain some moisture for any plants or shrubs planted in the garden. The last 150mm should be a clean uncontaminated topsoil which also complies with the multipurpose topsoil specification in BS3882.

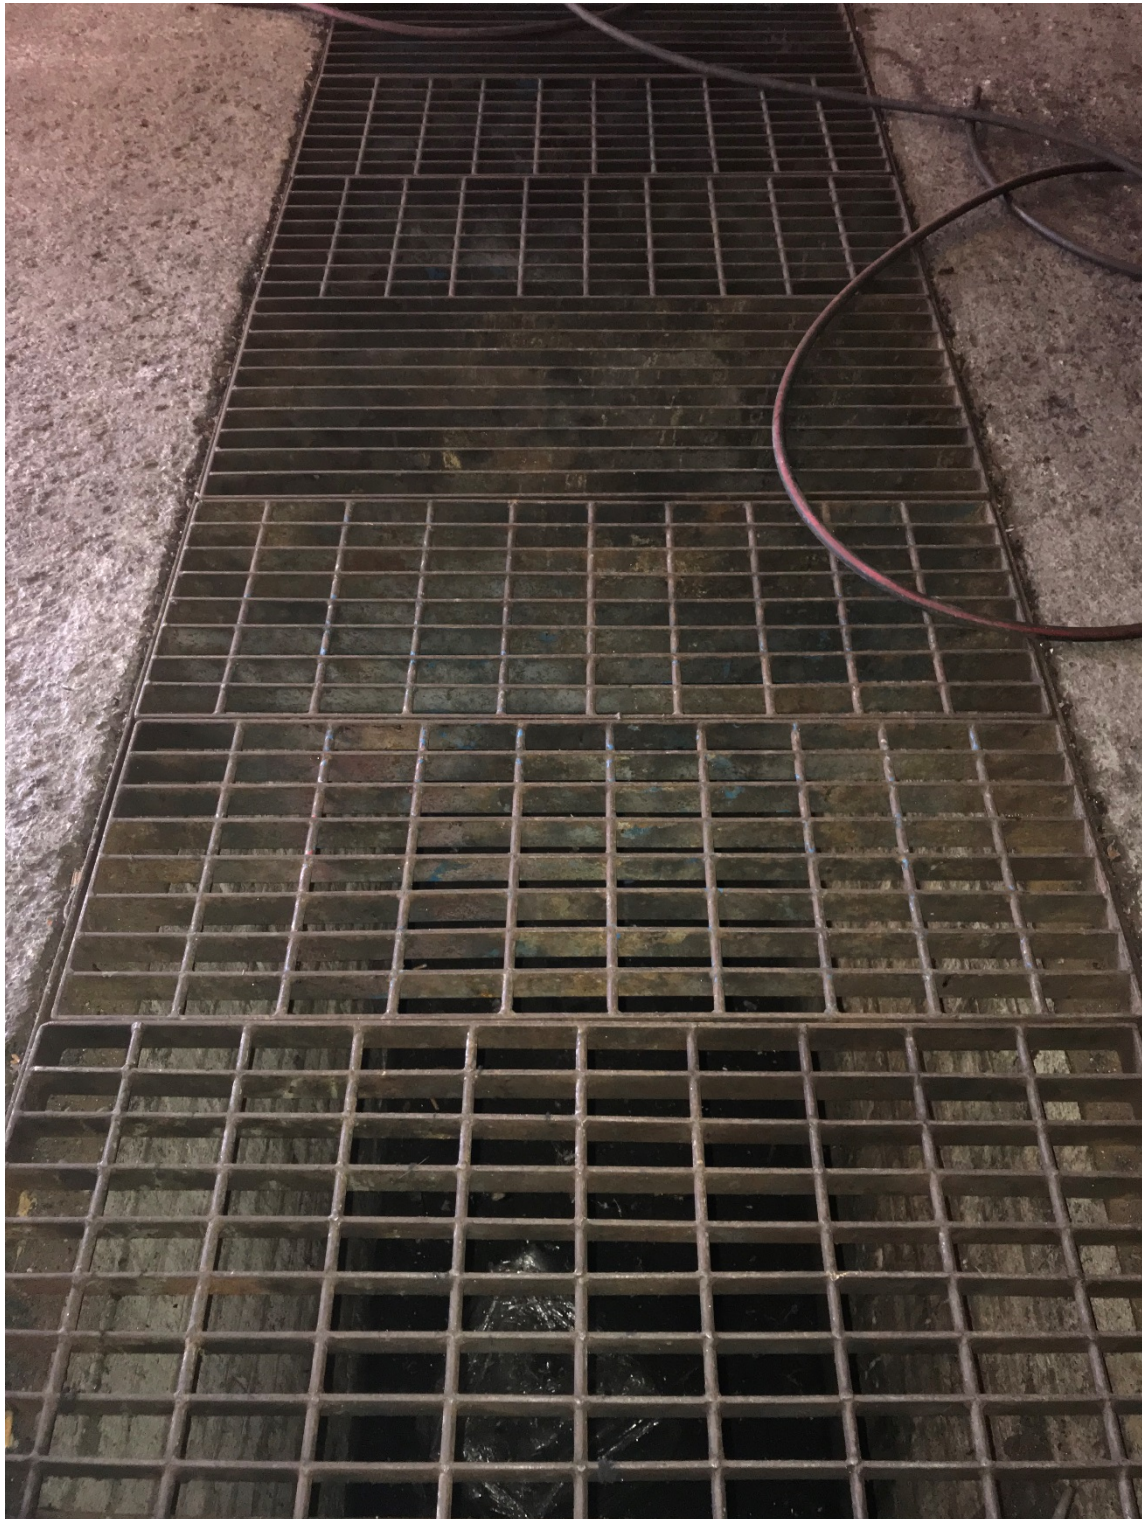
*Inspection pit within tyre fitters*

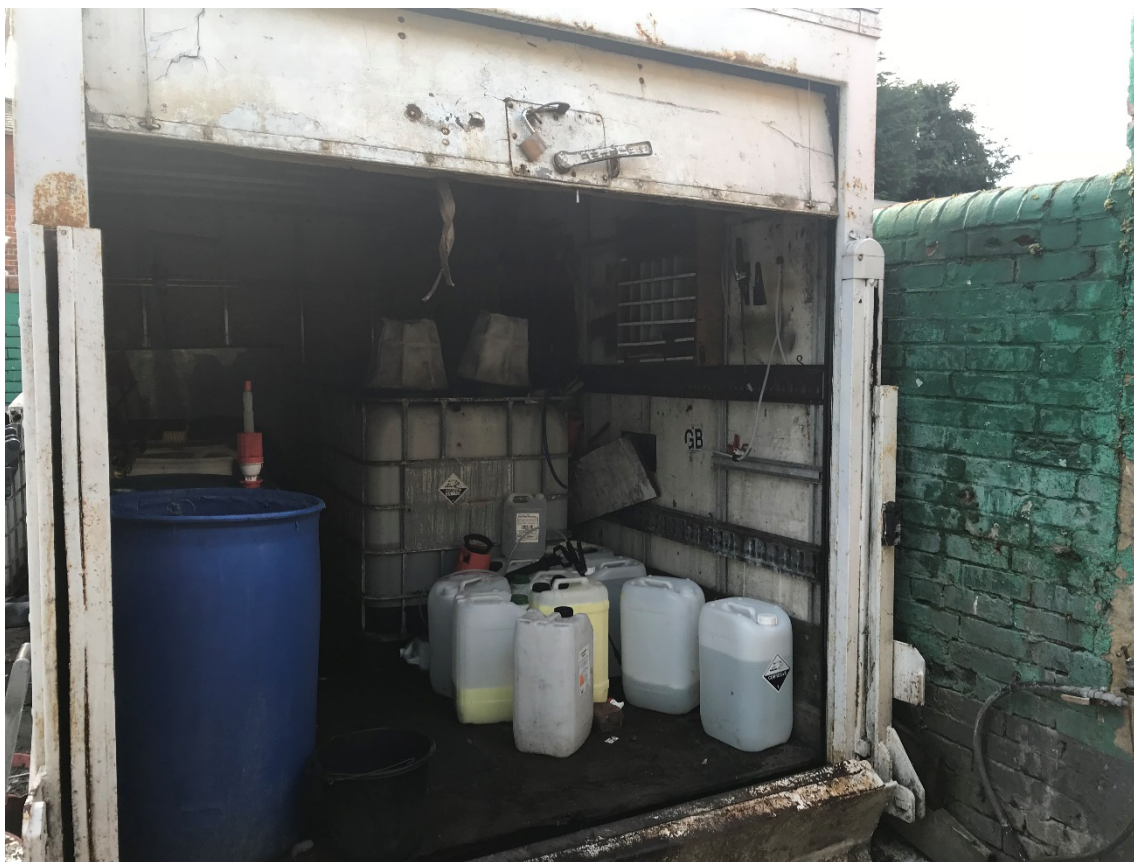
*Chemical storage container for car wash*

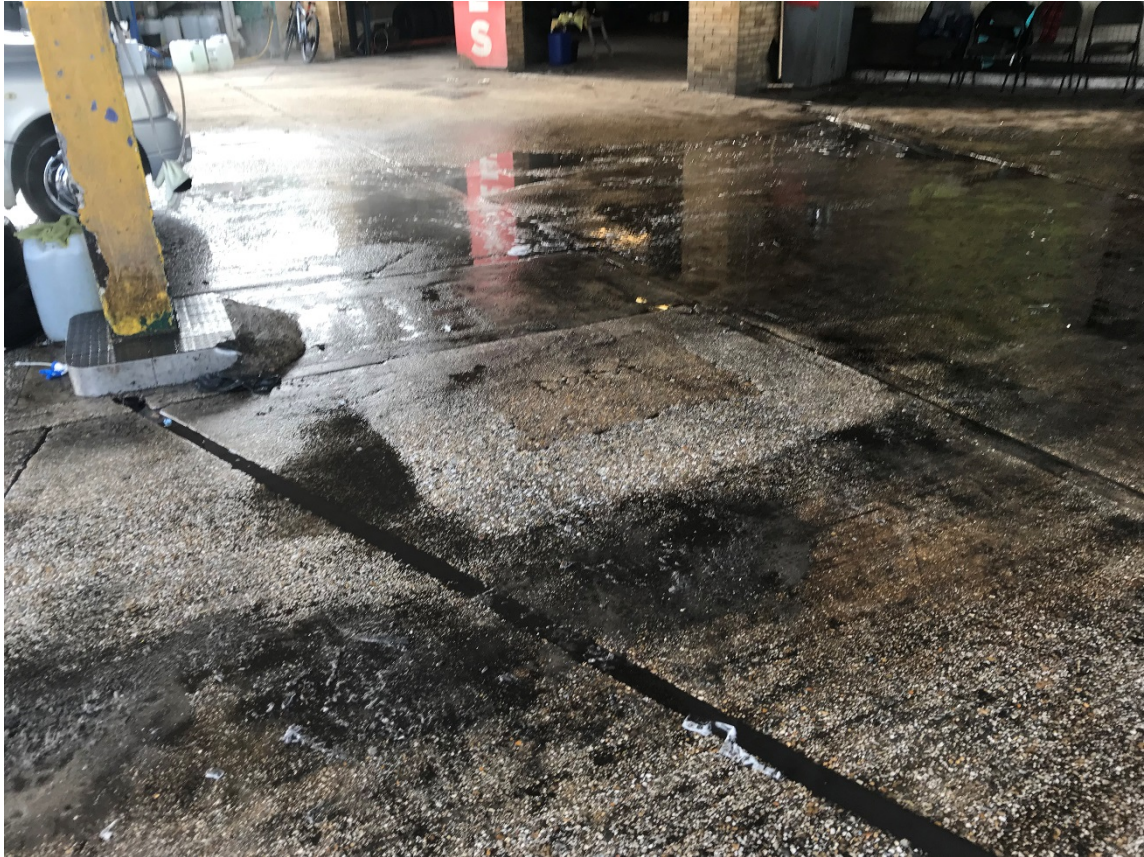
*Concrete 'mound' denoting suspected location of former fuel tank cover*

- 8.3 Prior to demolition the possible tank locations identified during the service scan should be examined by a specialist contractor, and any tanks found to be present should be cleared as gas safe by that specialist.

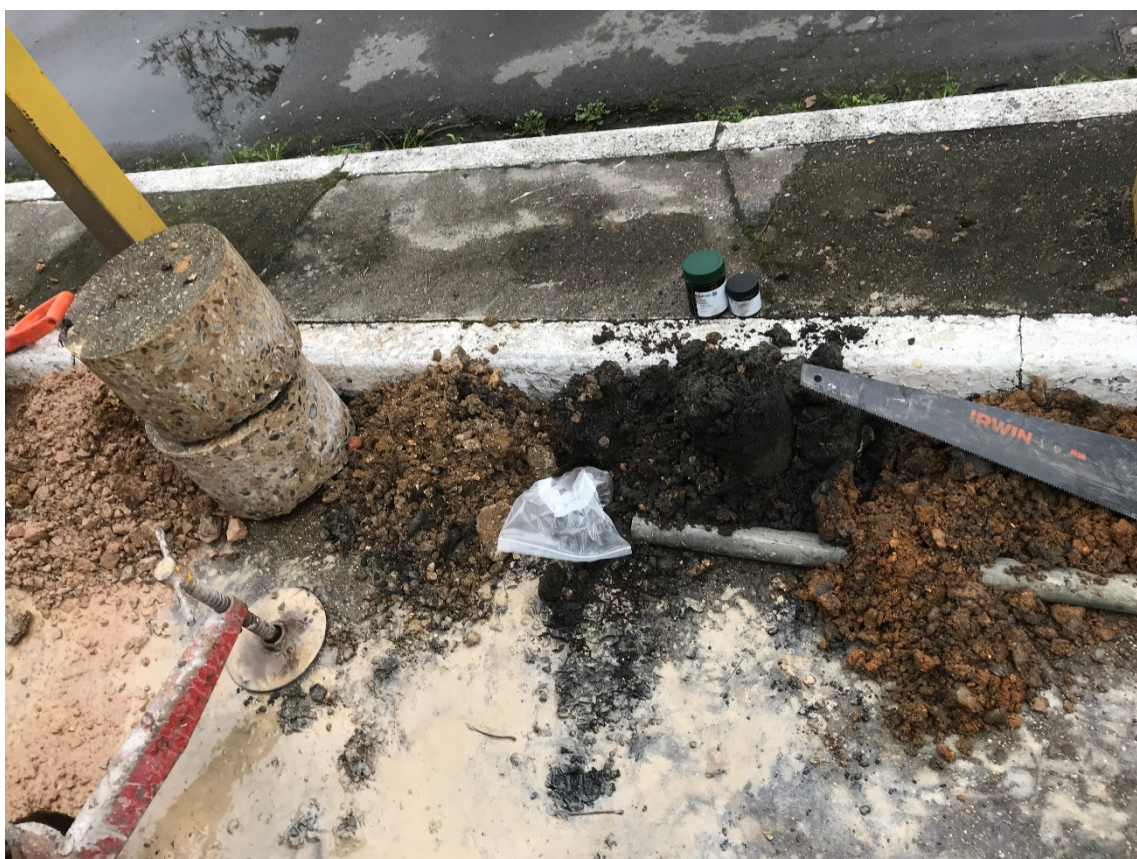
WS2A hand pit arisings

- 3.7 With the exception of hydrocarbon impacted soils encountered to 1.5m depth in WS2a, there was no visual or olfactory evidence of significant contamination noted by the logging engineer.

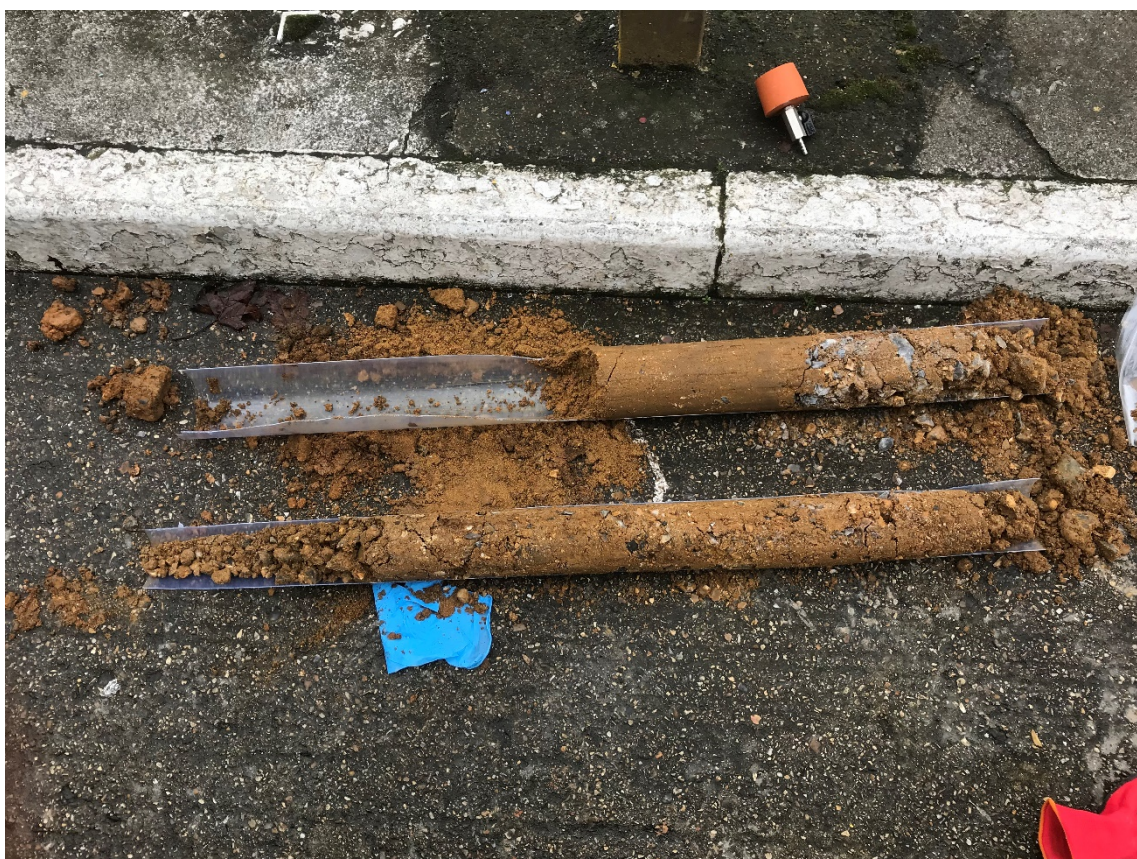
WS3 core

- 3.9 Weathered 'putty' chalk was encountered to termination in WS1 and WS3 representative of the mapped upper chalk was encountered. Due to disturbances caused by drilling, it was not possible to describe the chalk in accordance with CIRIA C574 guidance.
