# **FORMER RED LION PUBLIC HOUSE & No. 38, SOUTHAMPTON STREET, READING**

## **Heritage Statement**

Revised June 2018

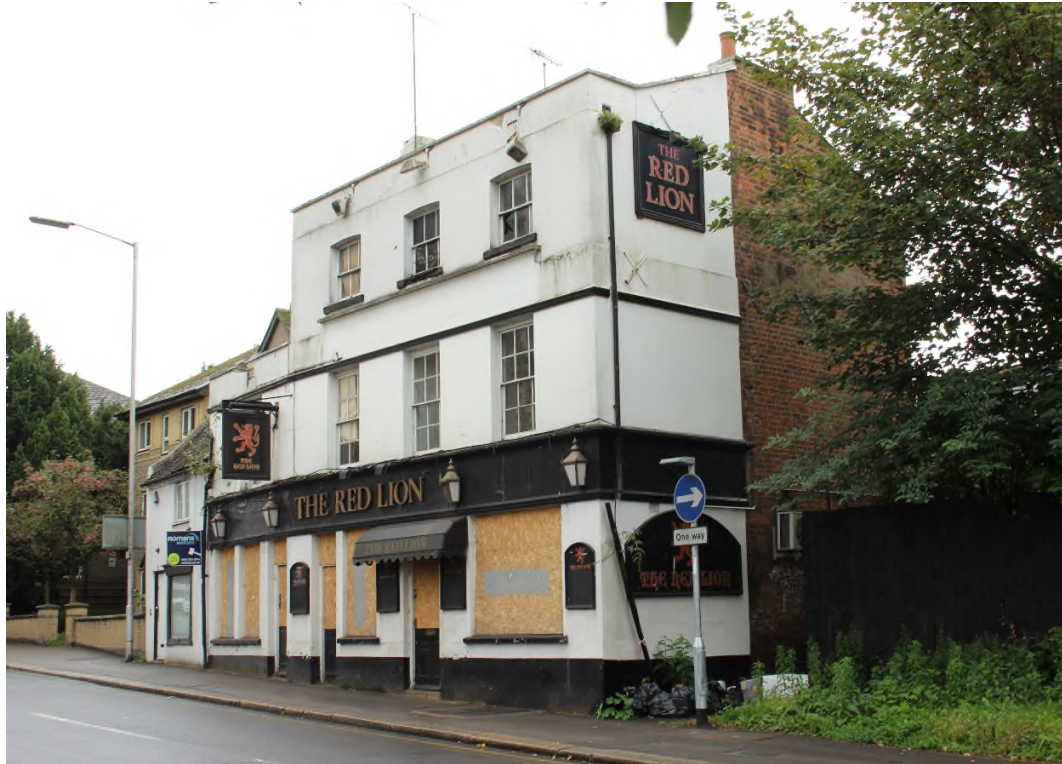
Figure 1 Front and north elevations

- 3.1 The principal element of the former Red Lion is a three-storey building of three bays with white painted render to the front elevation, the south gable end above a two-storey element and to the eastern part of the north elevation (Figure 1). The ground floor windows are currently boarded over; they are large openings that are probably later insertions. At first floor level there are six-over-six sashes and three-over-three sashes to the second floor, the latter having very shallow segmental arches over. Between the ground and first floor level there is a wide timber sign board across the whole of the front elevation and wrapping around the corner to the north elevation and between the first and second floor windows there is a wide, slightly projecting band which rises up to a stone 'capping' set centrally to the three-bay section – the band continuing as the parapet to the adjacent building to the south. The roof is a shallow-pitched slate roof hidden behind a parapet to the front elevation and there are large stacks to each gable end, that to the north rising only slightly above the coped gables.

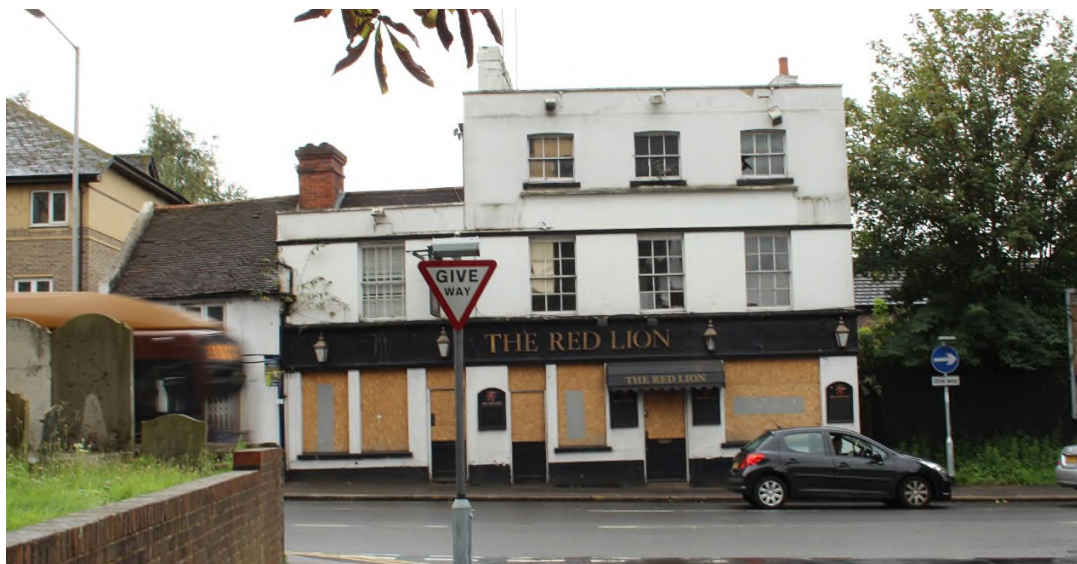
Figure 2 The former Red Lion, front elevation showing the two-storey element to the south of the principal block

- 3.2 To the south of the principal element of the building is a two-storey element which also has a painted render front with a parapet but this parapet conceals one bay of a pitched tiled roof, the second, southern bay forming part of a separate property, No. 38 (Figure 2). Between these two bays is a square ridge stack.

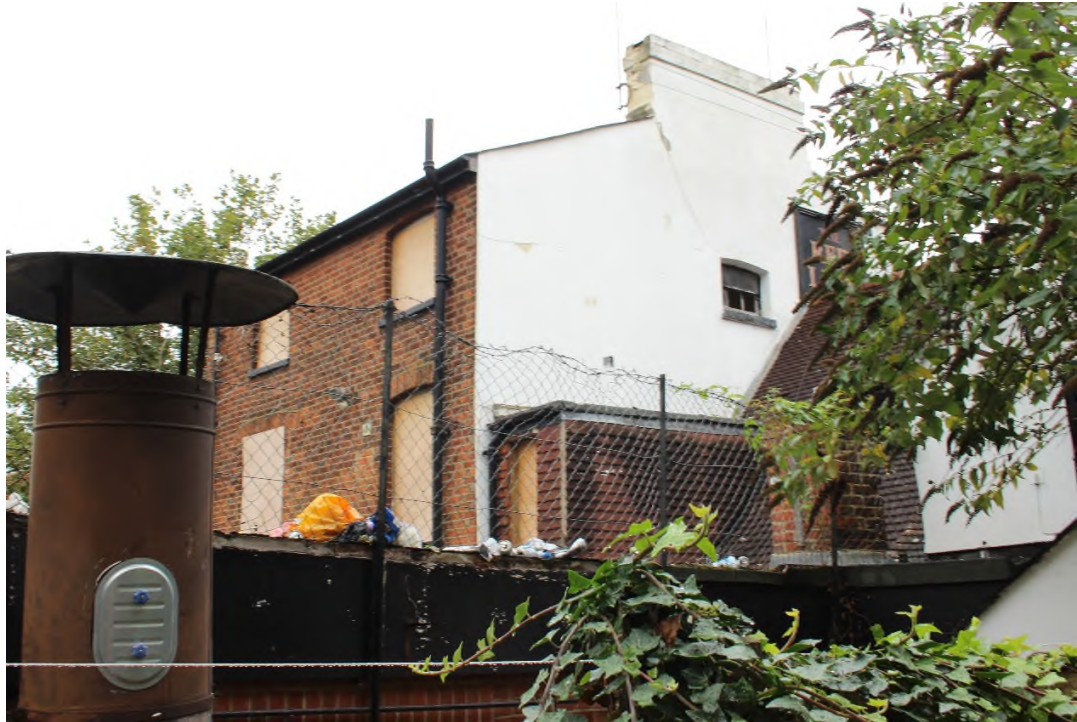
Figure 3 Rear elevation above the single storey extension with the rendered south elevation to the right.

- 3.3 The remaining part of the north elevation is of unpainted brick laid in Flemish bond, as is the rear elevation (Figure 3). The openings to the rear elevation have segmental arches over and there is some evidence for alteration to some of the openings. Across the whole of the ground floor of the rear elevation there is a flat-roofed single-storey modern extension.

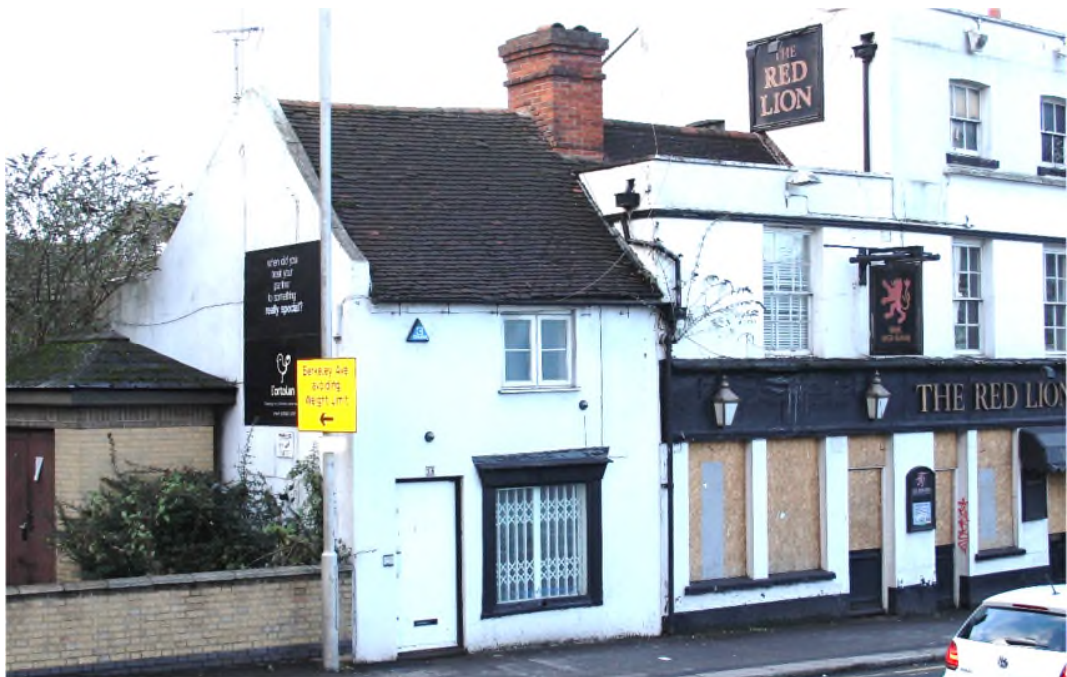
Figure 4 No. 38, front and south elevations.

- 3.7 No. 38 has a single bay rendered frontage and gable wall with a tile roof, gabled to the south (Figure 4). This element has been extended with various phases of two storey and single storey additions to the rear.

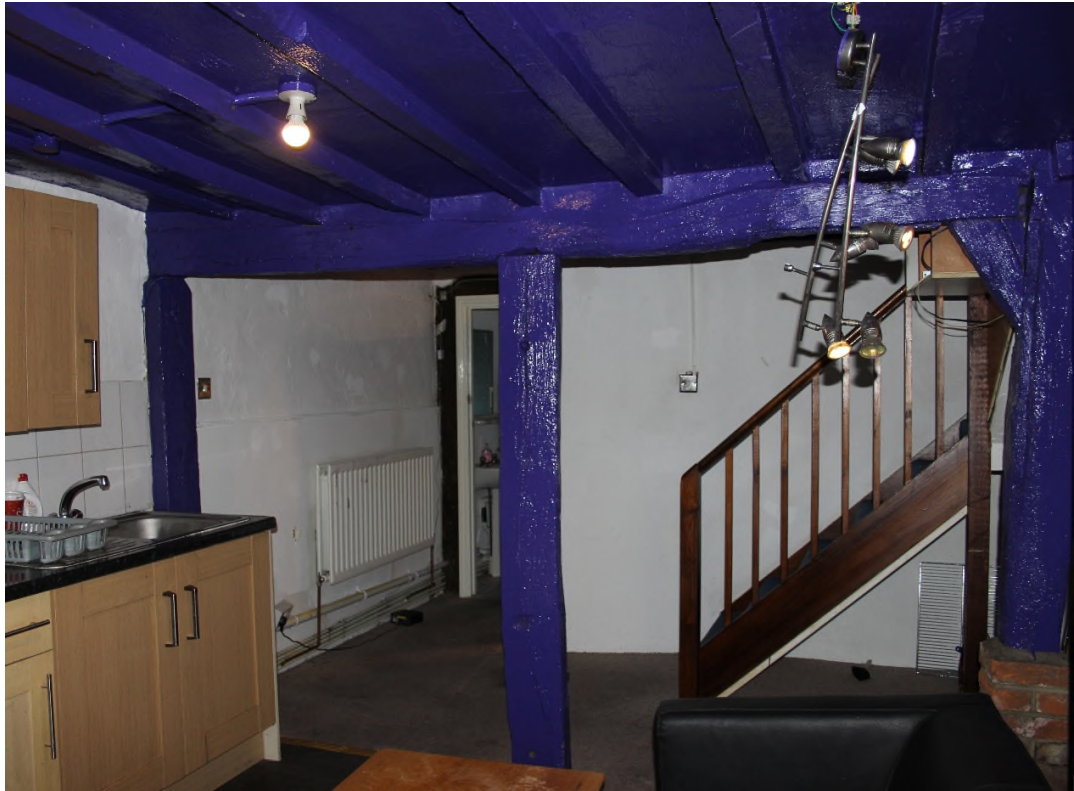
Figure 5 No. 38, front room with exposed ceiling joists.

- 3.8 Internally, the front door gives access to a lobby formed by modern partitions, the lobby being taken out of the main room. This room has a low ceiling with an axial spine beam and exposed joists ( $2\frac{1}{4}$  -  $2\frac{1}{2}$ " wide), all of which are heavily painted (Figure 5). The spine beam is chamfered and has a simple run out stop to the south. To the north the beam is set into a large stack which has been boarded over from floor to ceiling. The line of the original rear wall is marked by the girt beam which appears to be supported by three posts, the post to the north having a short brace up to the beam. Whilst this post is part of the primary build, the brace is not and is fastened by screws. The central post appears to be an insertion. Although there are peg holes in the area where the post stands, generally there does not seem to be the typical evidence for studs forming wall framing as would be expected for a rear wall. The modern stairs are set west of the line of the former rear wall. Beyond, to the rear are later elements with no features of architectural interest.

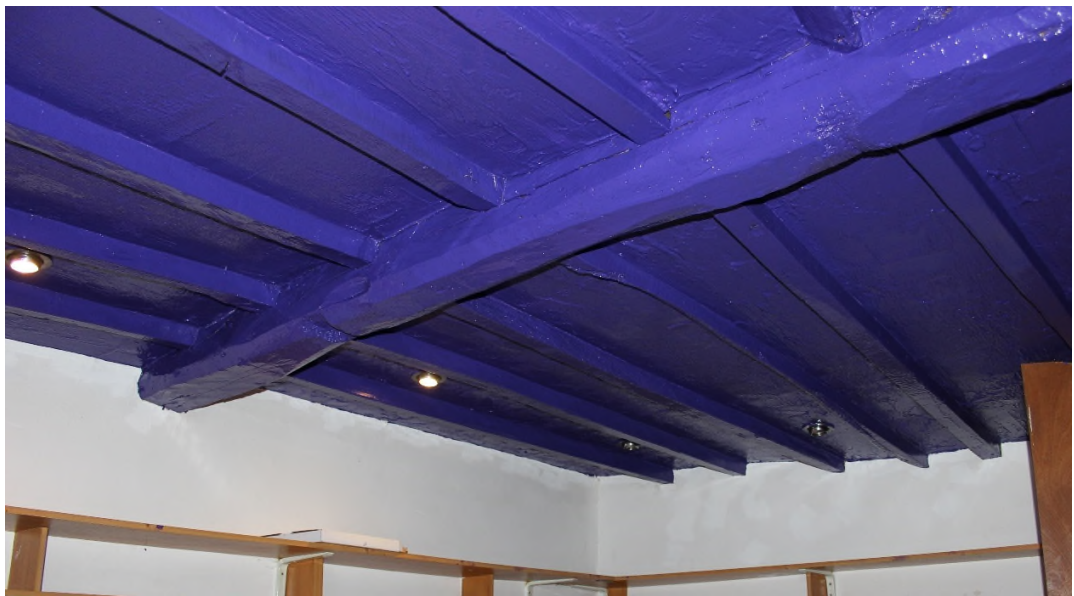
Figure 6 Ceiling beams to the first floor bedroom within the single bay of No. 38.

- 3.9 At first floor level there is also an historic ceiling with a spine beam and exposed joists. These joists are relatively narrow and the spine beam is a relatively irregular timber, probably due to the loss of sap wood. Remains of a chamfer survive at the northern end. There is no exposed framing in the walls.
