# MEMO

**SUBJECT:** Rising Sun Public House, Reading – Bat Roost Potential Assessment

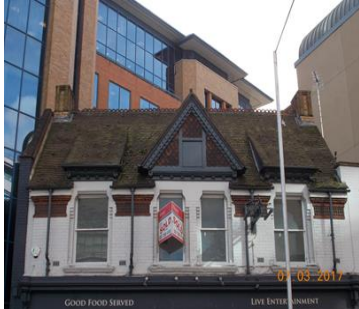
| | Building/Structure | Description of relevant features | Bat Roost Potential |
|---|---|---|---|
| Rising Sun Public House, Reading | | Some loose roof tiles, bats may use for roosting on occasional basis | Low |

During the external inspection of the building it was noted that some of the tiles on the roof had become loose and slipped, allowing for the gaps to potentially be used for roosting.

Whilst no signs of bat roosting was confirmed at the Rising Sun Public House, it was noted that some loose tiles on the roof could be used by a small number of bats such as crevice dwelling bat species, such as pipistrelle species, as a day roost on an occasional basis and the building was assessed as having low potential to support roosting bats.

In order to determine whether bats are utilising the building for roosting it is recommended that one emergence survey be undertaken between May and August in-line with current best practice (Collins, 2016). It is recommended that the survey is undertaken in advance of any works so as to ensure the required works do not result in any infringement to legislation.
