# Remediation Action Plan

Corner of Crown Street and Silver Street, Reading, Berkshire  
RG1 2SE

Project Ref. 28957-R02 (01)

MAY 2017

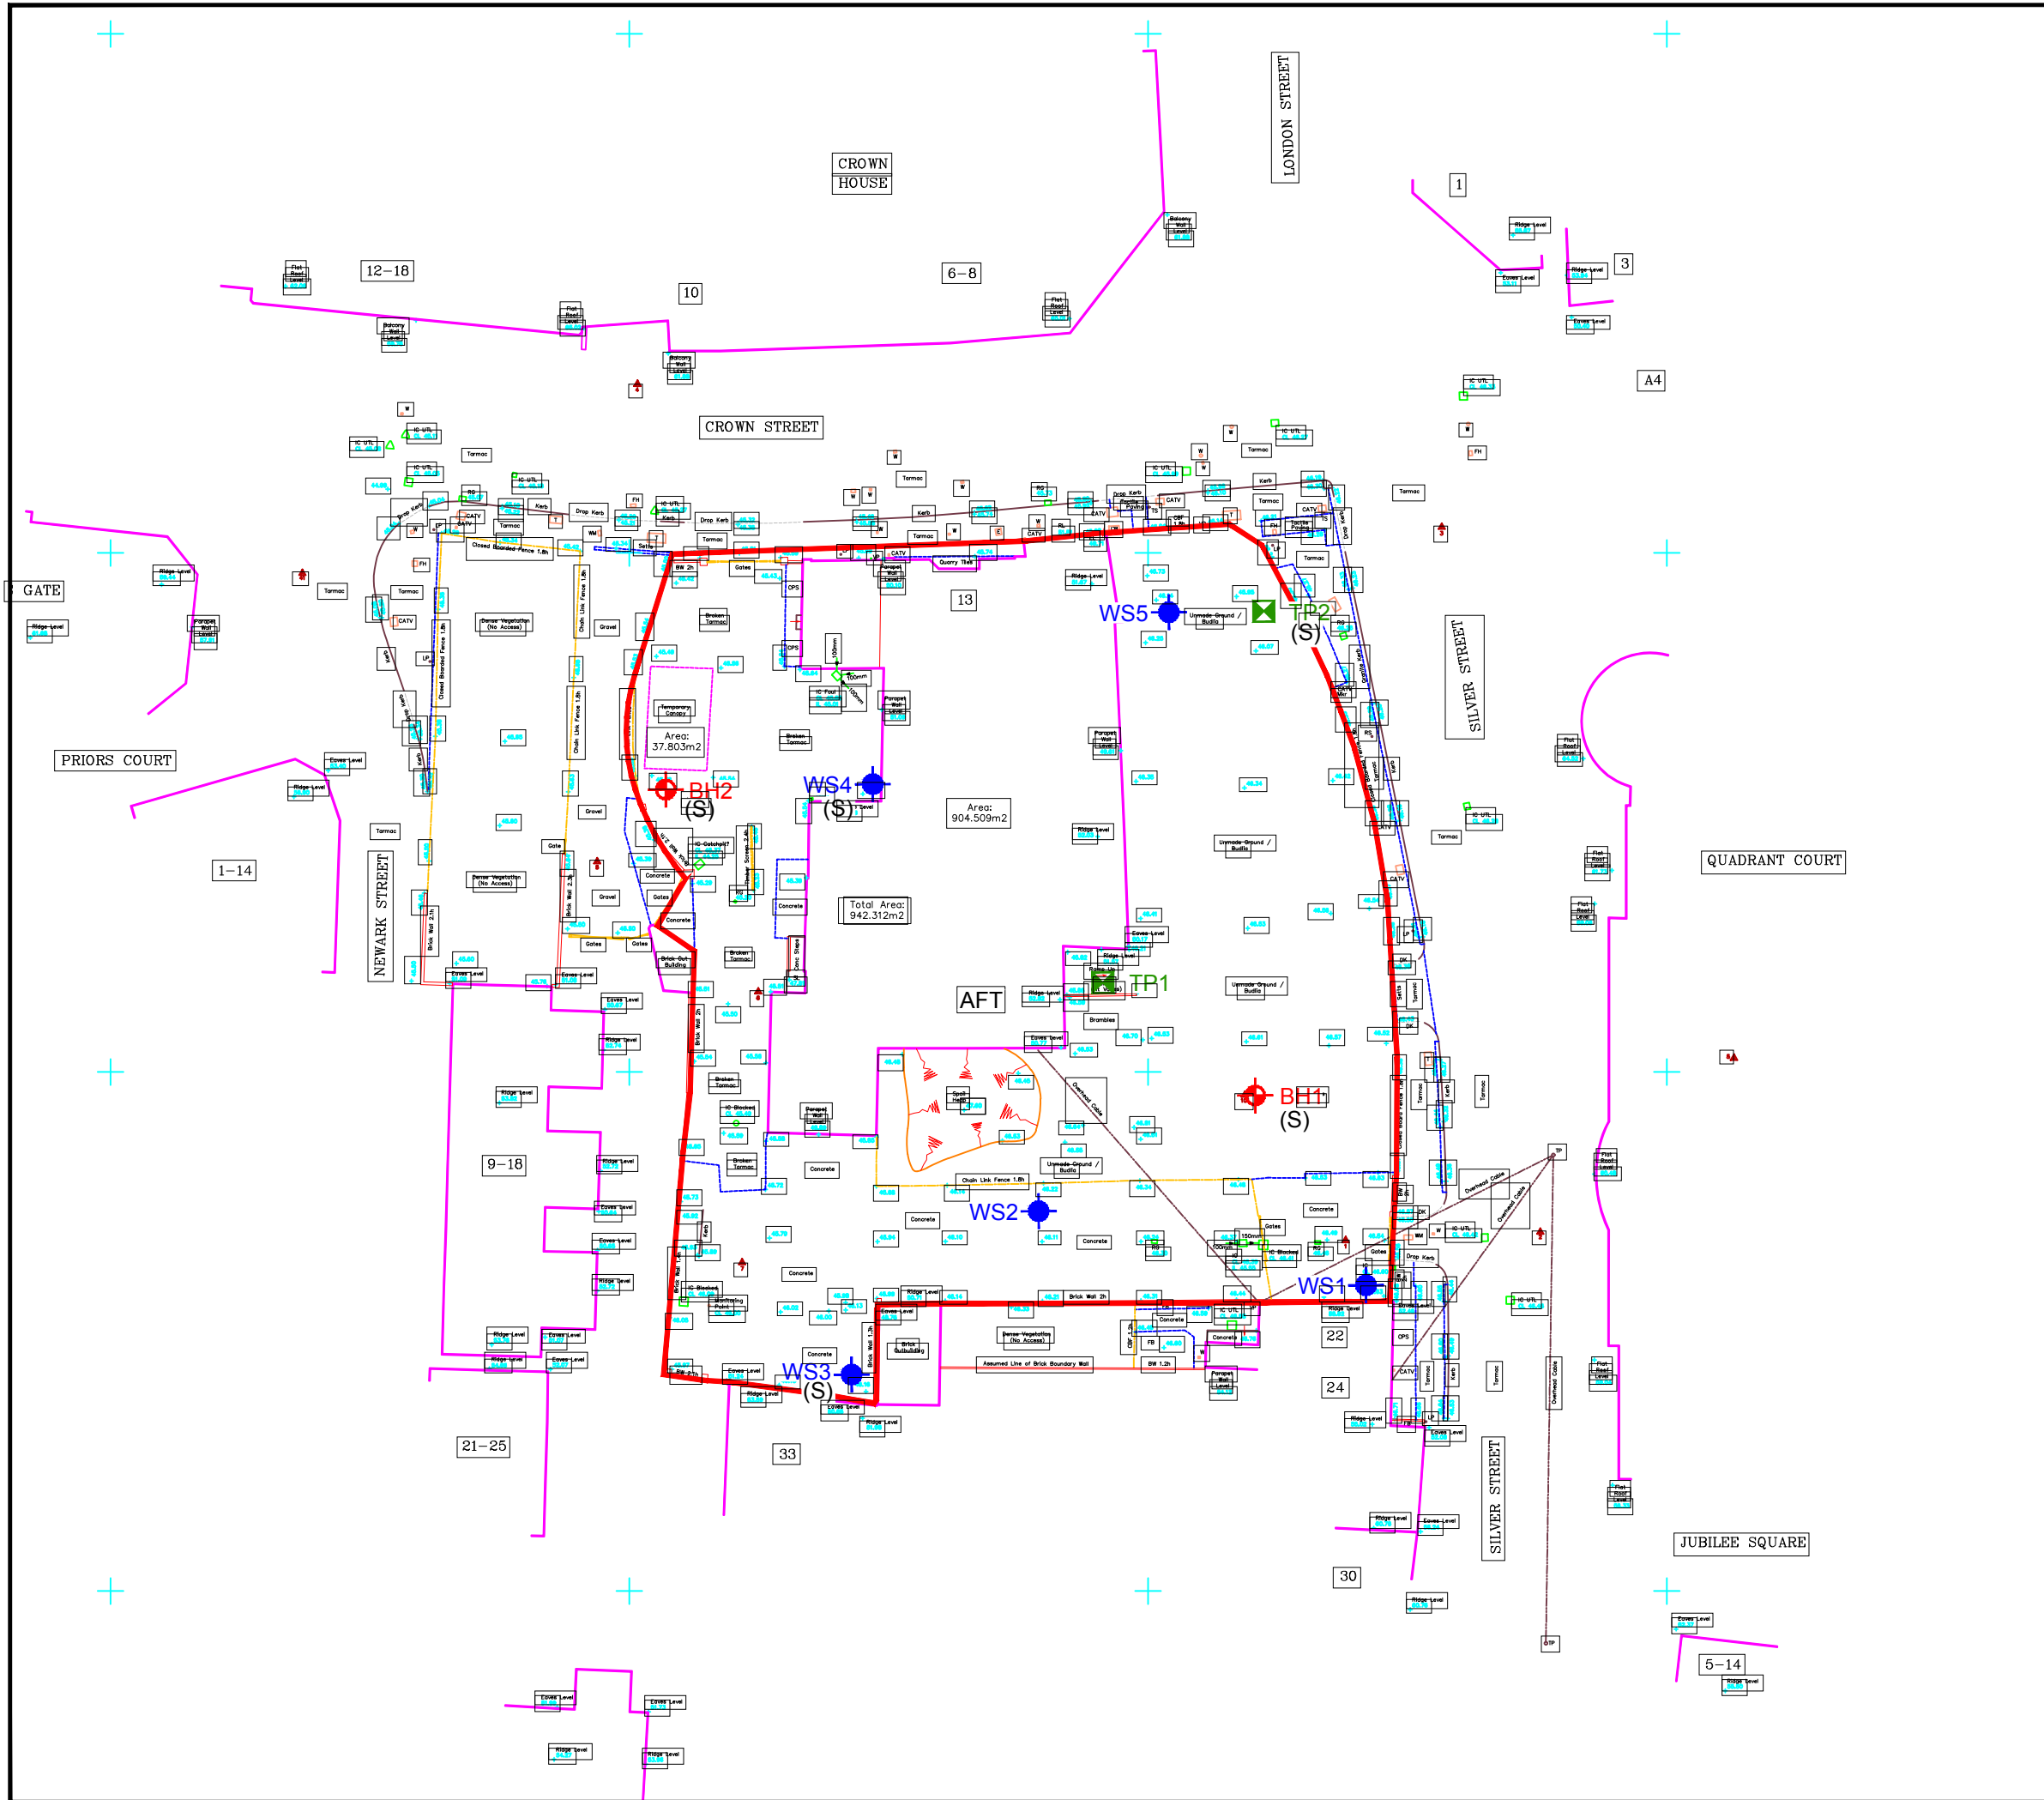
| FIGURE 2 | P1 |

- Approximate Site Boundary
- Borehole Location
- Drive-in Sample Location
- Trial Pit Location
- (S) Standpipe Locations
- AFT Approximate Location of an Above Ground Fuel Tank

The site covers approximately 0.33ha at an elevation of approximately 50m above Ordnance Datum (AOD) and comprises the following main attributes some of which are shown on **Figure 2**:

A buried masonry wall was exposed in location TP2. It is considered to be potentially associated with a former basement structure relating to terraced housing that was present on the corner of Crown Street and Silver Street.

A small amount of discoloured black hardstanding was noted on the ground surface next to the fuel storage tank within the main building. Exploratory location TP1 was chosen to target this potential contamination. PID readings within this trial pit were all recorded <0.1ppm indicating an absence of significant volatile organic compounds.
