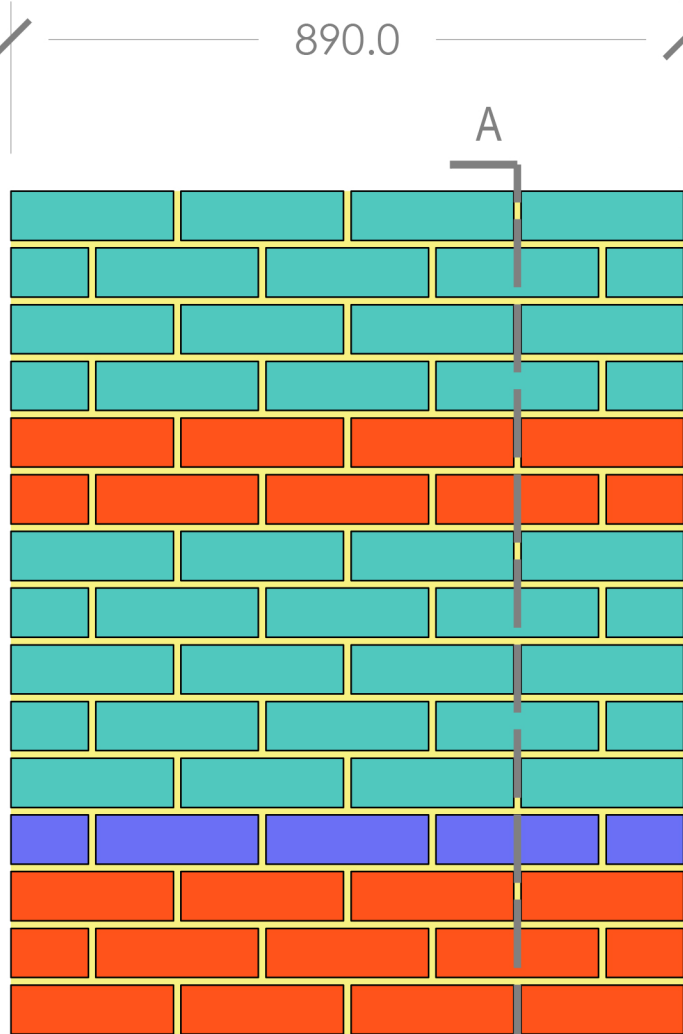
**Panel 4 (Palette 3) Front Elevation**

- Walls| Wienerberger, Hathersage Blend
- Walls| Wienerberger, Olde Autumn Antique
- Detail Brick| Blockleys, Synthesis S15
- Mortar| Euromix M3ALB000 (Bucket Handle Joint)

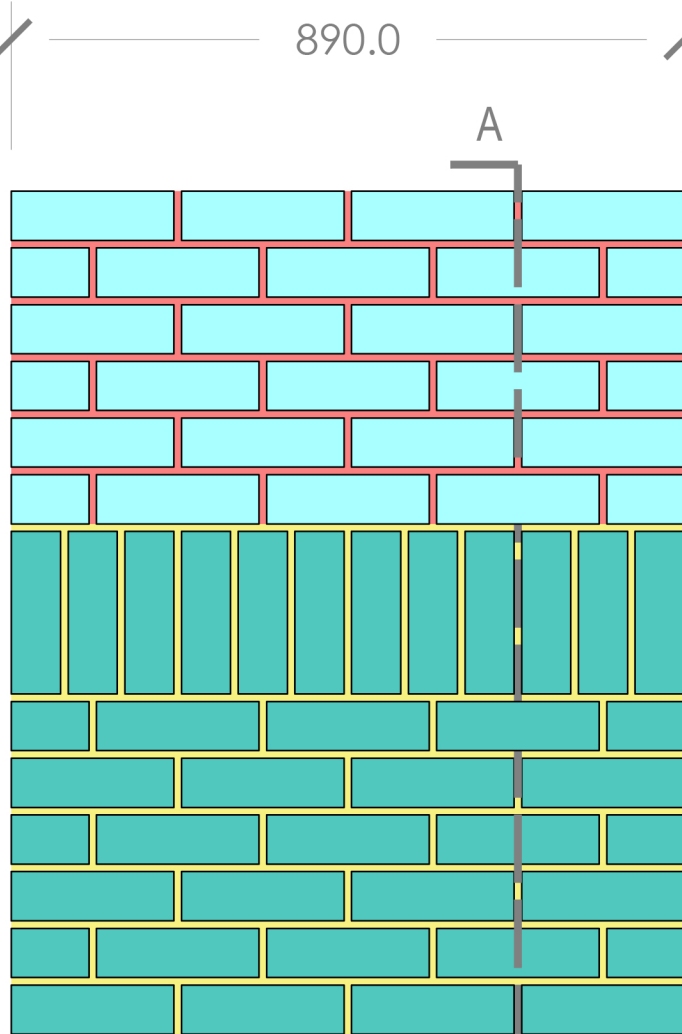
**Panel 5 (Palette 4) Front Elevation**

- Walls| Wienerberger, Oakington Buff
- Walls| Wienerberger, Hathersage Blend
- Mortar| Euromix M3ANBFS182 (Bucket Handle Joint)
- Mortar| Euromix M3ALB000 (Bucket Handle Joint)

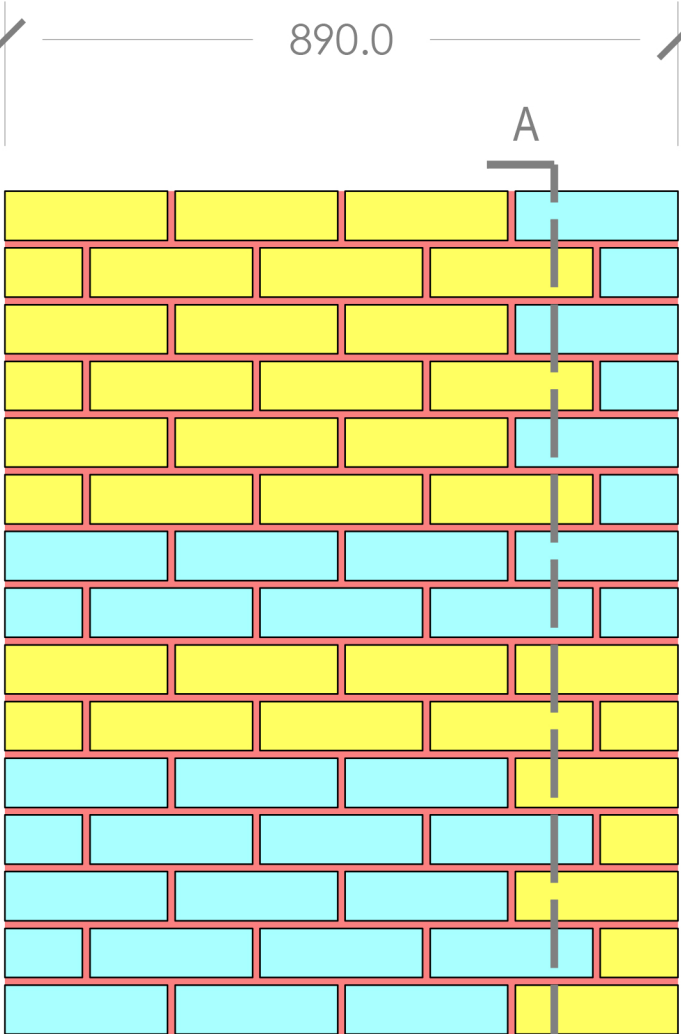
**Panel 6 (Palette 5) Front Elevation**

- Walls| Wienerberger, Oakington Buff
- Walls| Wienerberger, Thorn White (19 Bricks)
- Mortar| Euromix M3ANBFS182 (Bucket Handle Joint)
