## Bennet Court Reading Drainage Strategy

| Project No. | 2022-124 |

## Surface Water Drainage Strategy

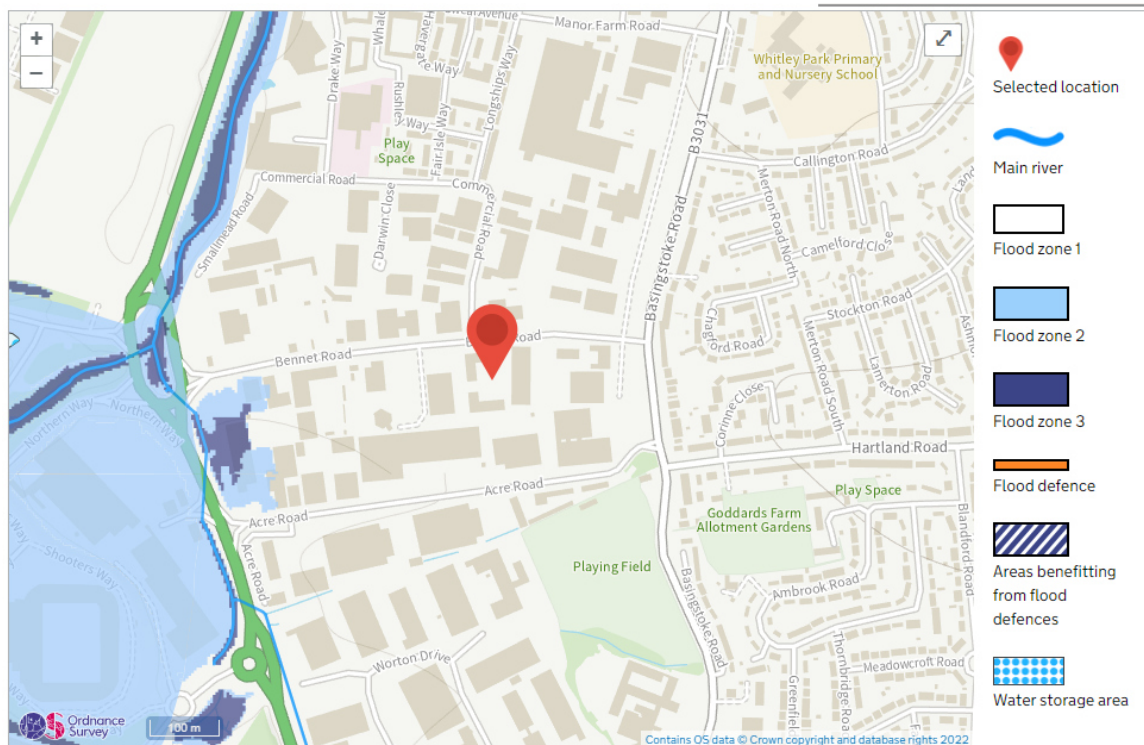
It can be seen from the flood map below that the site lies within Flood Zone 1.

Therefore, as the site is under 1 Ha and lies within flood zone 1 a Flood Risk Assessment is not required.

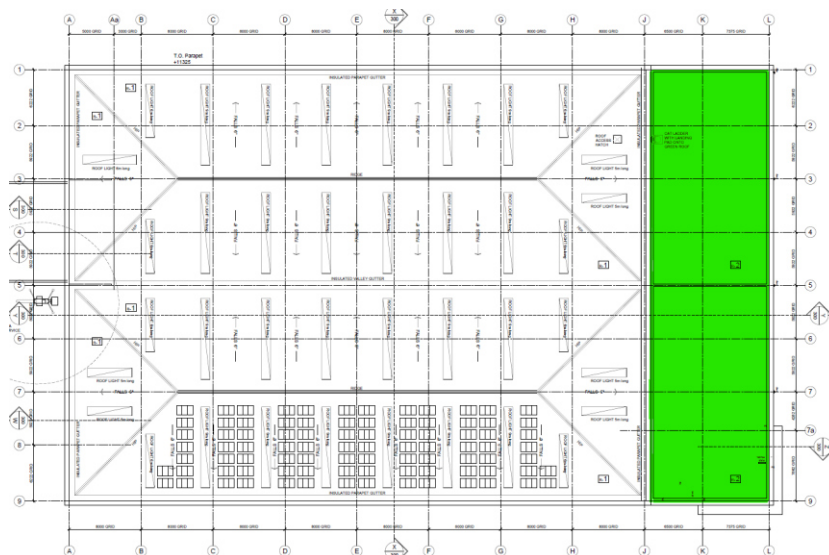
The extent of green roof is shown highlighted below and a copy of the proposed Roof Plan is at Appendix C.

Source control has also been provided by the incorporation of a green roof to part of the main warehouse building.

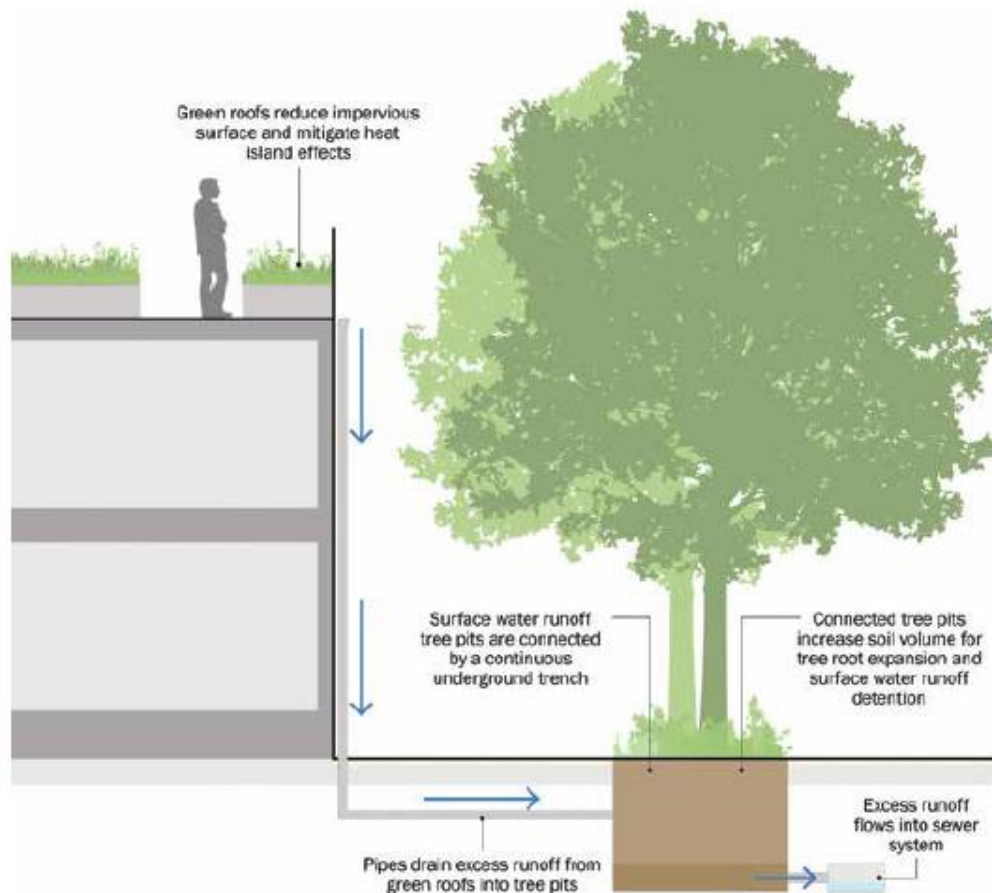
The figure below extracted from the SuDS manual shows a typical arrangement between green roof and tree pits. Refer Aspect Tree Pit drawing 8085.TPD.5.1C for Details.

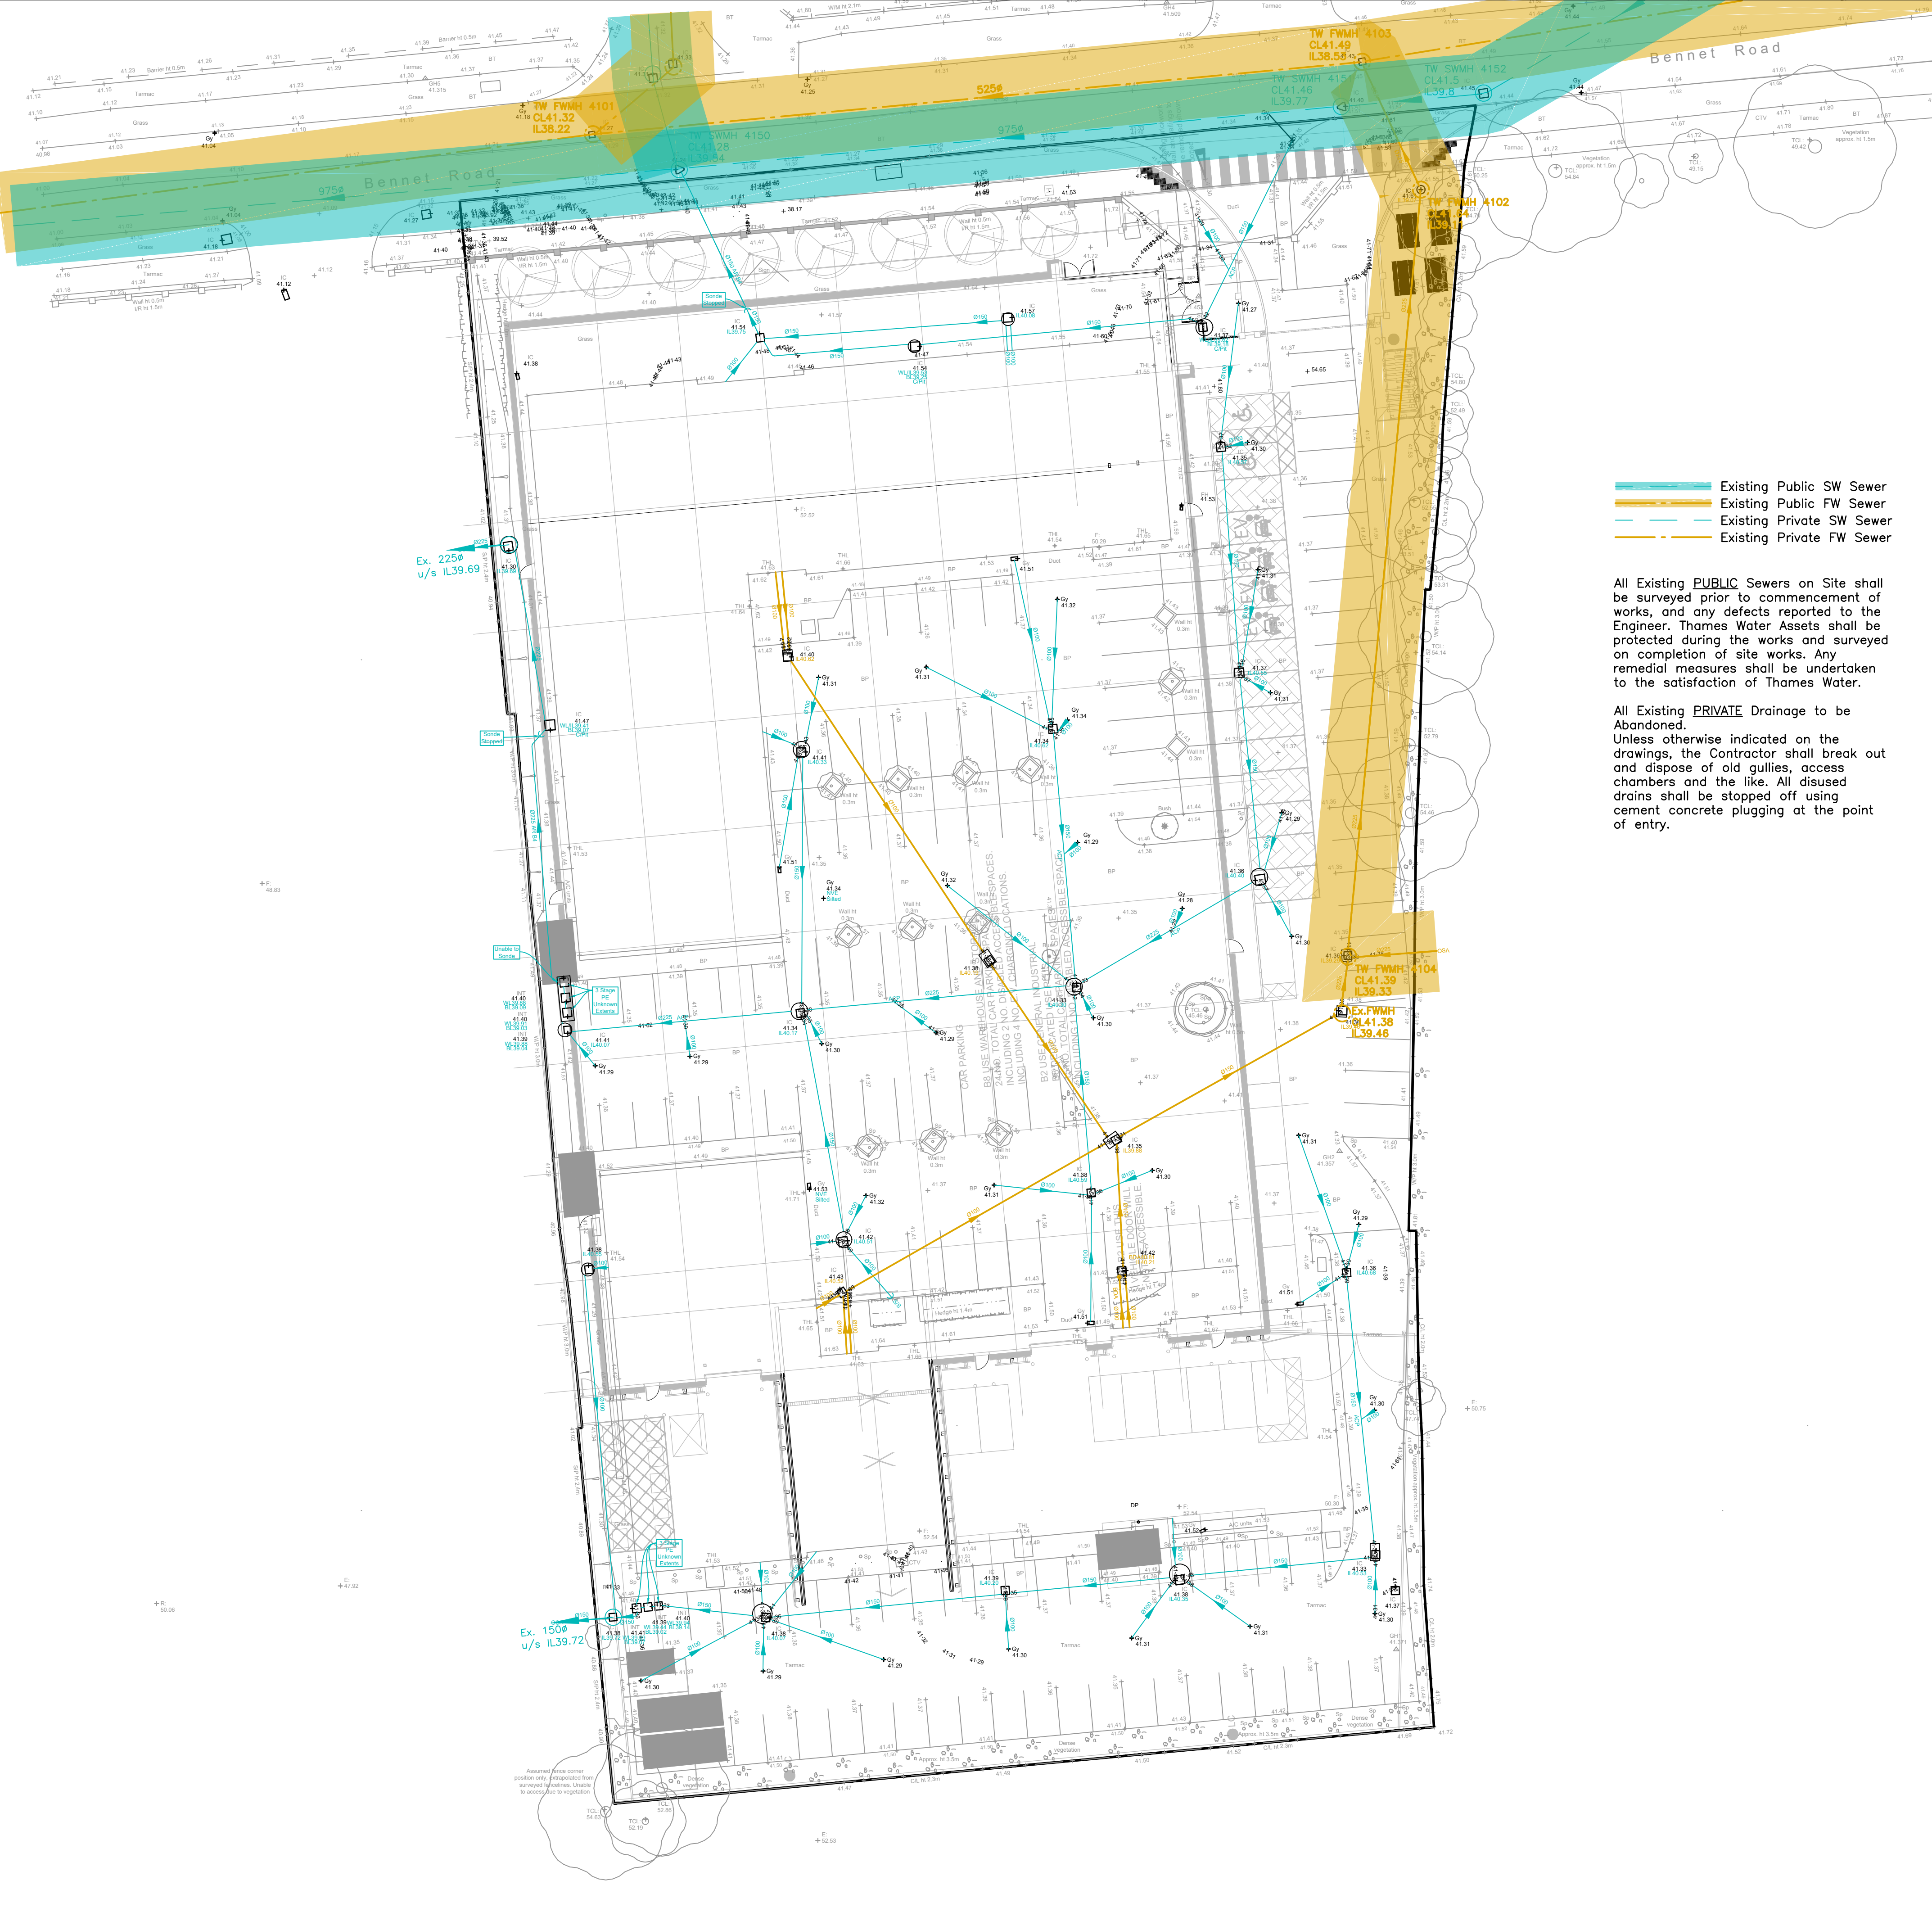
Existing Drainage Layout

Existing Site Drainage  
Existing Drainage Survey

- Existing Public SW Sewer
- Existing Public FW Sewer
- Existing Private SW Sewer
- Existing Private FW Sewer

The existing site drainage has been extensively surveyed and a number of surface water outfalls have been identified. The existing drainage information including CCTV Survey is at Appendix A

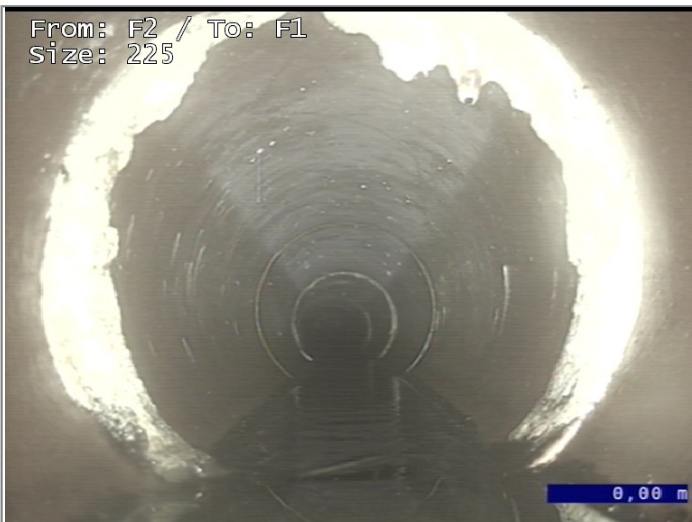
Attached deposits, encrustation from 7 to 5 o'clock 10% cross-sectional area loss

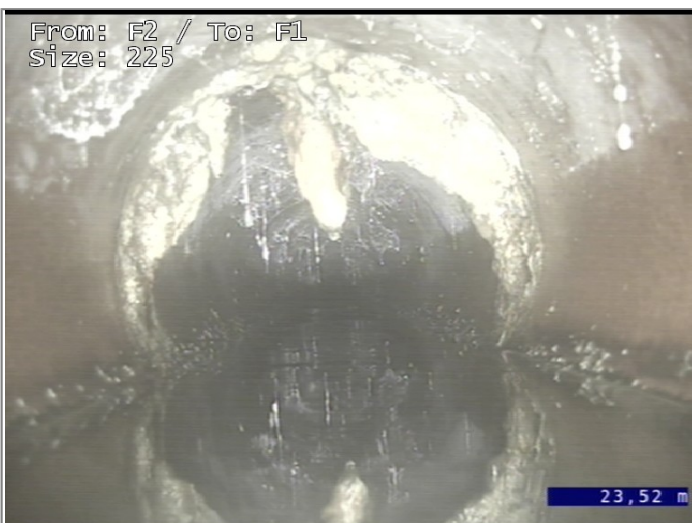
Attached deposits, encrustation from 9 to 3 o'clock 25% cross-sectional area loss

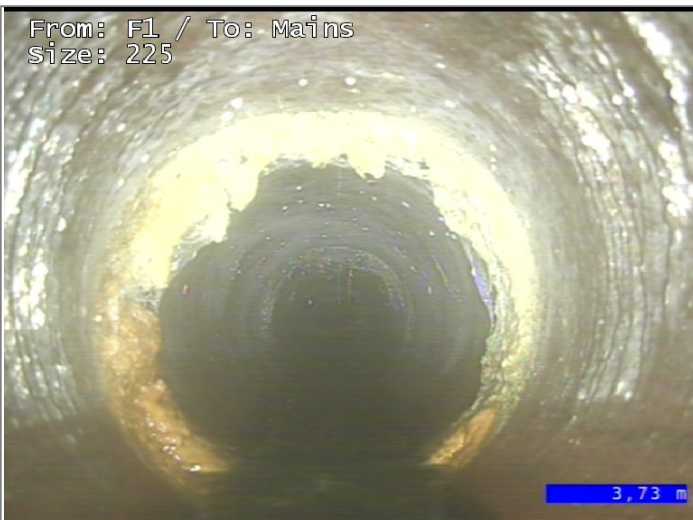
Attached deposits, encrustation from 7 to 5 o'clock 10% cross-sectional area loss

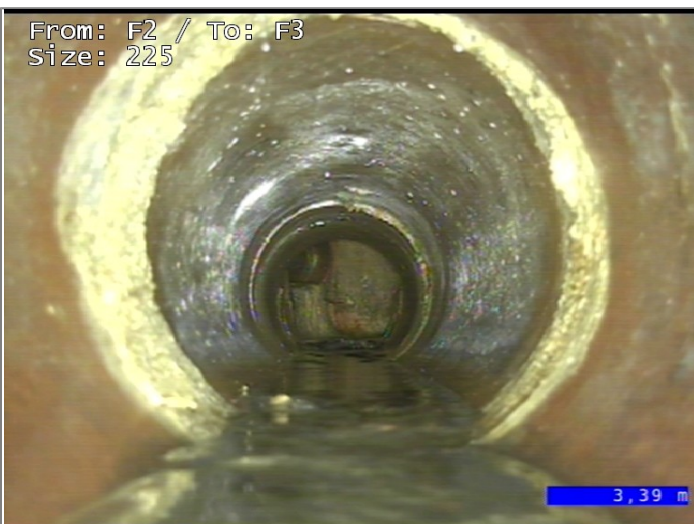
Attached deposits, encrustation from 7 to 5 o'clock 10% cross-sectional area loss

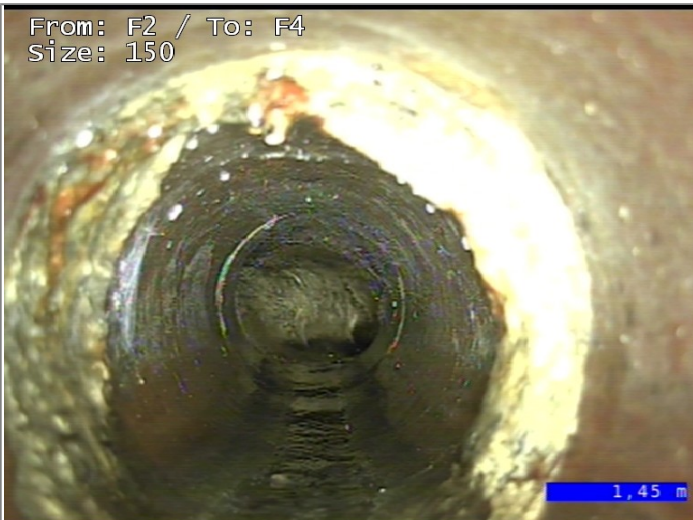
Attached deposits, encrustation from 11 to 5 o'clock 10% cross-sectional area loss

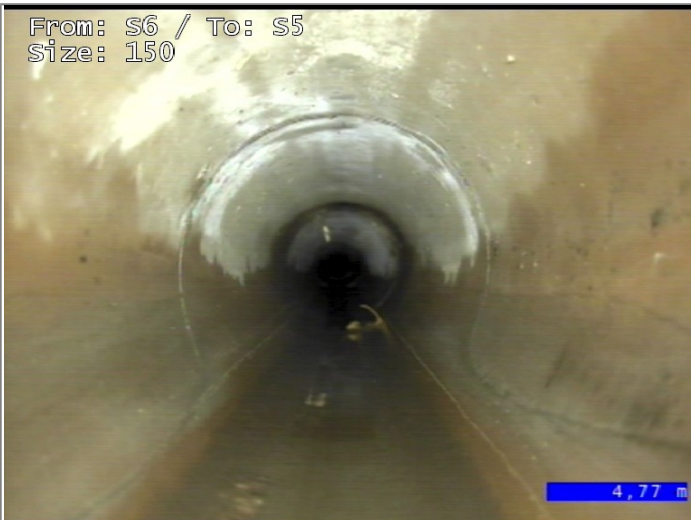
Crack circumferential from 8 to 4 o'clock

| Start Node Ref:S6 I/L :0.81 metres | | | | Photo | Type/Grade |
|---|---|---|--|---|---|
| 4.77 | CC | Crack circumferential from 8 to 4 o'clock | | 7869963 | Structural / 2 |

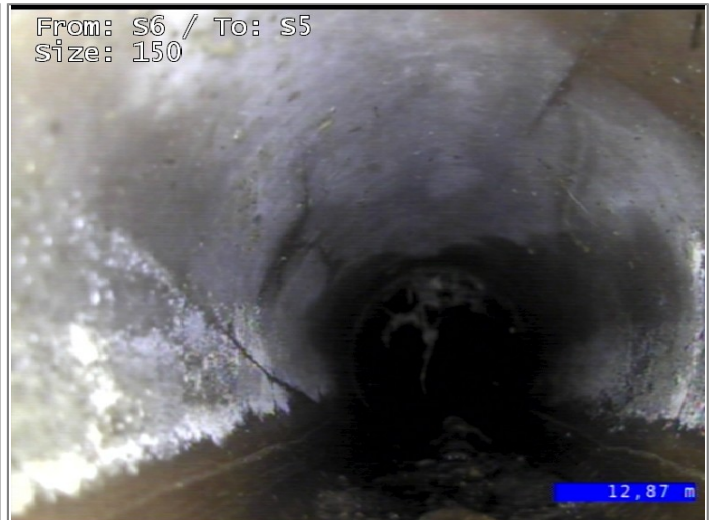
Crack longitudinal at 9 o'clock

| Start Node Ref:S6 I/L :0.81 metres | | | | Photo | Type/Grade |
|---|---|---|--|---|---|
| 12.87 | CL | Crack longitudinal at 9 o'clock | | 7870011 | Structural / 2 |

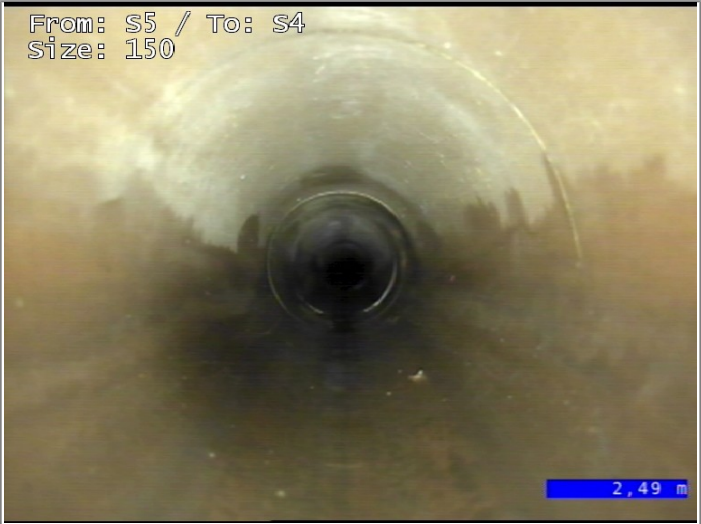
| Job Number<br>17983 | Surveyed by (Operator)<br>Shaun Phillips | Base Unit<br>69HWF65MBE | Date<br>09/05/2023 |
|---|---|---|---|
| <p>From: S5 / To: S4<br/>Size: 150</p> <p>Crack circumferential from 10 to 3 o'clock</p> | | | |

| Start Node Ref:S5 I/L :1.04 metres | | | | Photo | Type/Grade |
|---|---|---|--|---|---|
| 2.49 | CC | Crack circumferential from 10 to 3 o'clock | | 7870062 | Structural / 2 |

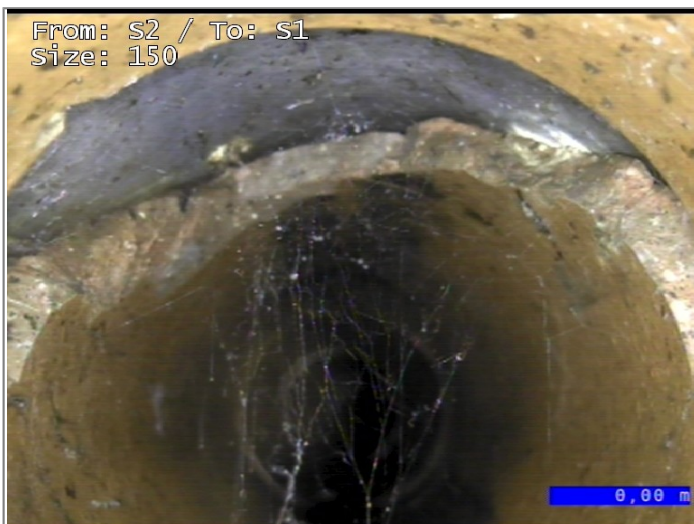
Point repair, hole repaired from 10 to 2 o'clock

| Position | Code | Description | Photo | Type/Grade |
|---|---|---|---|---|
| 0.01 | RPH | Point repair, hole repaired from 10 to 2 o'clock | 7870510 | Comment / 0 |

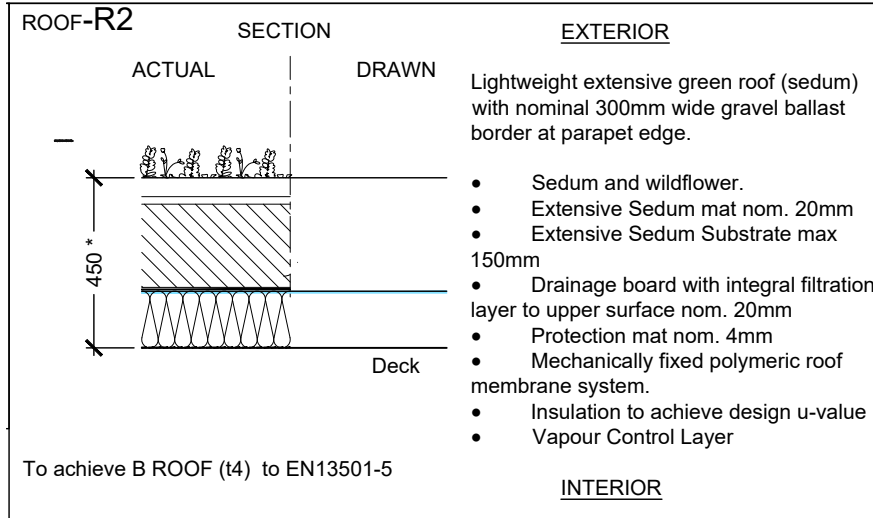
GREEN ROOF

In accordance with the recommendations from Ecologists (FCPR), the implementation of a 620m² Green Roof, inclusive of gravel margin with ephemeral species acting as pollinators and fire breaks will contribute towards achieving a minimum of 10% BNG, in addition to previously agreed off-site tree planting.

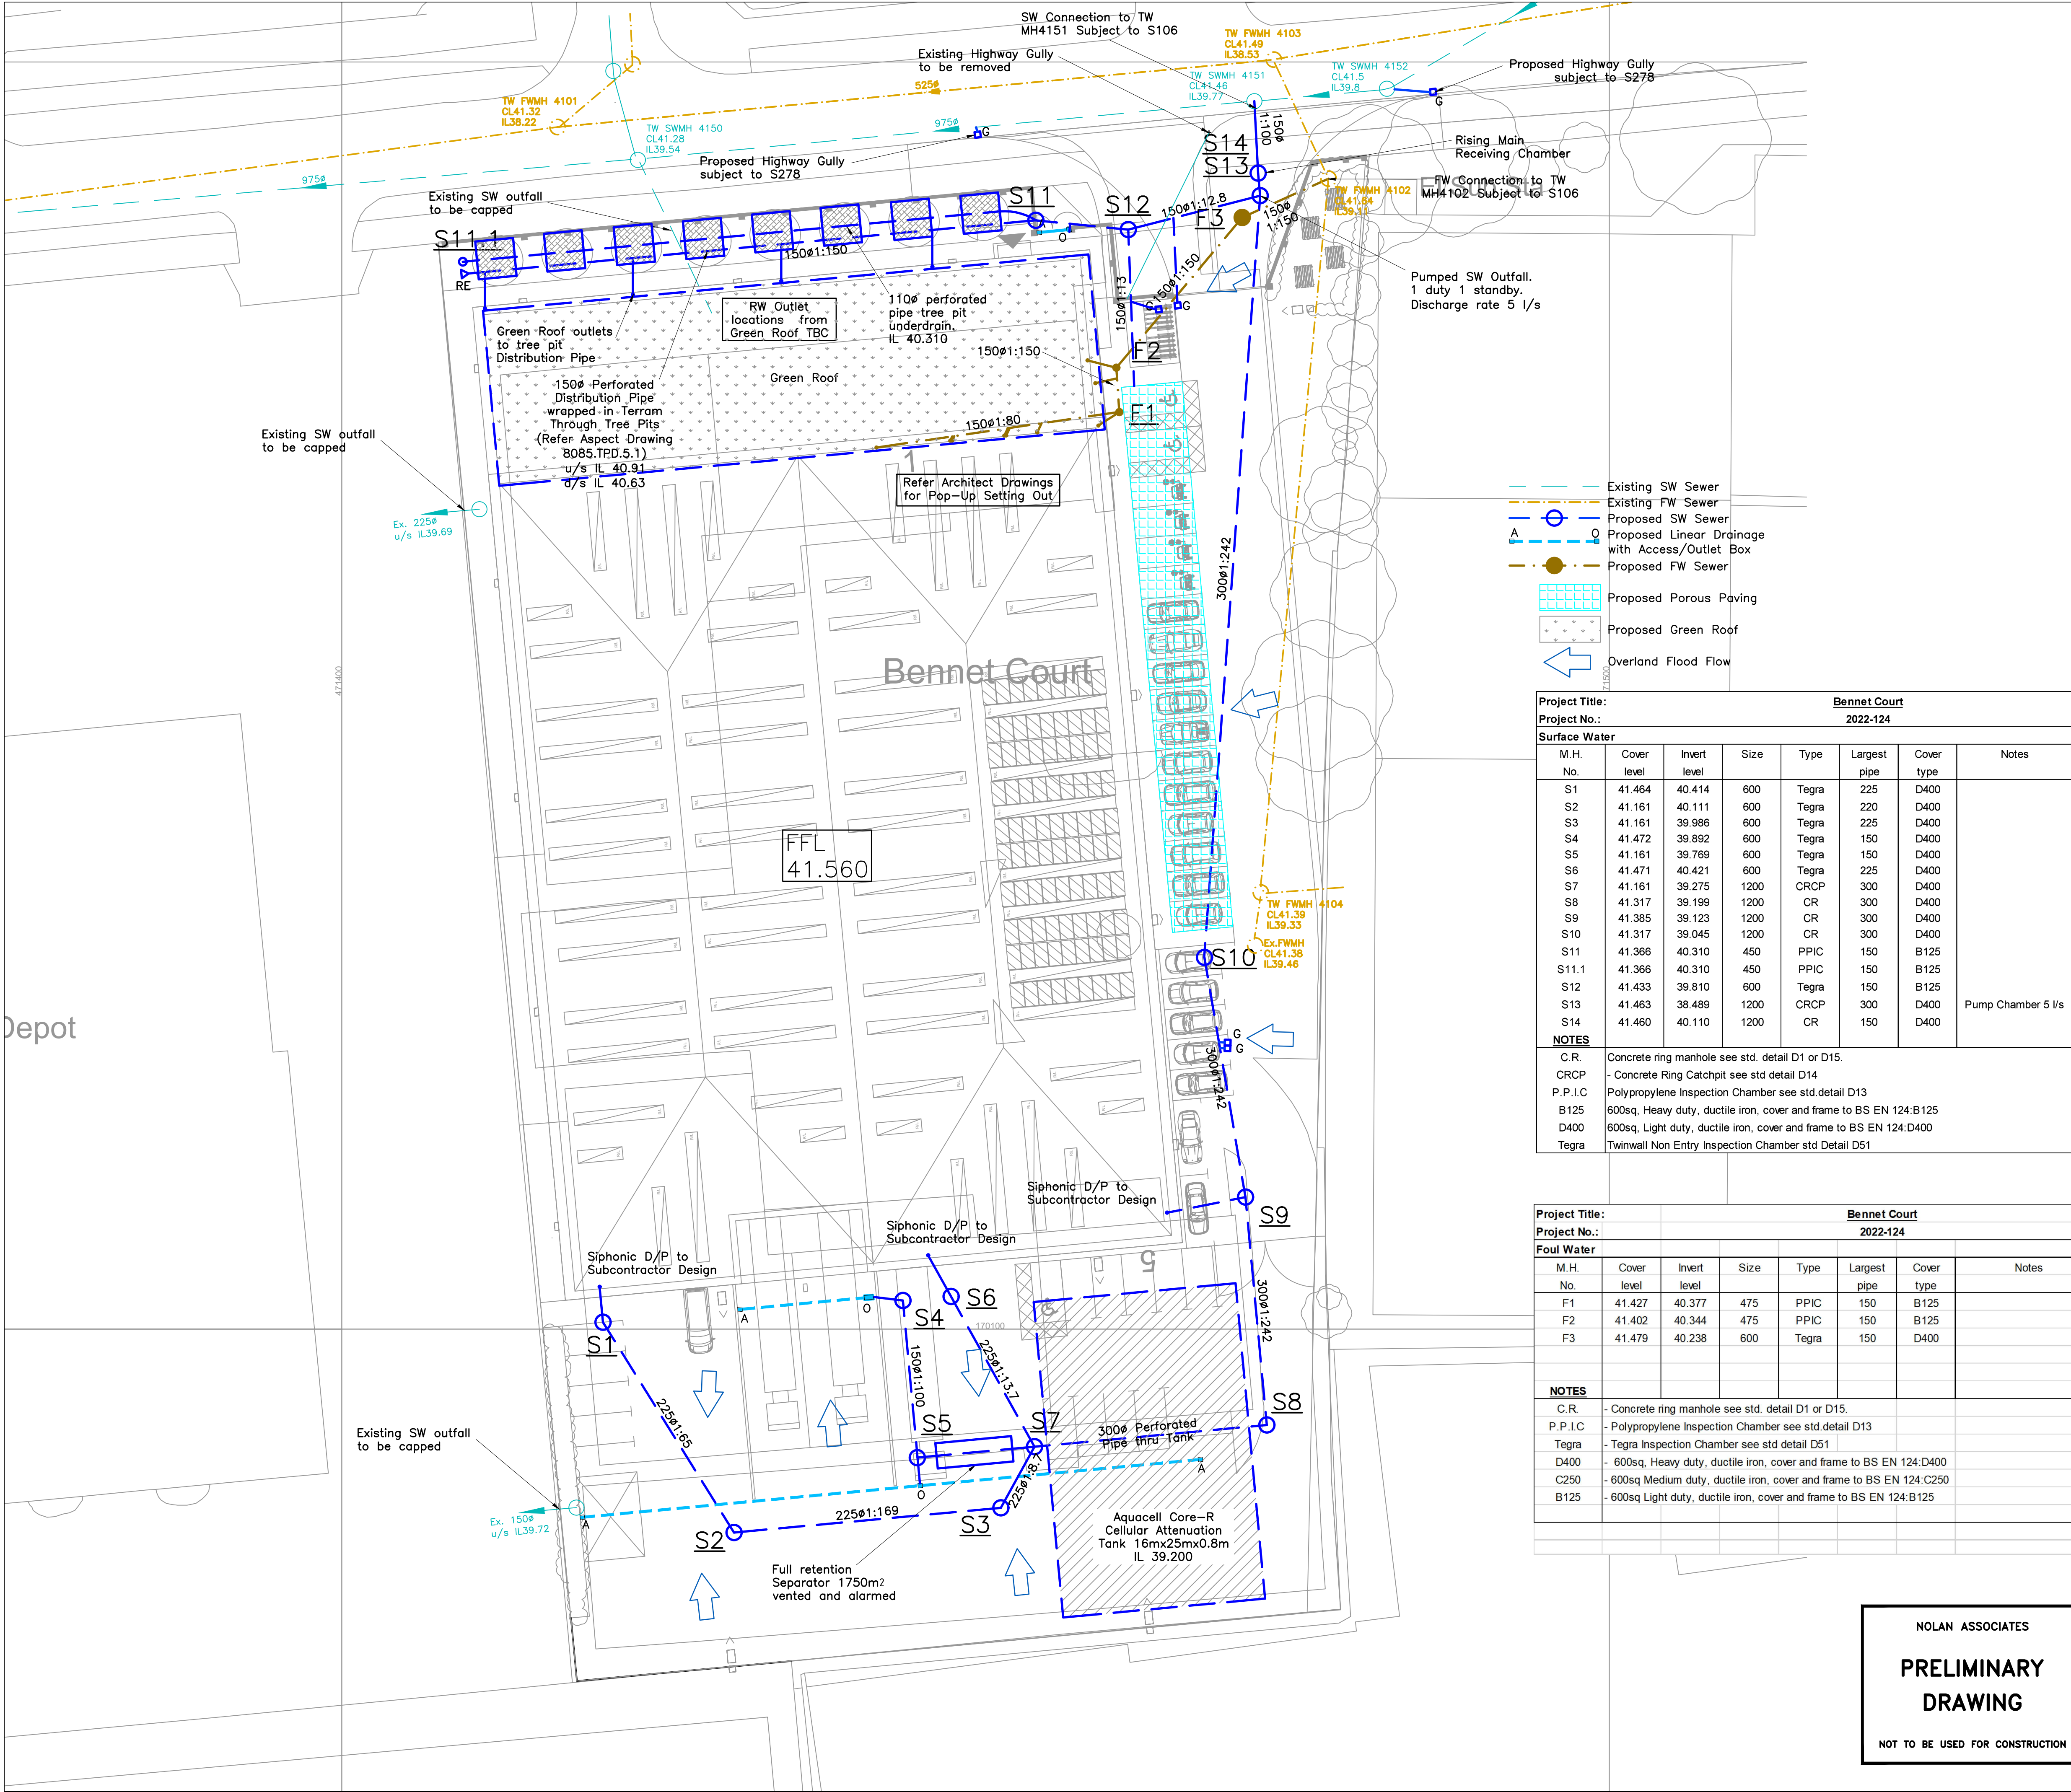
- NOTES.**
- This drawing is to be read in conjunction with all relevant Architect's, Engineer's, Specialists details and the Specification.
  - All surface water pipes 150Ø u.n.o.

- All foul water pipes 100Ø u.n.o.
  - All drainage pipes to BS EN 295 (clayware) or BS EN 1401 (plastic) U.N.O. Other materials may be permitted subject to the approval of the Engineer.

The proposed drainage layout is at Appendix C. The overall performance of the drainage network has been analysed using the MicroDrainage Simulation computer programme and this can be seen in Appendix D.
