# Tree Protection Report

## ICS Urology Project

Royal Berkshire Hospital

Revision A – 16/10/2024

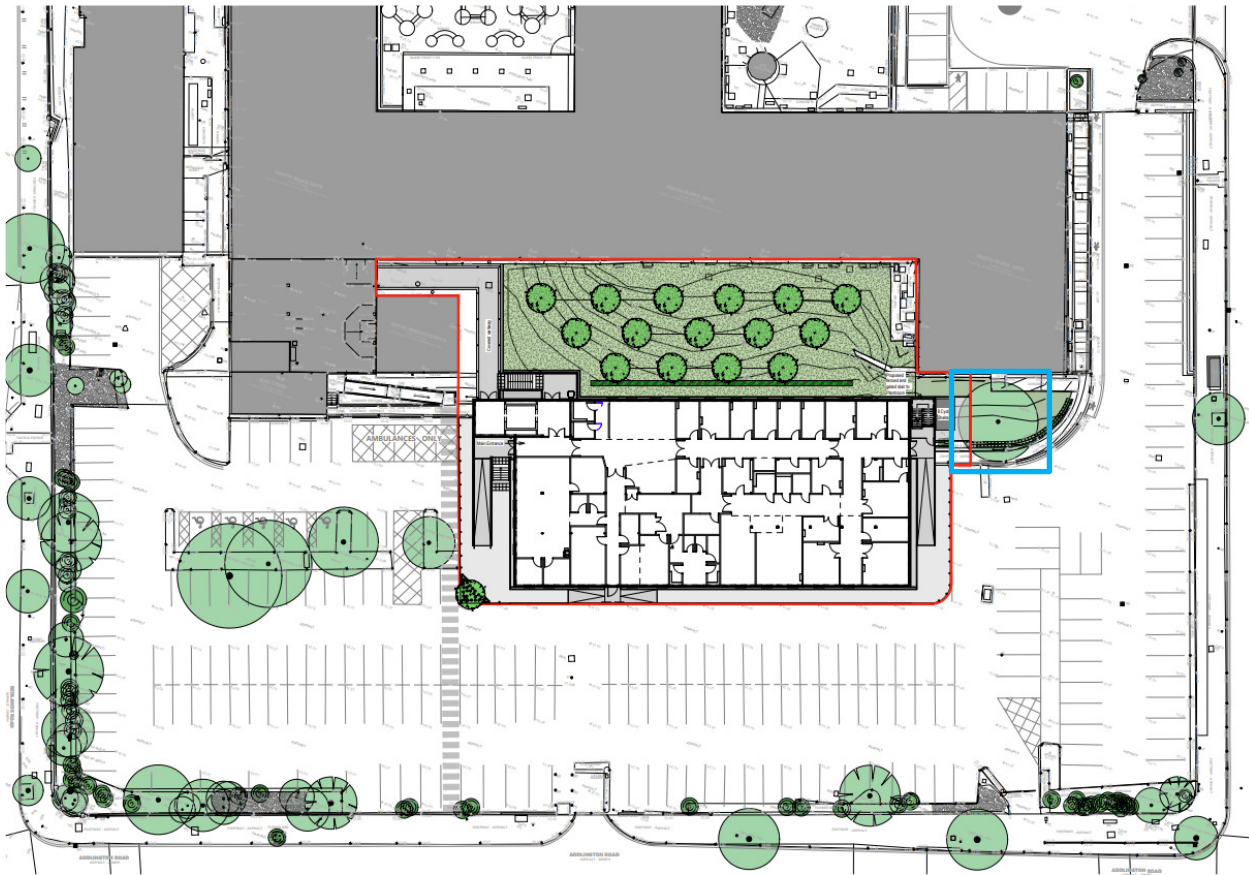
Site Plan – Blue line tree protection around T2 retained tree

The above image highlights the new building and the closest tree that may be affected during the works. Tree T2 (named in the arboricultural report) has been assessed as a category B tree and of moderate quality. The trees on the left of the new proposal are outside the works area and will be unaffected. Trees T3 & T4 are both category B but are small saplings and do not form a constraint and are being removed. There is a small tree by the entrance that will need to be removed due to access. This has been assessed by the Arboriculturalist and deemed of minimal value with no constraints on it being removed.

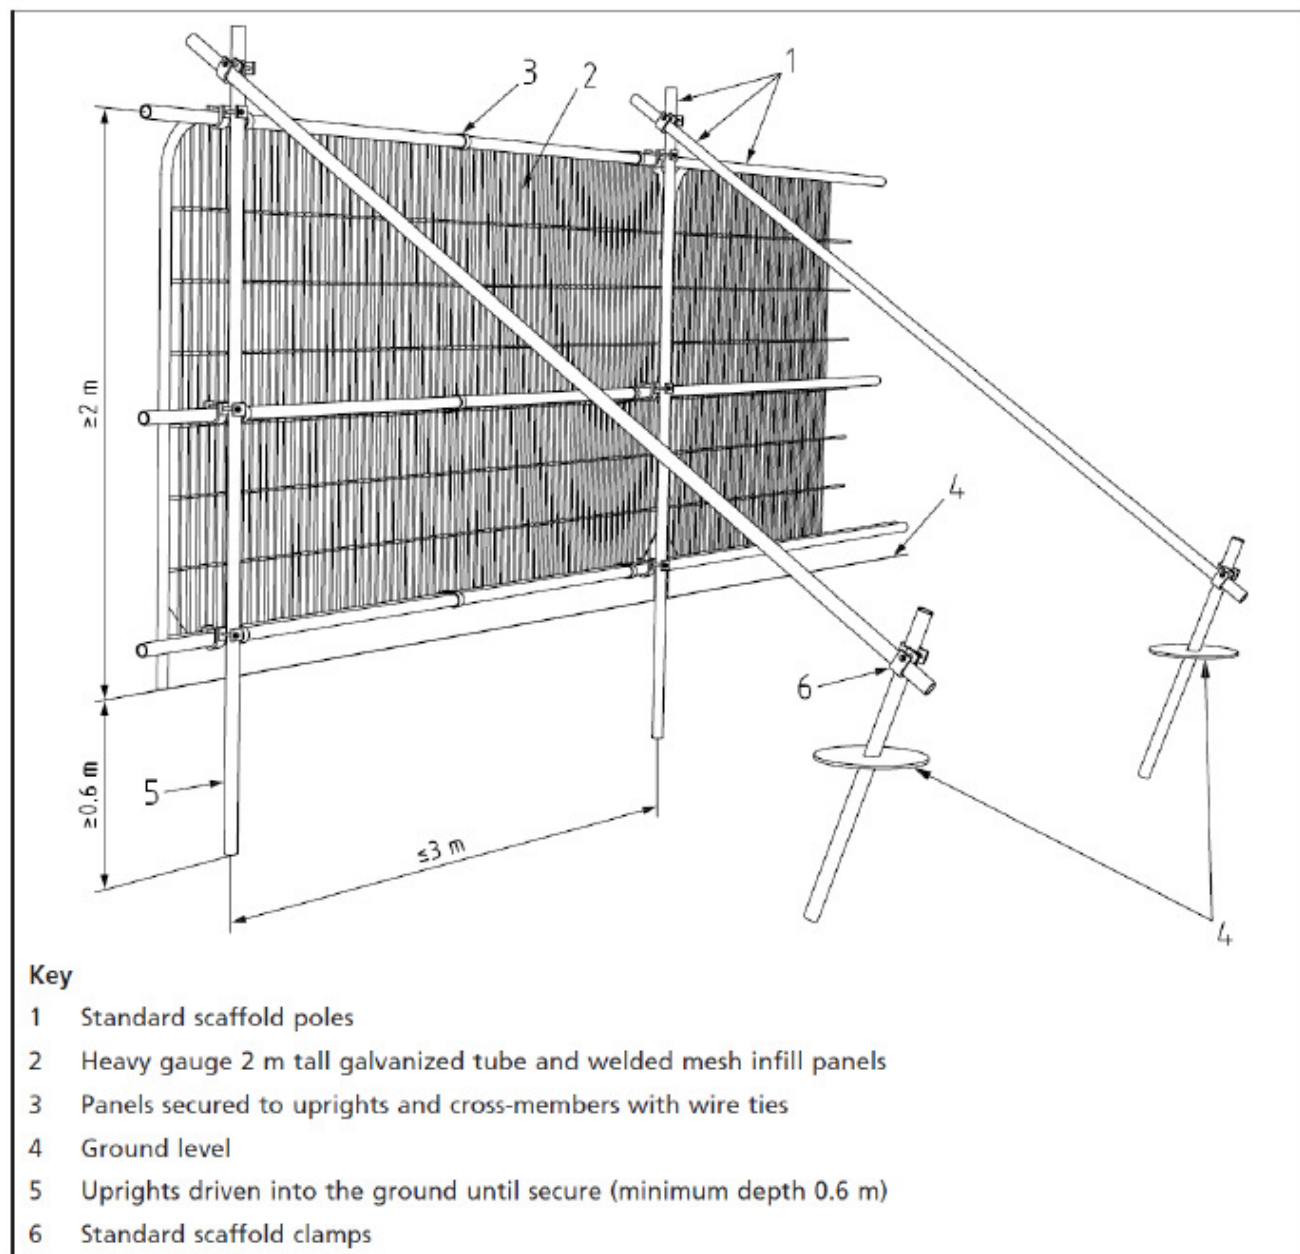
**Figure 2: Default Specification of protective barrier BS5837:2012**

Fence protection is required for the retained trees during the works. This will be comprised of Heras fencing and will be based on Figure 2 'Default Specification for Protective Barrier' as recommended within British Standard 5837:2012 and shown below. Fencing will be erected prior to any site development and must remain in situ and be fit for purpose for the duration of the development. The fencing must not be prematurely removed without the prior consent of the project Arborculturalist or the Local Planning Authority (LPA)

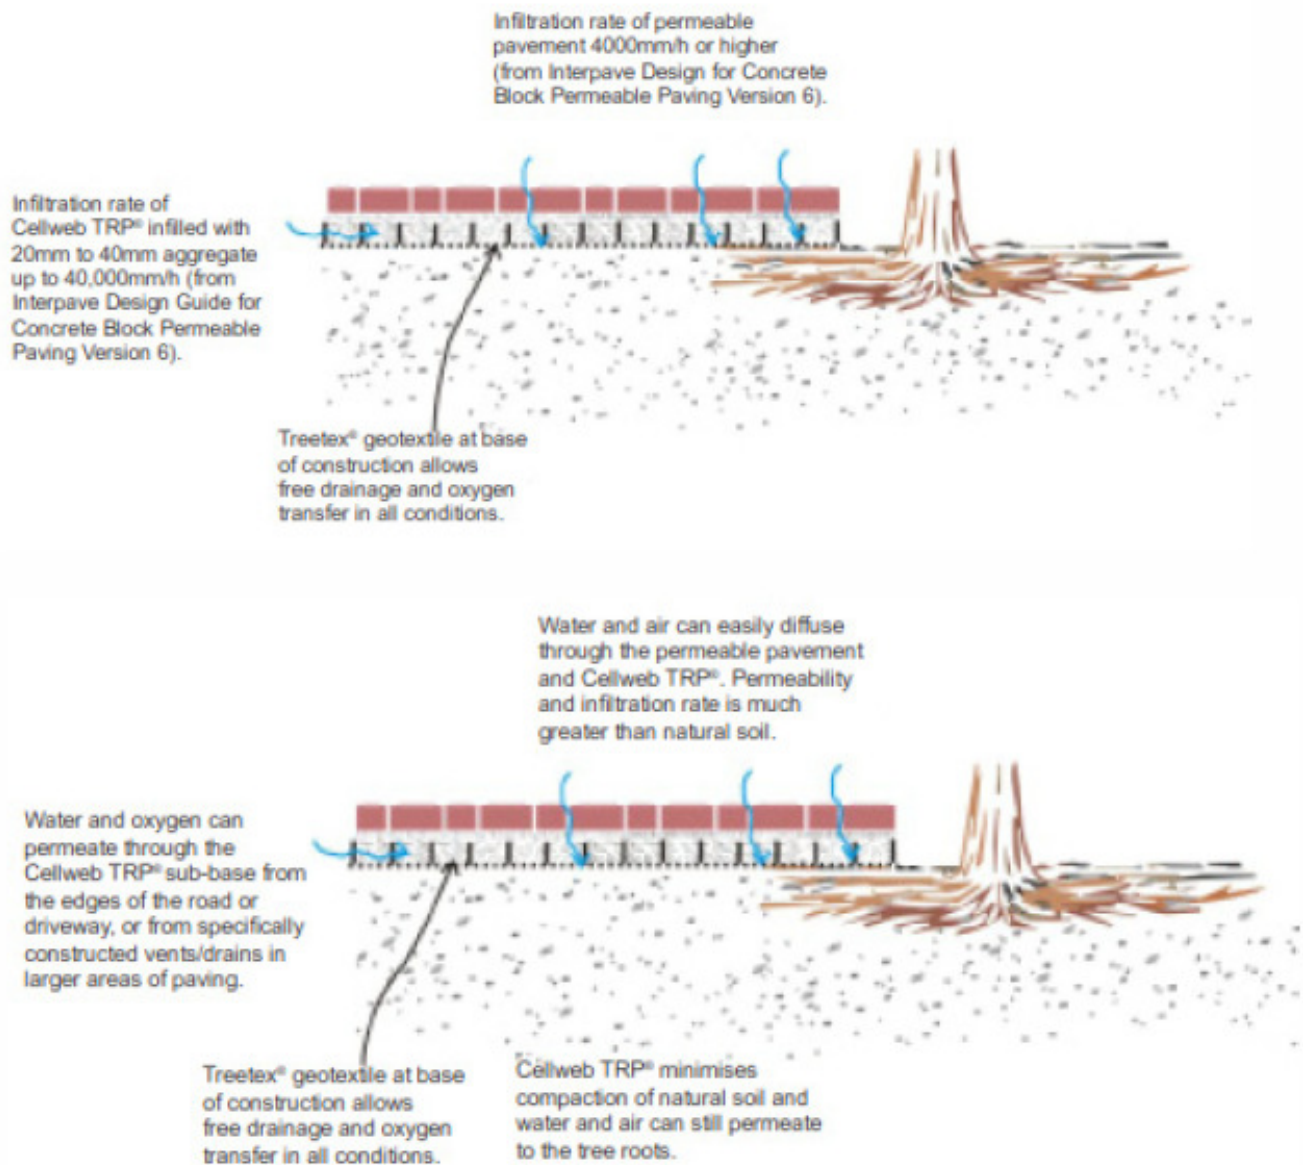
Areas of root protection as identified in the Arborculturalist report are to be protected with Cellweb TRP matting. This is a cellular conformer system that creates a load bearing surface that displaces and weight and damage, protecting roots from compaction and desiccation of the soil, while still allowing water and oxygen to permeate through (see below).

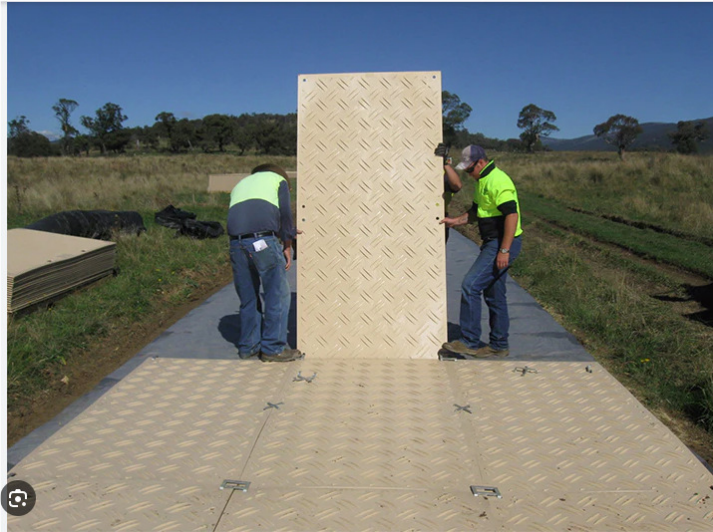
**PRODUCT SPECIFICATIONS**  
**DD2**

In addition, ground protection measures are also required to facilitate the work. It has been recommended by the Arborculturalist that the ground protection comprises of Duradek Mats. These are ground protection mats, moulded from a proprietary blend of High Density Polyethylene, designed to link together to form a temporary surface, protecting the ground from damage.

**Side 1:** Double-traction tread design includes two parallel traction treads positioned at a 90-degree angle to adjacent double traction tread sets.

**Side 2:** Pedestrian friendly alternating cross shaped traction design.

**Length:** 8' / 2.44 m

**Width:** 4' / 1.22 m

**Thickness:** ½" thick mat + 3/8" cleat

Black High-Density Polyethylene (HDPE) post-industrial recycled plastic, naturally UV resistant due to the carbon black used for color. White UV-stabilized mats available.

Varies, depending on sub-surface, up to 80 tons capacity.

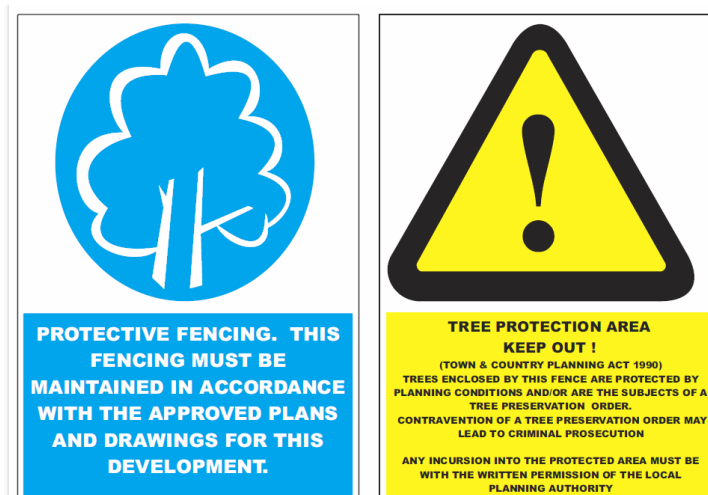
To inform site personnel of the purpose of the protective fencing, information notices shall be fixed to the fencing at 5m intervals. These notices shall be of all-weather design and examples of the notices can be found below as part of this report below.

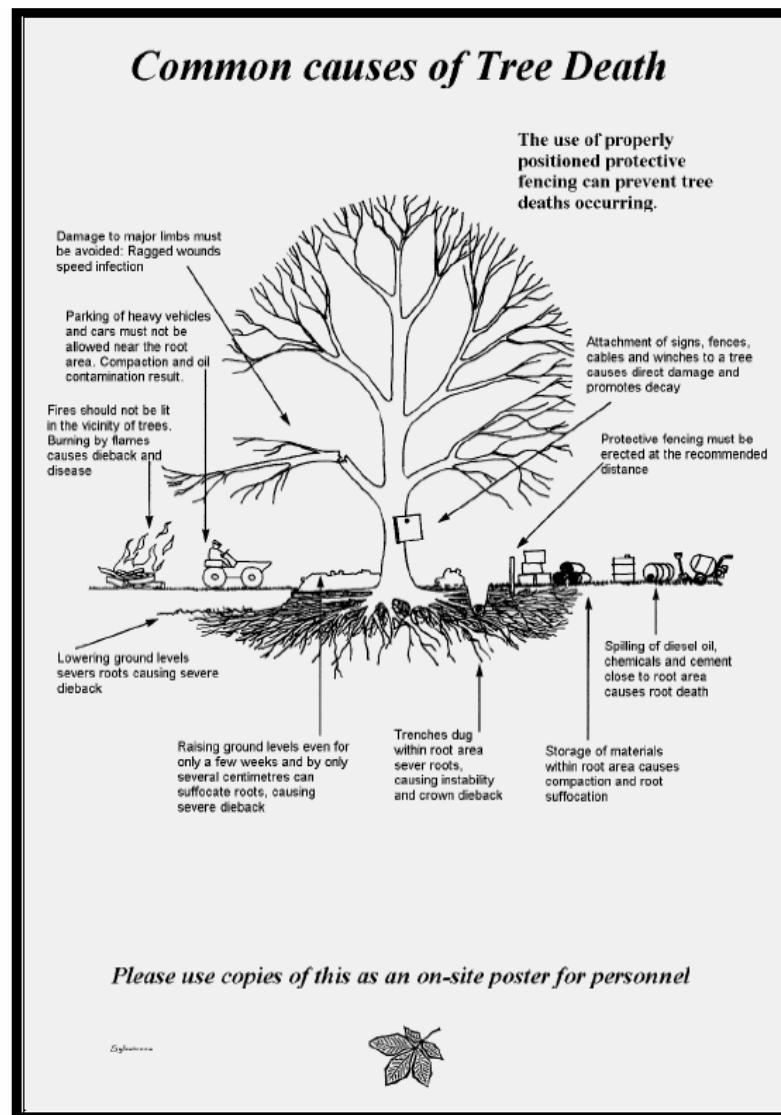
# Construction and Trees

## Why Is Fencing Erected Around Trees?

1. The major cause of damage to trees on construction sites is due to **soil compaction**.
2. Roots use the spaces between soil particles to obtain Oxygen, Water and Nutrients.

3. Heavy plant and machinery compresses (compacts) the soil, squashing out the air spaces and preventing root function.
4. A compacted soil structure will stay compacted.

5. Consequently the tree suffers and will show signs of branch die-back.
6. Symptoms such as die-back may take several years to appear.
7. Soil compaction over roots can be prevented by maintaining a fenced exclusion zone over the tree roots.

8. The exclusion zone distance is calculated using British Standard 5837.
9. Protective Fencing is installed at the calculated distance.
10. Protective Fencing is a condition of planning approval, if it is removed or repositioned the construction firm is in breach of a condition and may be subjected to legal action.
