Lines of sight

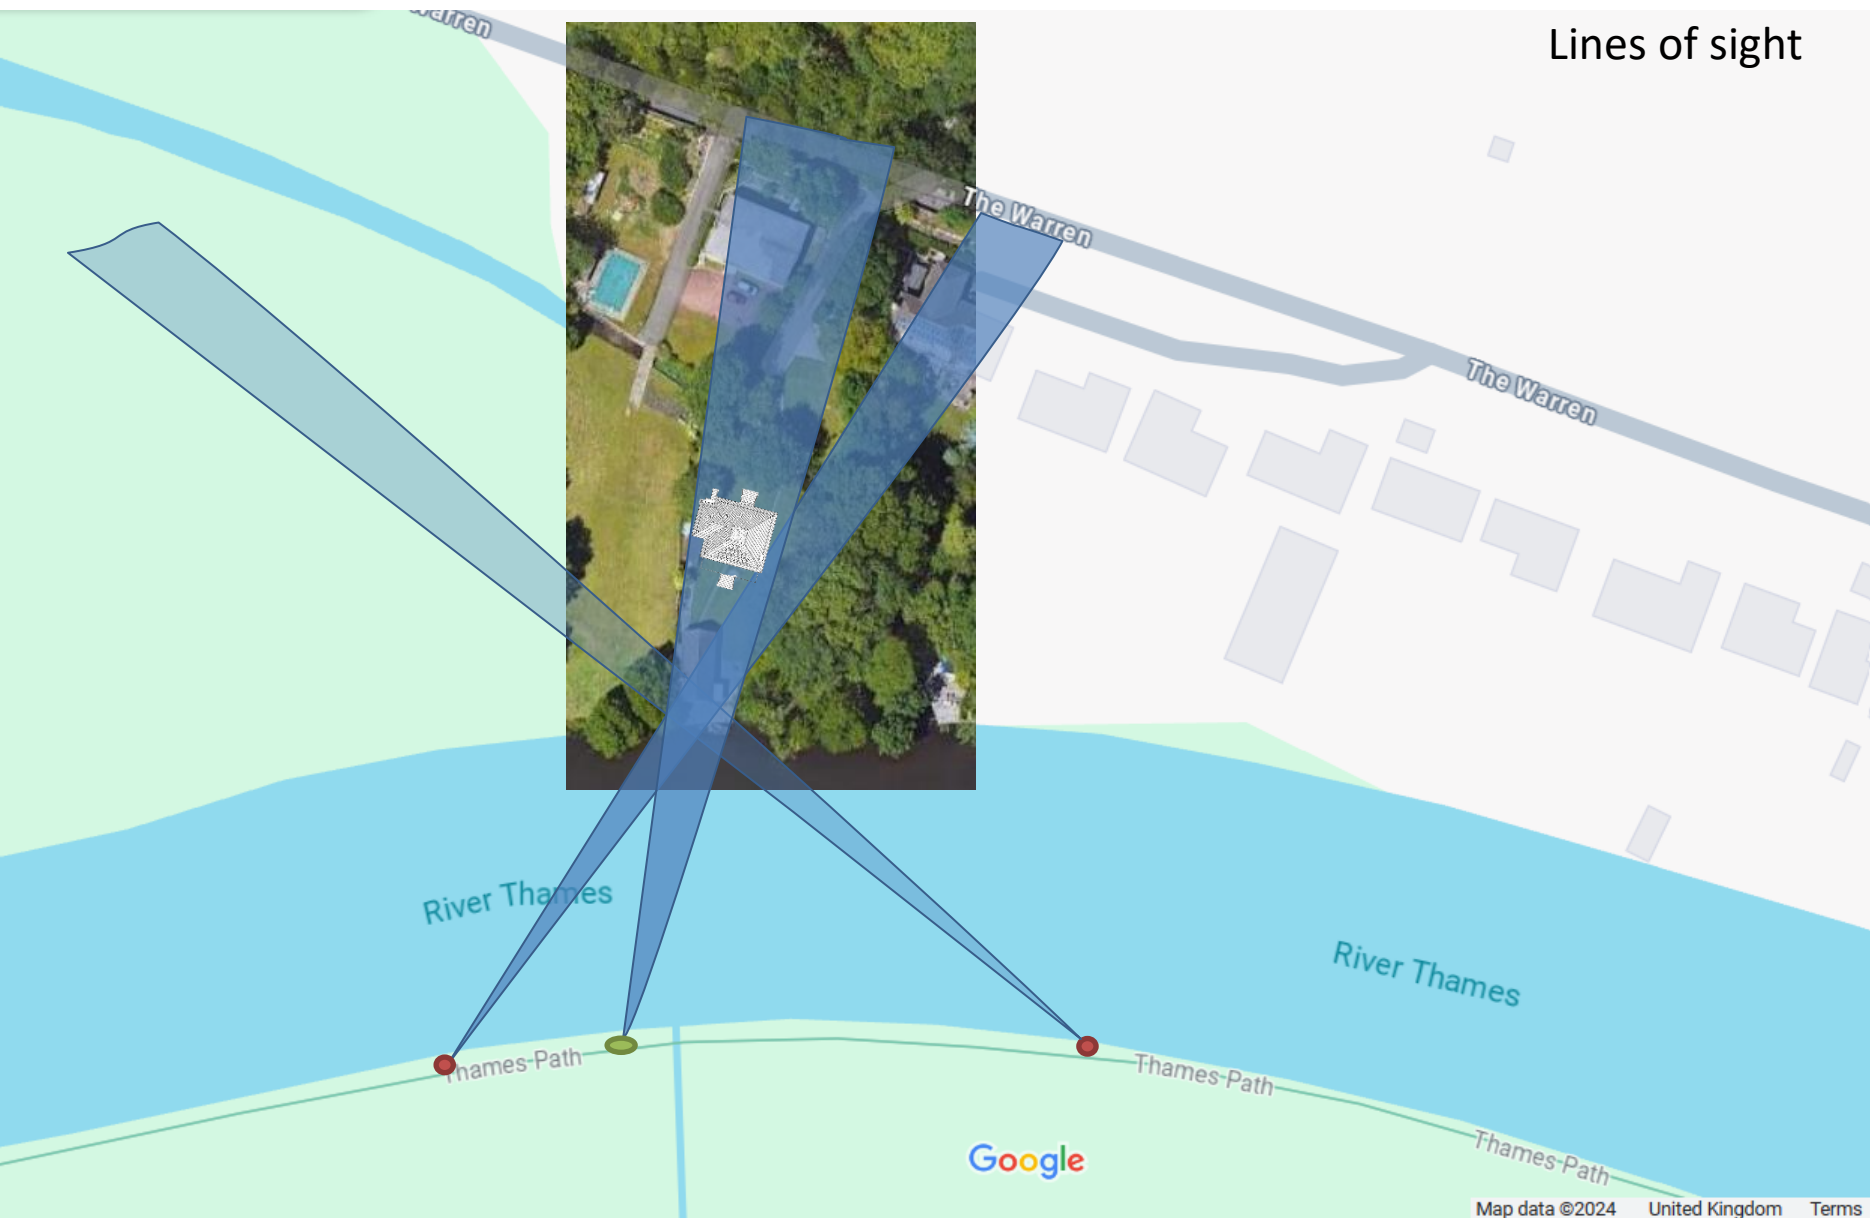
## Easterly position – line of sight

- The northerly right corner of the building is aligned to the most westerly tree trunk on the eastern waters edge
- The whole of the current house can be seen
- Waimarie cant be seen

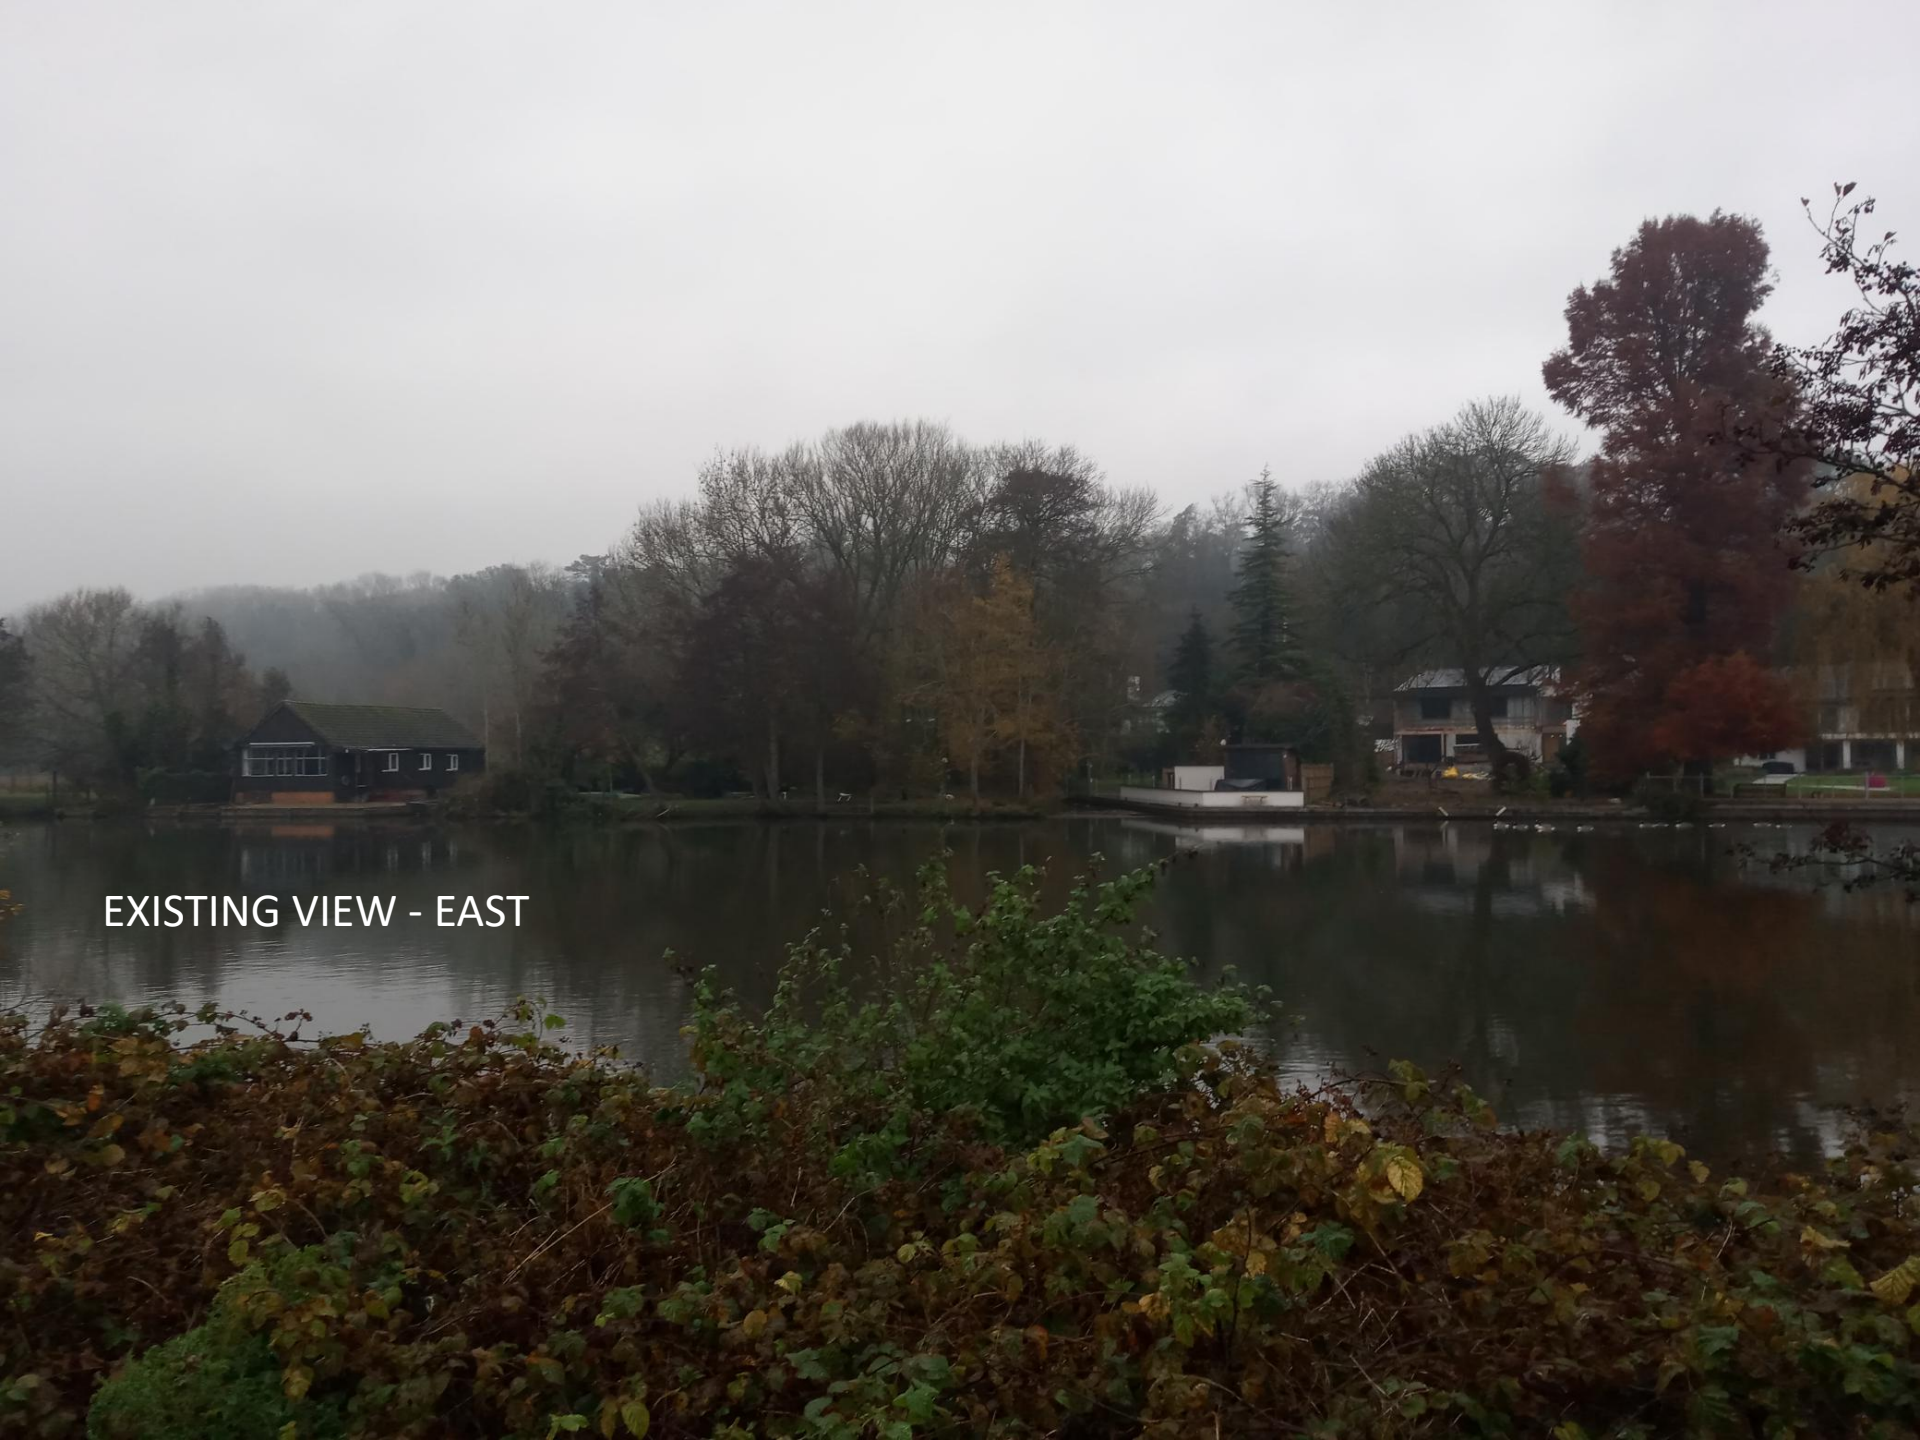
EXISTING VIEW - EAST

A landscape photograph showing a calm body of water, likely a lake or a wide river. In the foreground, there is a dense thicket of bushes with green and brown leaves. The water reflects the sky and the surrounding trees. On the far bank, there are several buildings: a dark, single-story house with a gabled roof on the left, and a larger, multi-story building with a light-colored facade on the right. The background is filled with a dense forest of trees, some with autumn-colored foliage. The sky is overcast and grey. The text "EXISTING VIEW - EAST" is overlaid on the left side of the image.

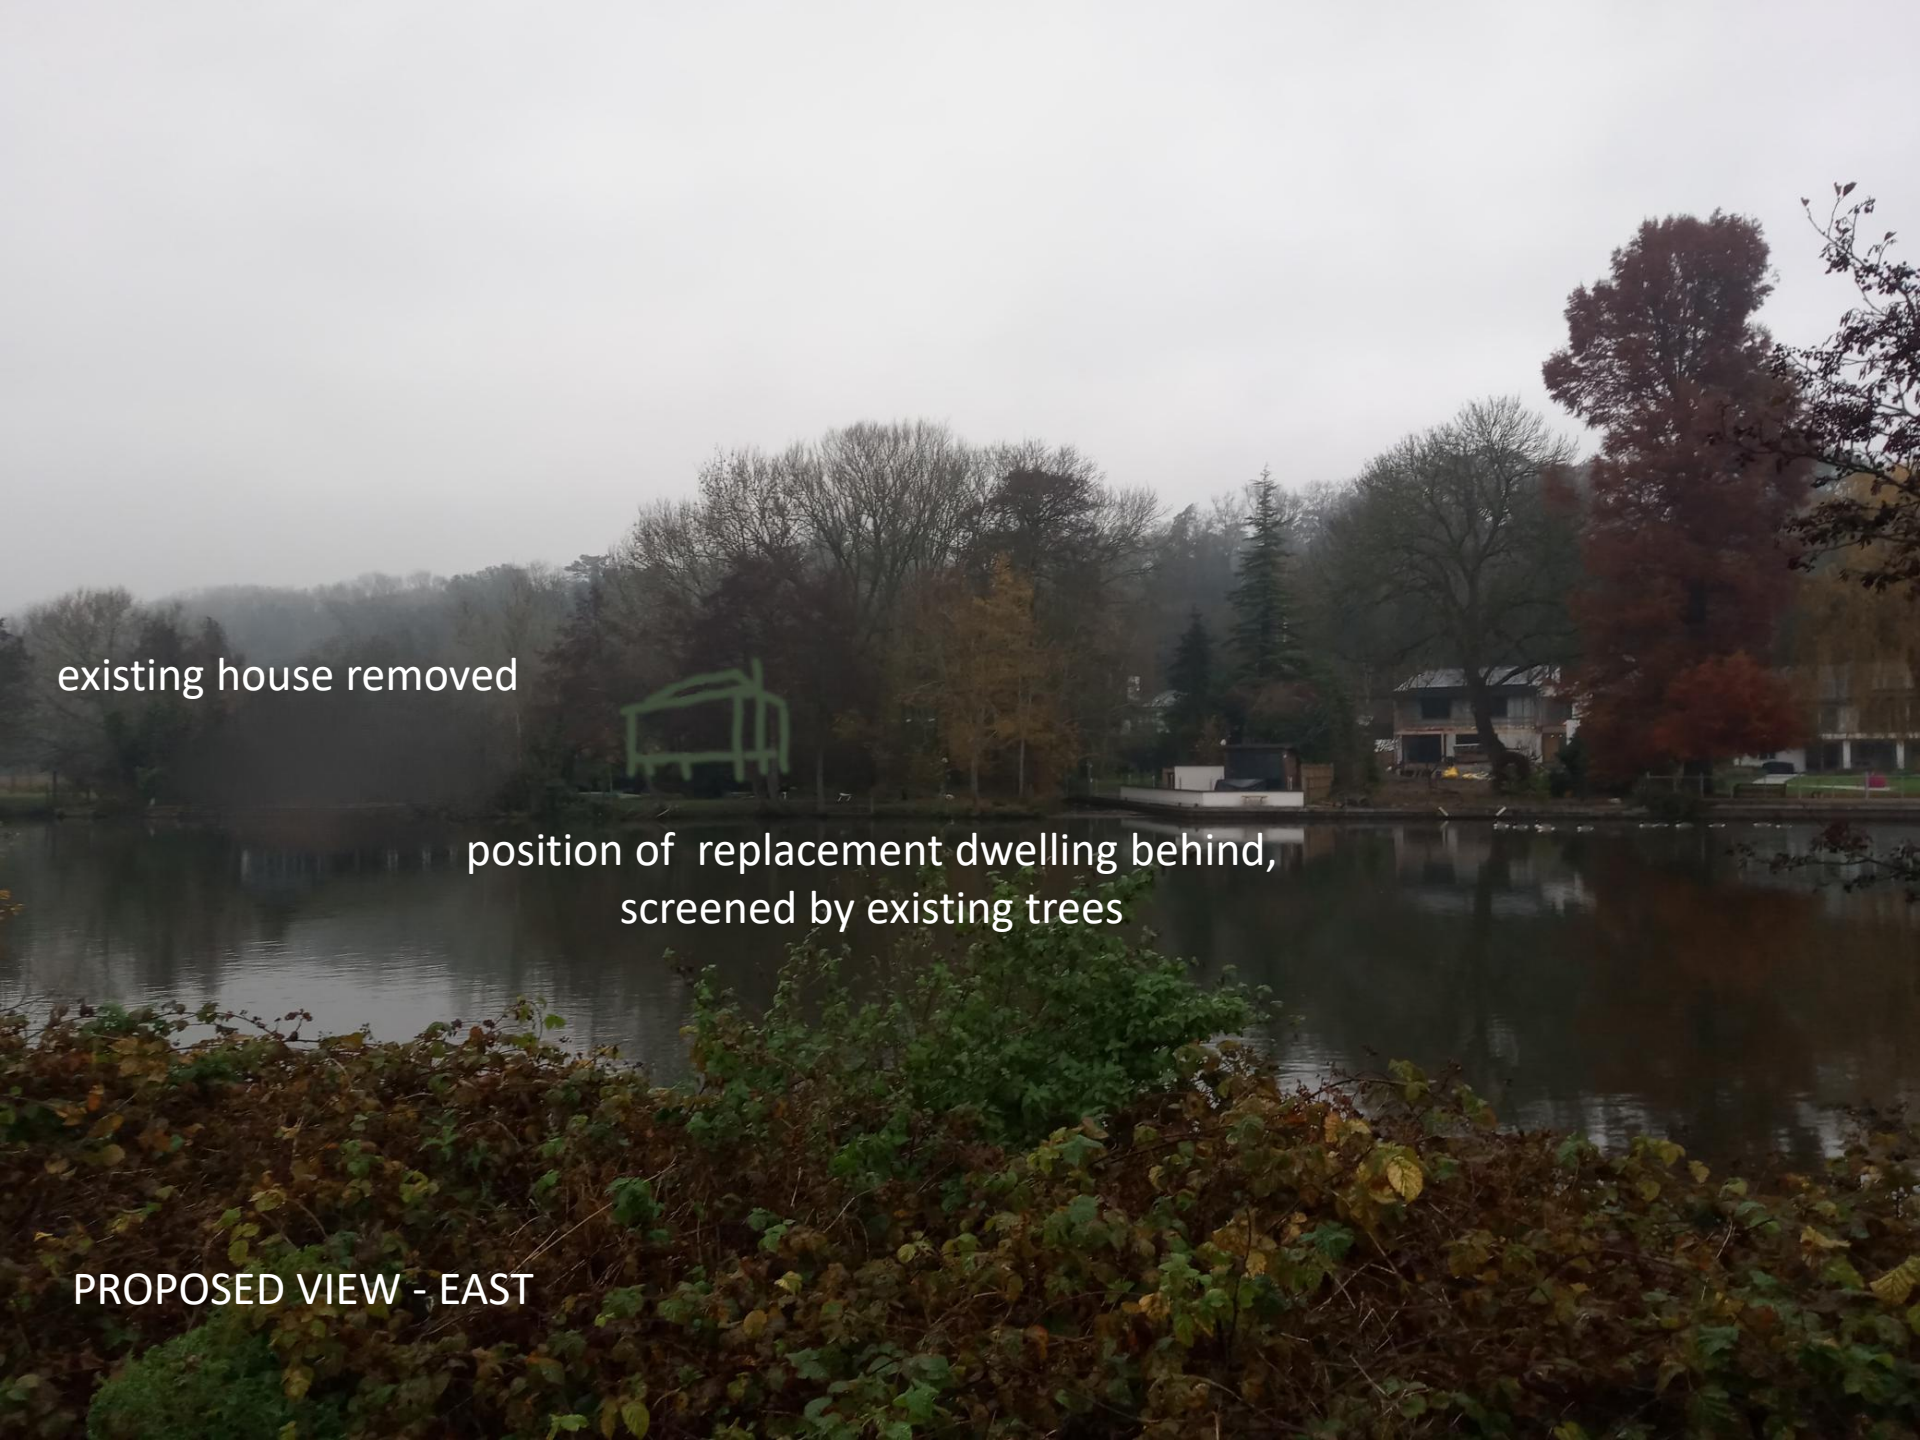
PROPOSED VIEW - EAST

existing house removed

position of replacement dwelling behind,  
screened by existing trees

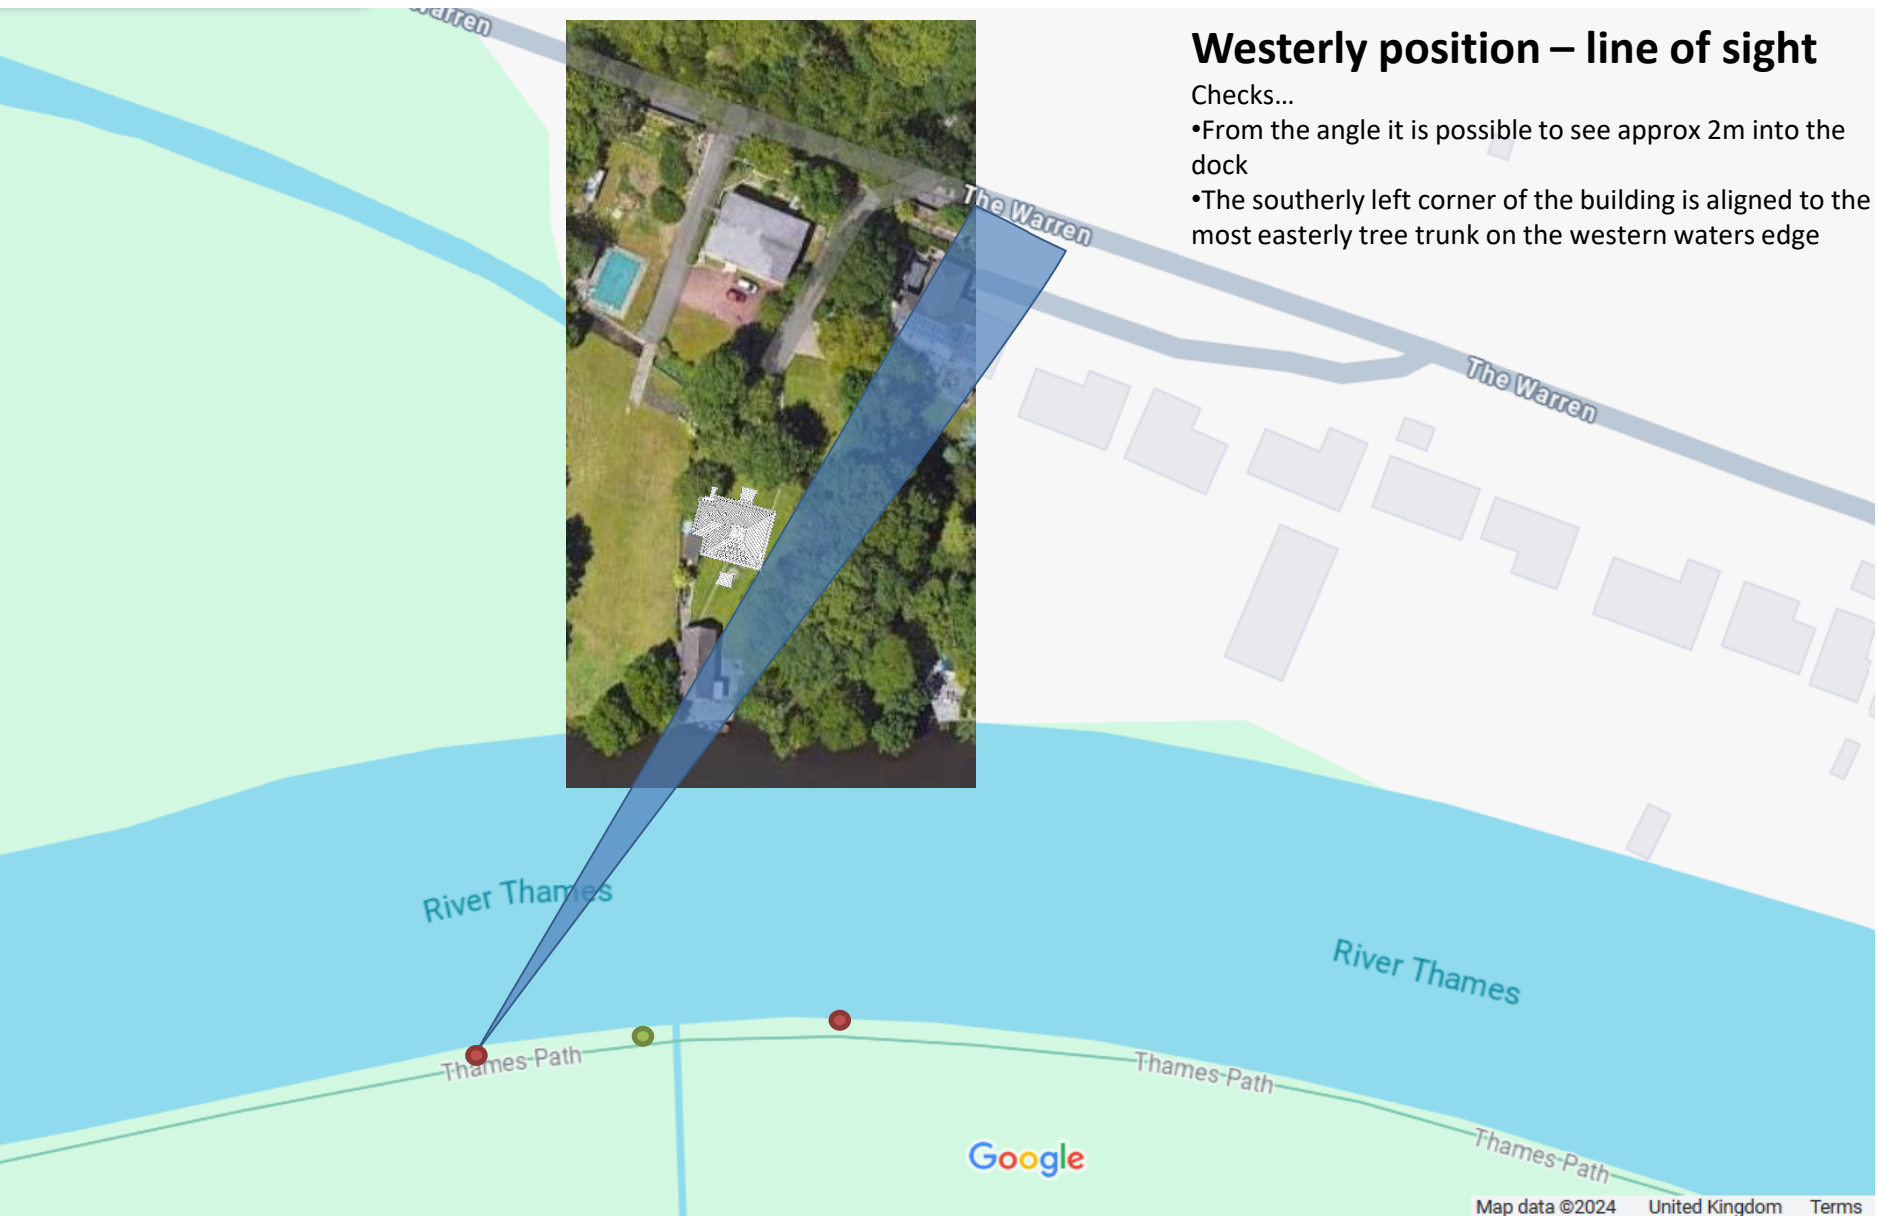
## Westerly position – line of sight

- From the angle it is possible to see approx 2m into the dock
- The southerly left corner of the building is aligned to the most easterly tree trunk on the western waters edge

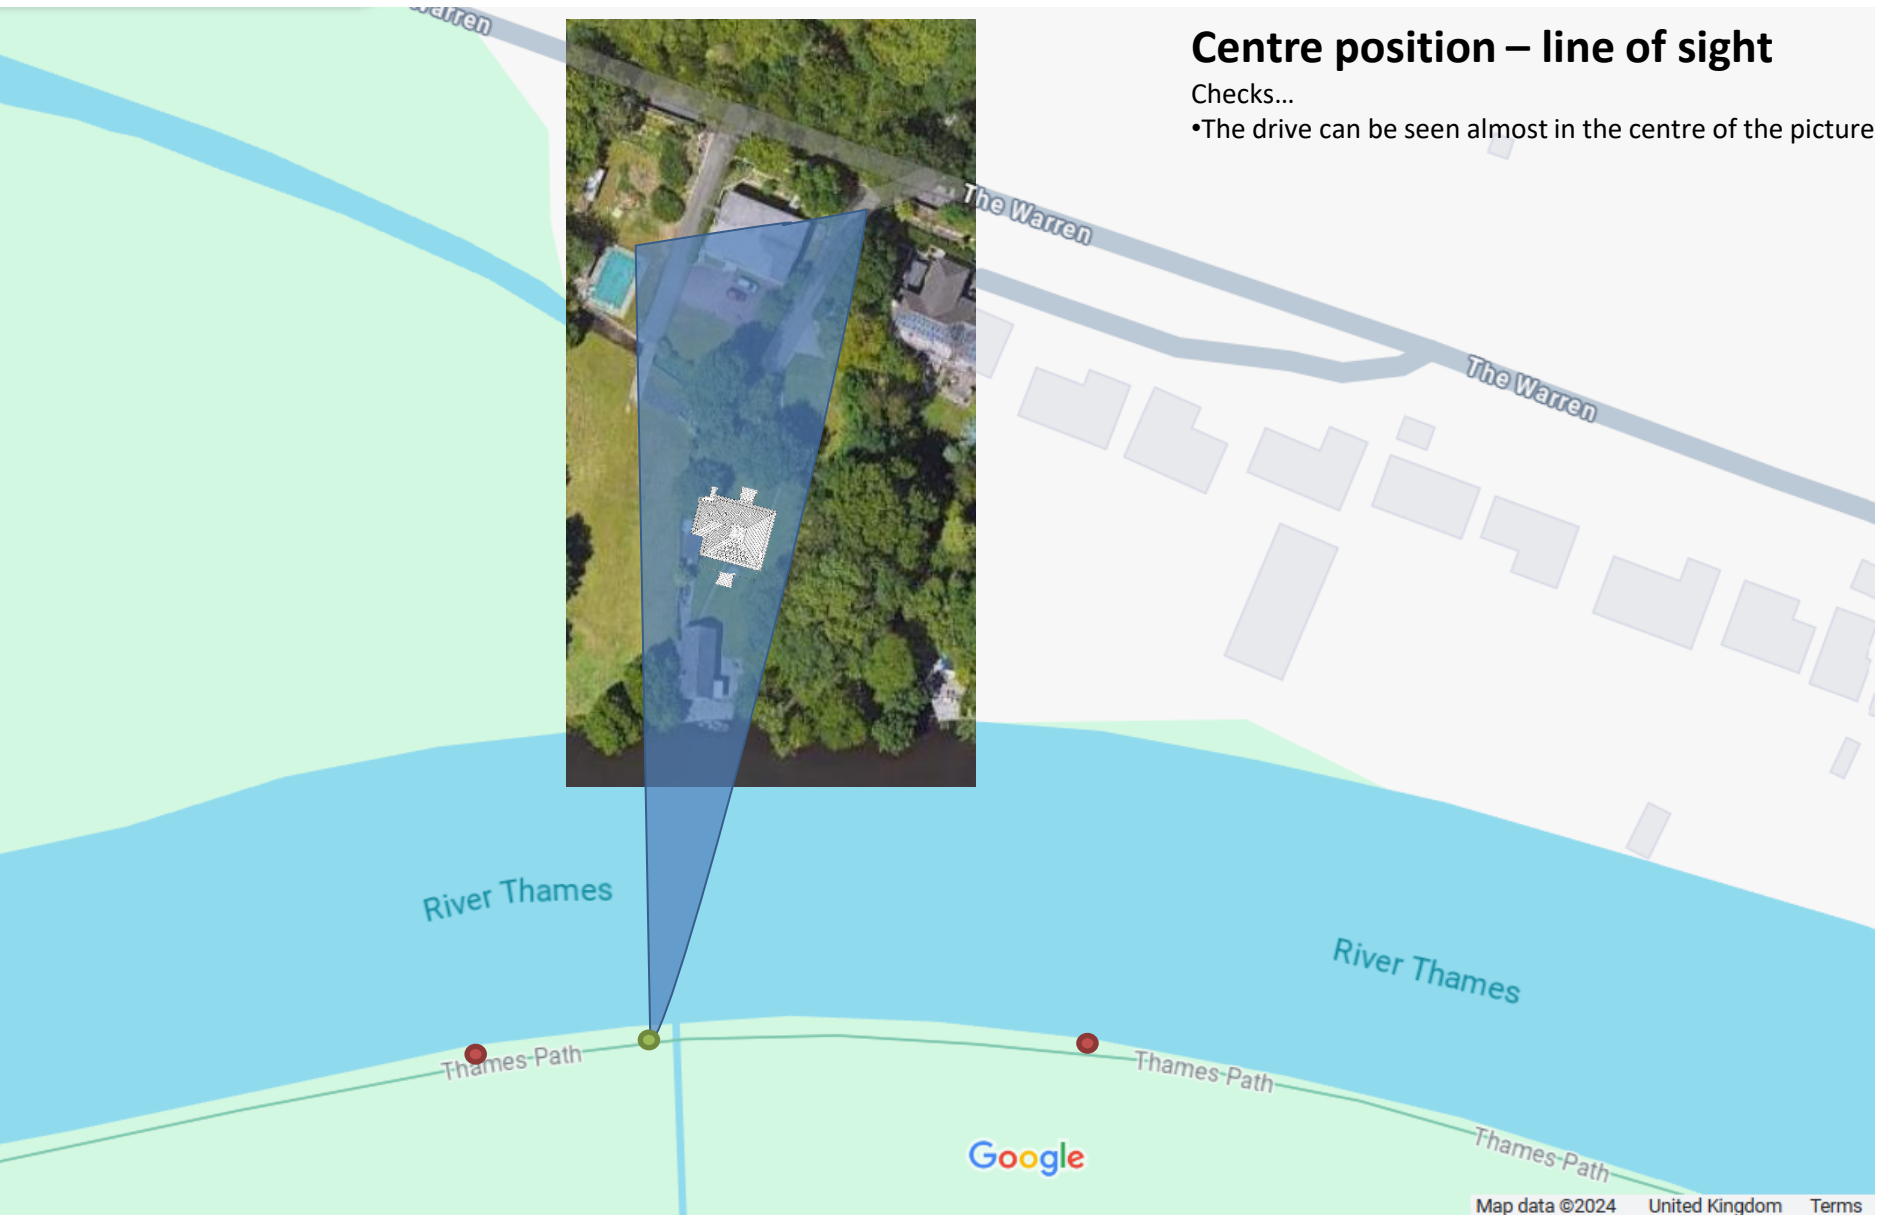
## Centre position – line of sight

- The drive can be seen almost in the centre of the picture
