**71 - 73 Caversham Road  
Reading  
RG1 8JA**

**Geo-Environmental Investigation**

**On behalf of Soil Investigation Eastern Ltd**

Document Reference: 24-728

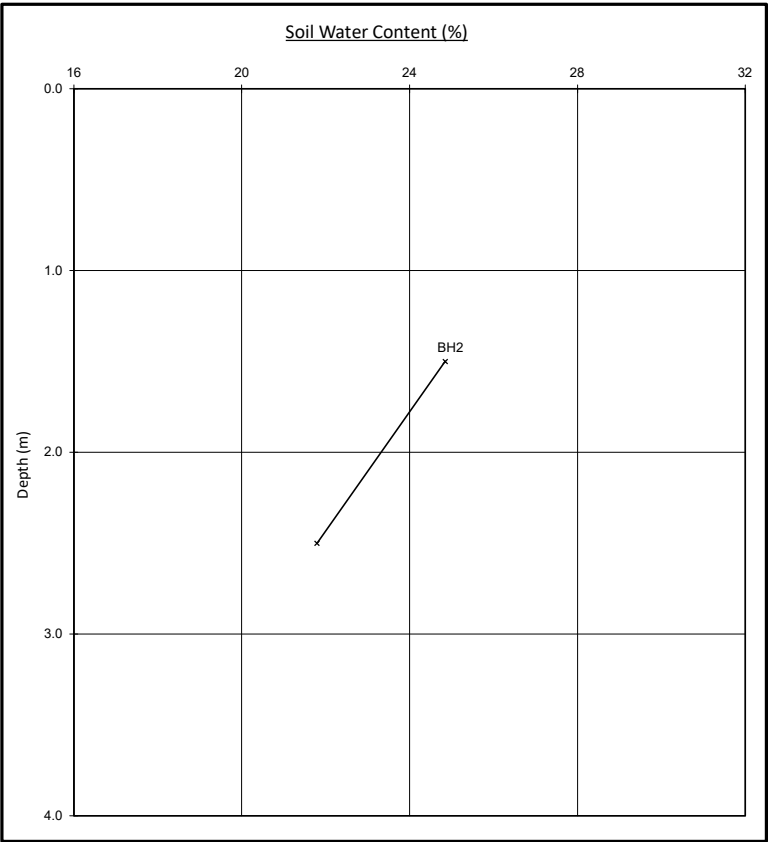
## Water Content Profiles

Notes  
1. If plotted, 0.4 LL and PL+2 ( after Driscoll, 1983 ) should only be applied to London Clay ( and similarly overconsolidated clay) at shallow depths.

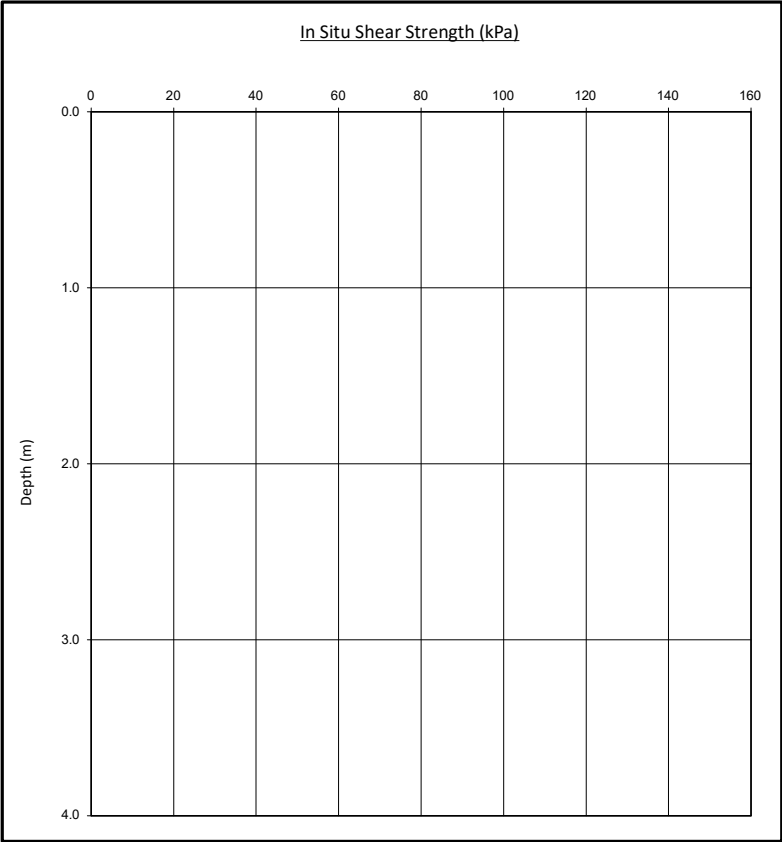
## Shear Strength Profiles

Note  
1. Values of Shear Strength were determined in situ by use of a pilcon hand vane of which is limited to a maximum reading of 140kPa.
