# **30 Queen Victoria Street, Reading, RG1 1TG:**

## ***Listed Building Consent Application to Reading Borough Council***

## ***Heritage Specification***

**27<sup>th</sup> April 2025**

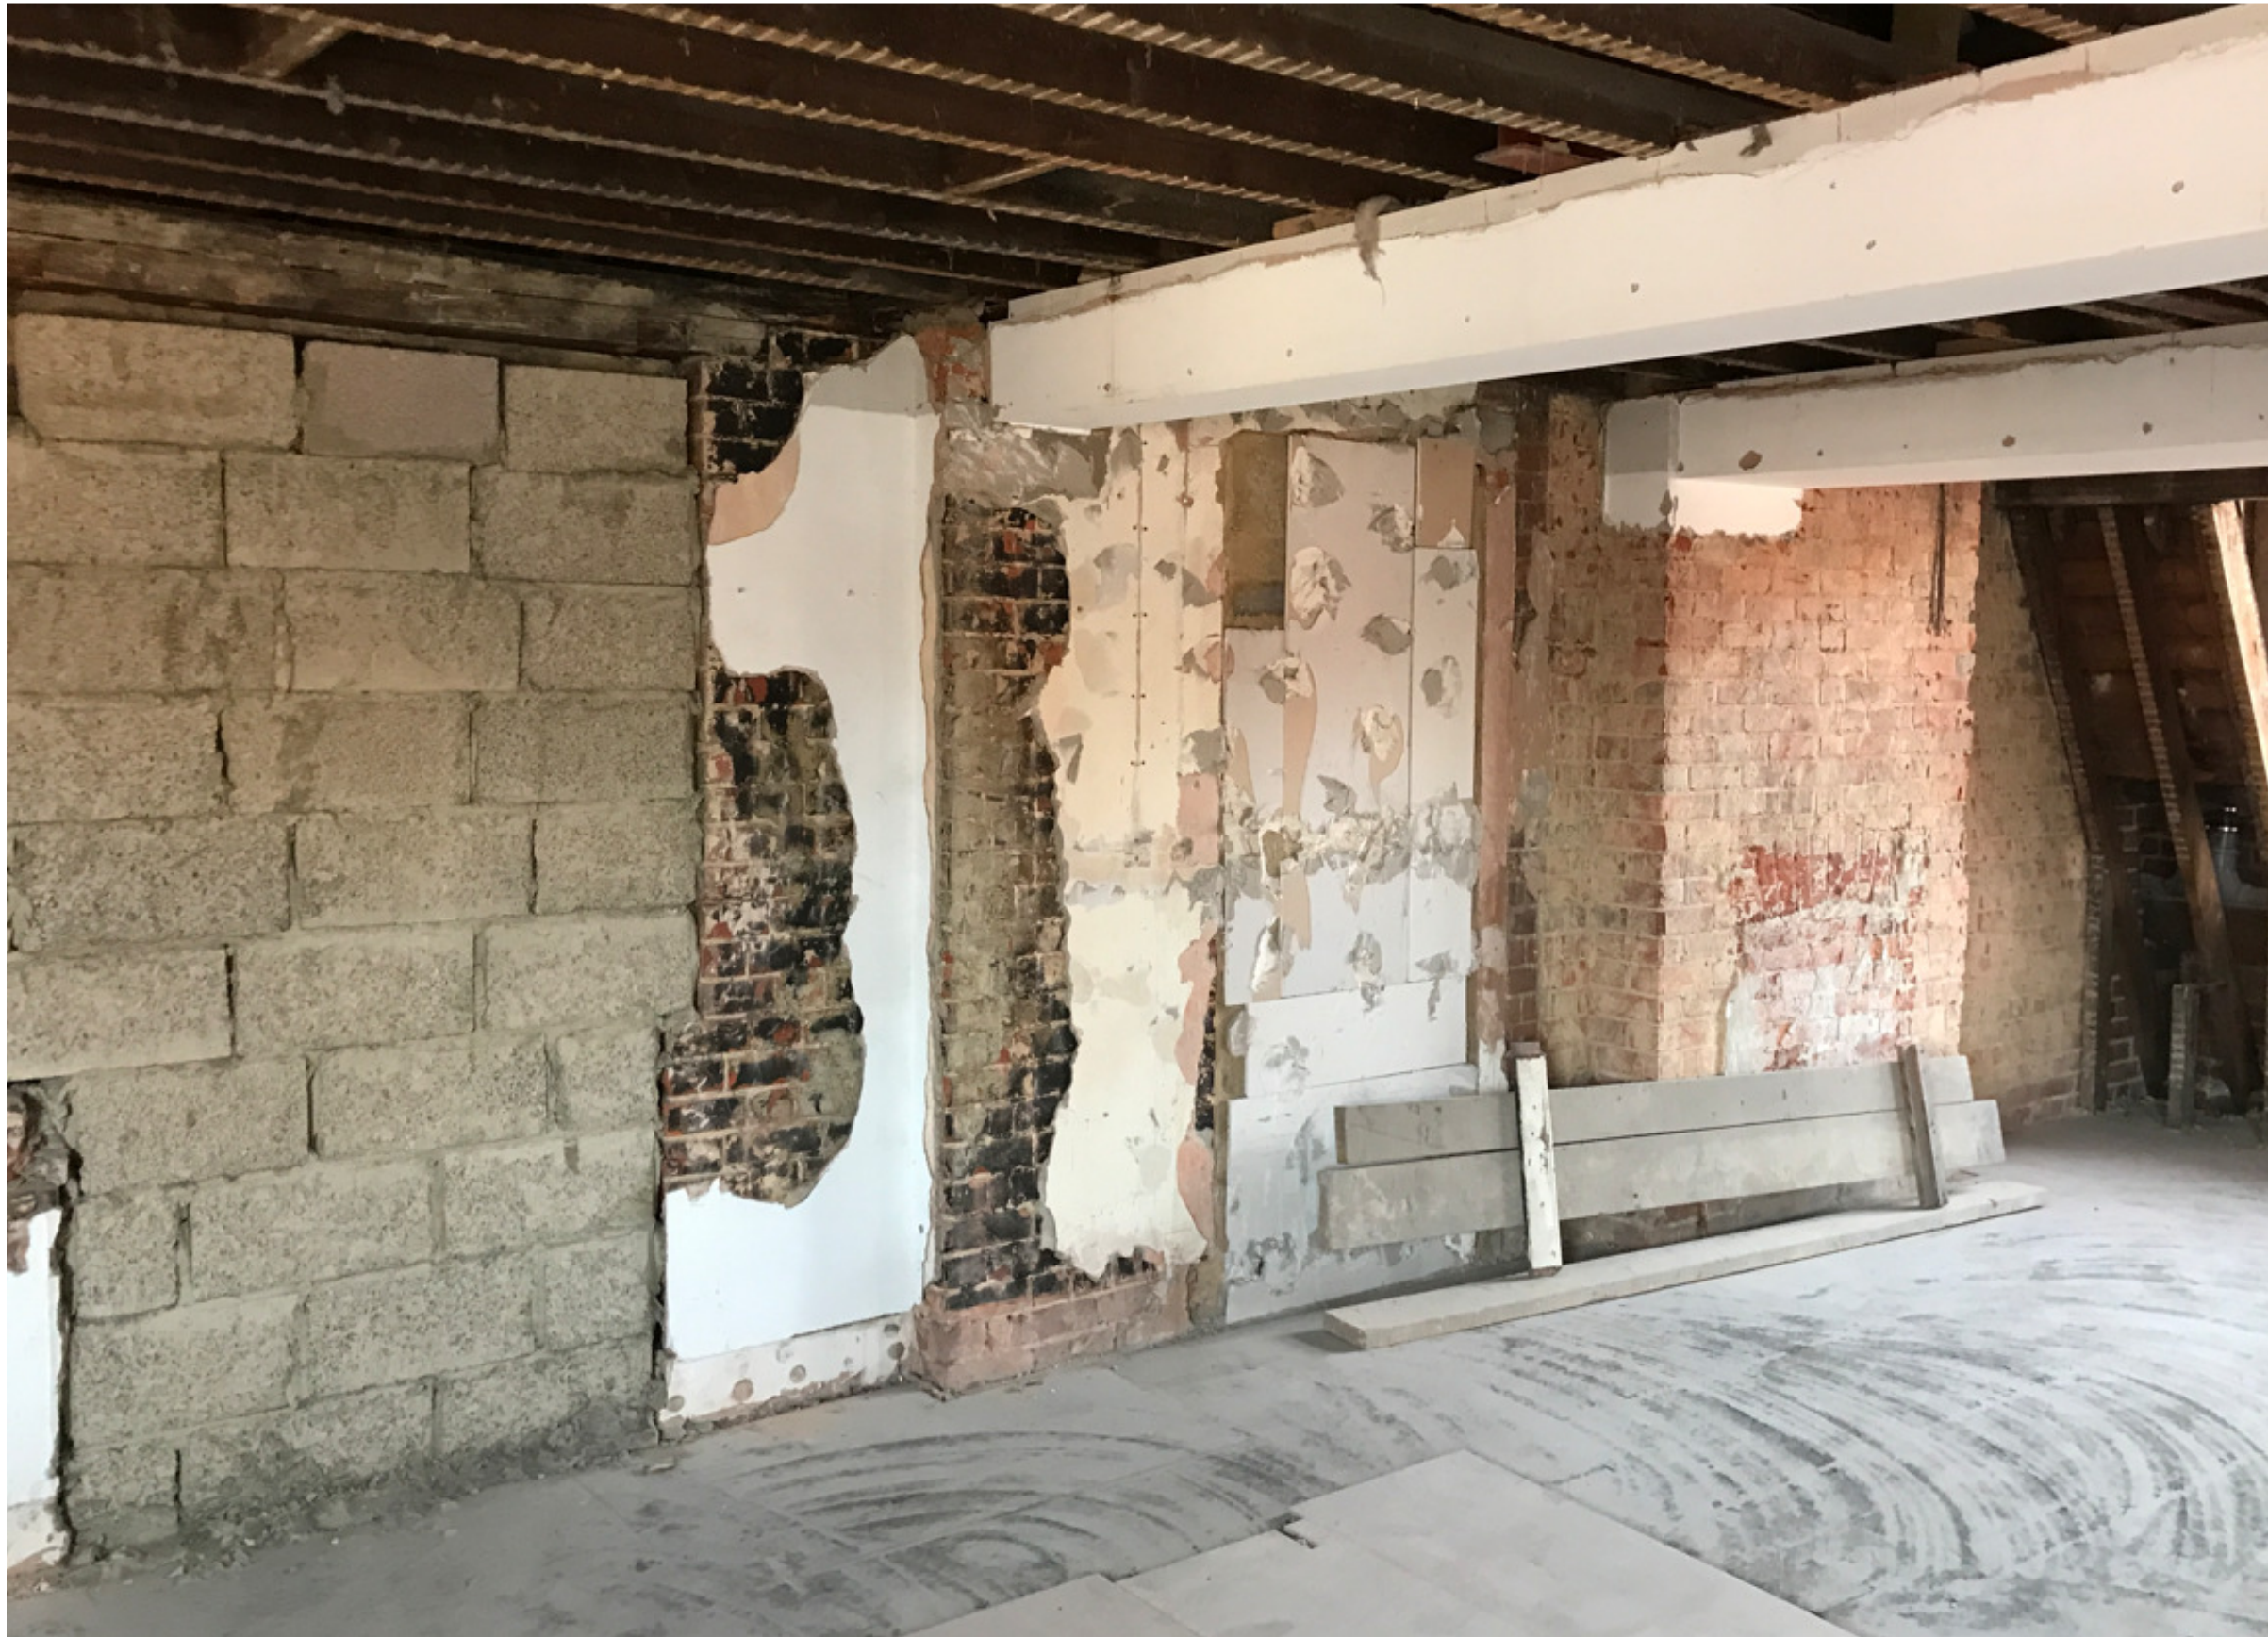
**Existing Typical Internal Party Wall :**

- Floor – Structural Concrete Slab with Terrazzo Floor Tiles (Modern HSBC Bank Style Grey Floor Tiles).
- External Walls – Poor Quality Brickwork with Modern Block Work In-fills.
- Internal Partitions – None exist.
- Over Head – Currently Exposed Timber Floor Joists to the floor level above.
- Other Features – None.

- Floor – Exposed Floor Boards (previously office carpet).
- External Walls – Poor Quality Brickwork with Modern Block Work In-fills.
- Internal Partitions – None exist.
- Over Head – Currently Exposed Timber Floor Joists to the floor level above.
- Other Features – 6No Sash Windows.

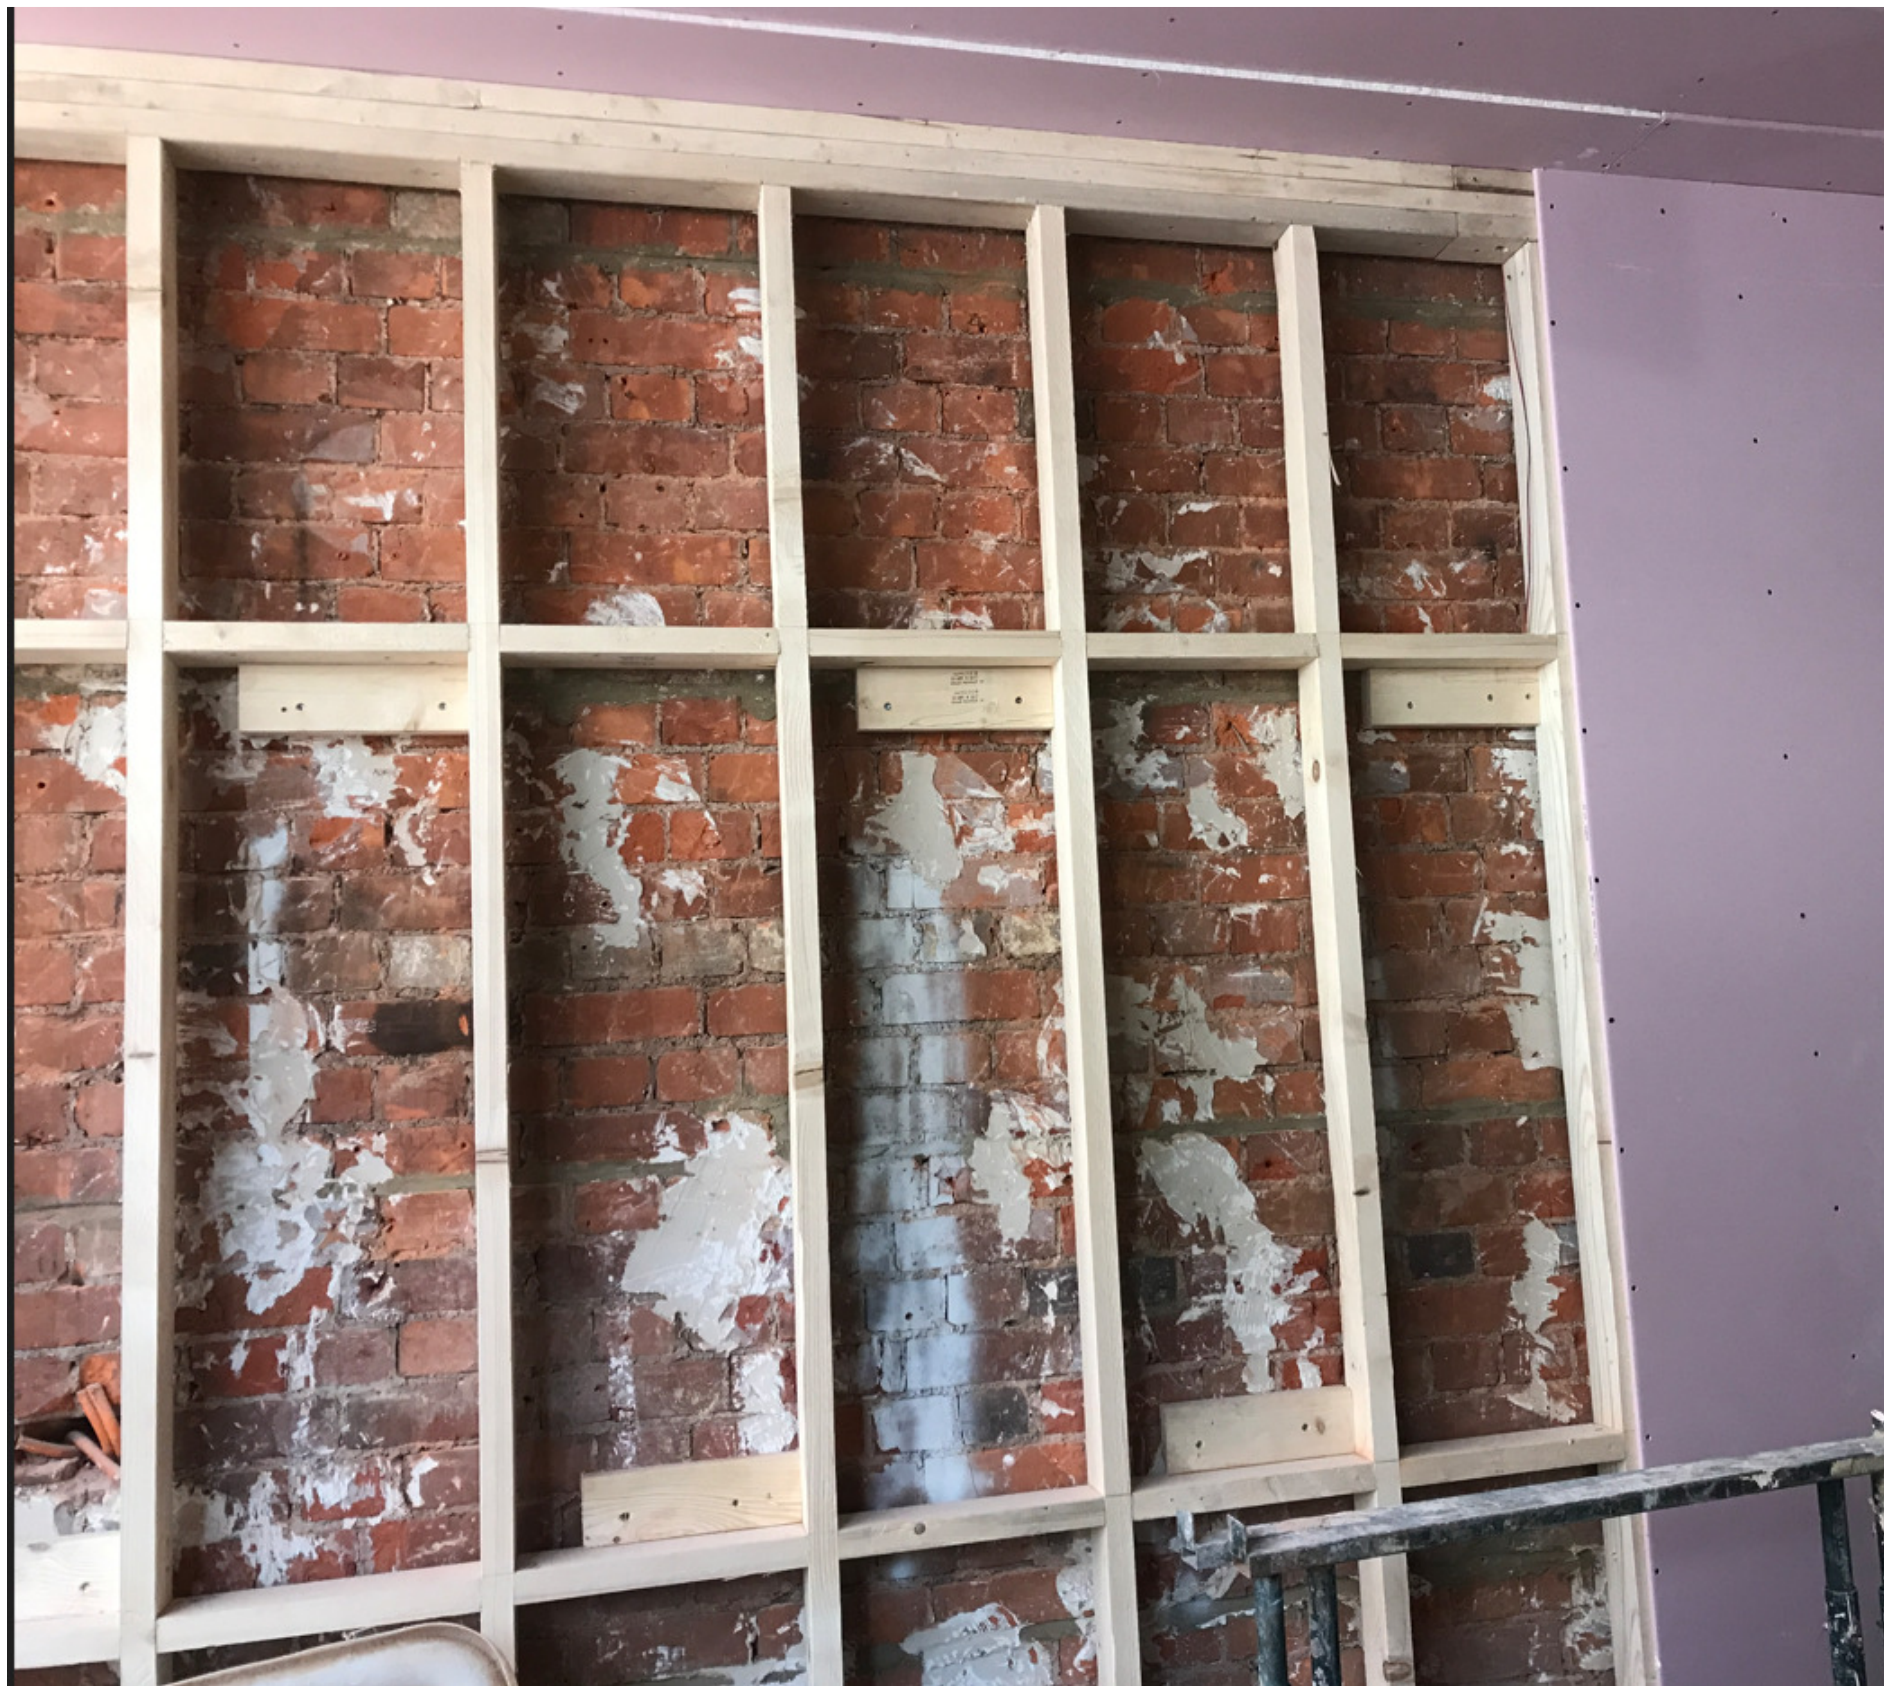
**External Walls - Proposed Internal Timber Studwork linings:  
This Provides Acoustic & Thermal Insulation as required by The Building Regulations:**

Existing Brick & Block work Walls will be clad in timber studwork with plasterboard wall linings, to meet the Acoustic & Thermal Requirements of The Building Regulations.

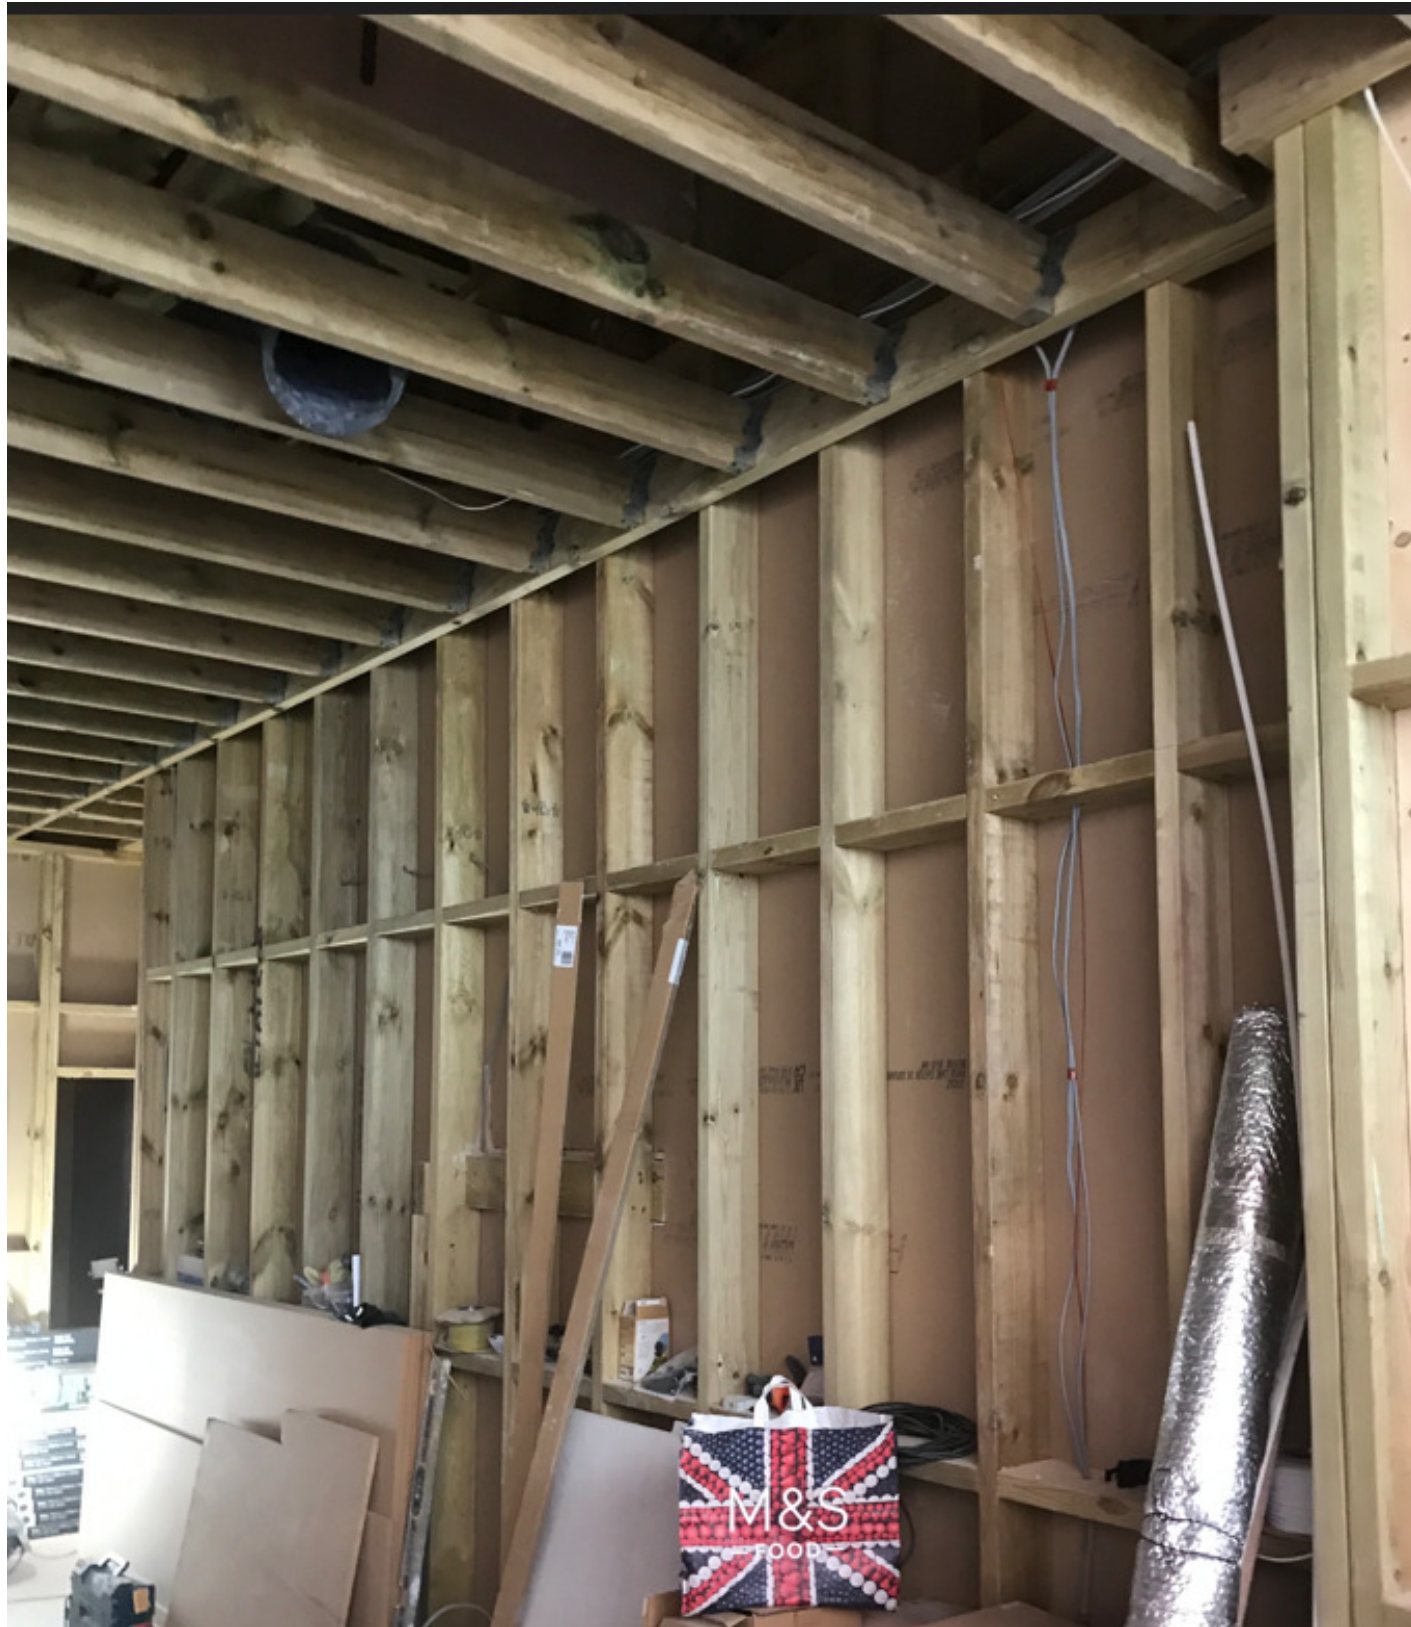
## Proposed Internal Timber Studwork Partitions:

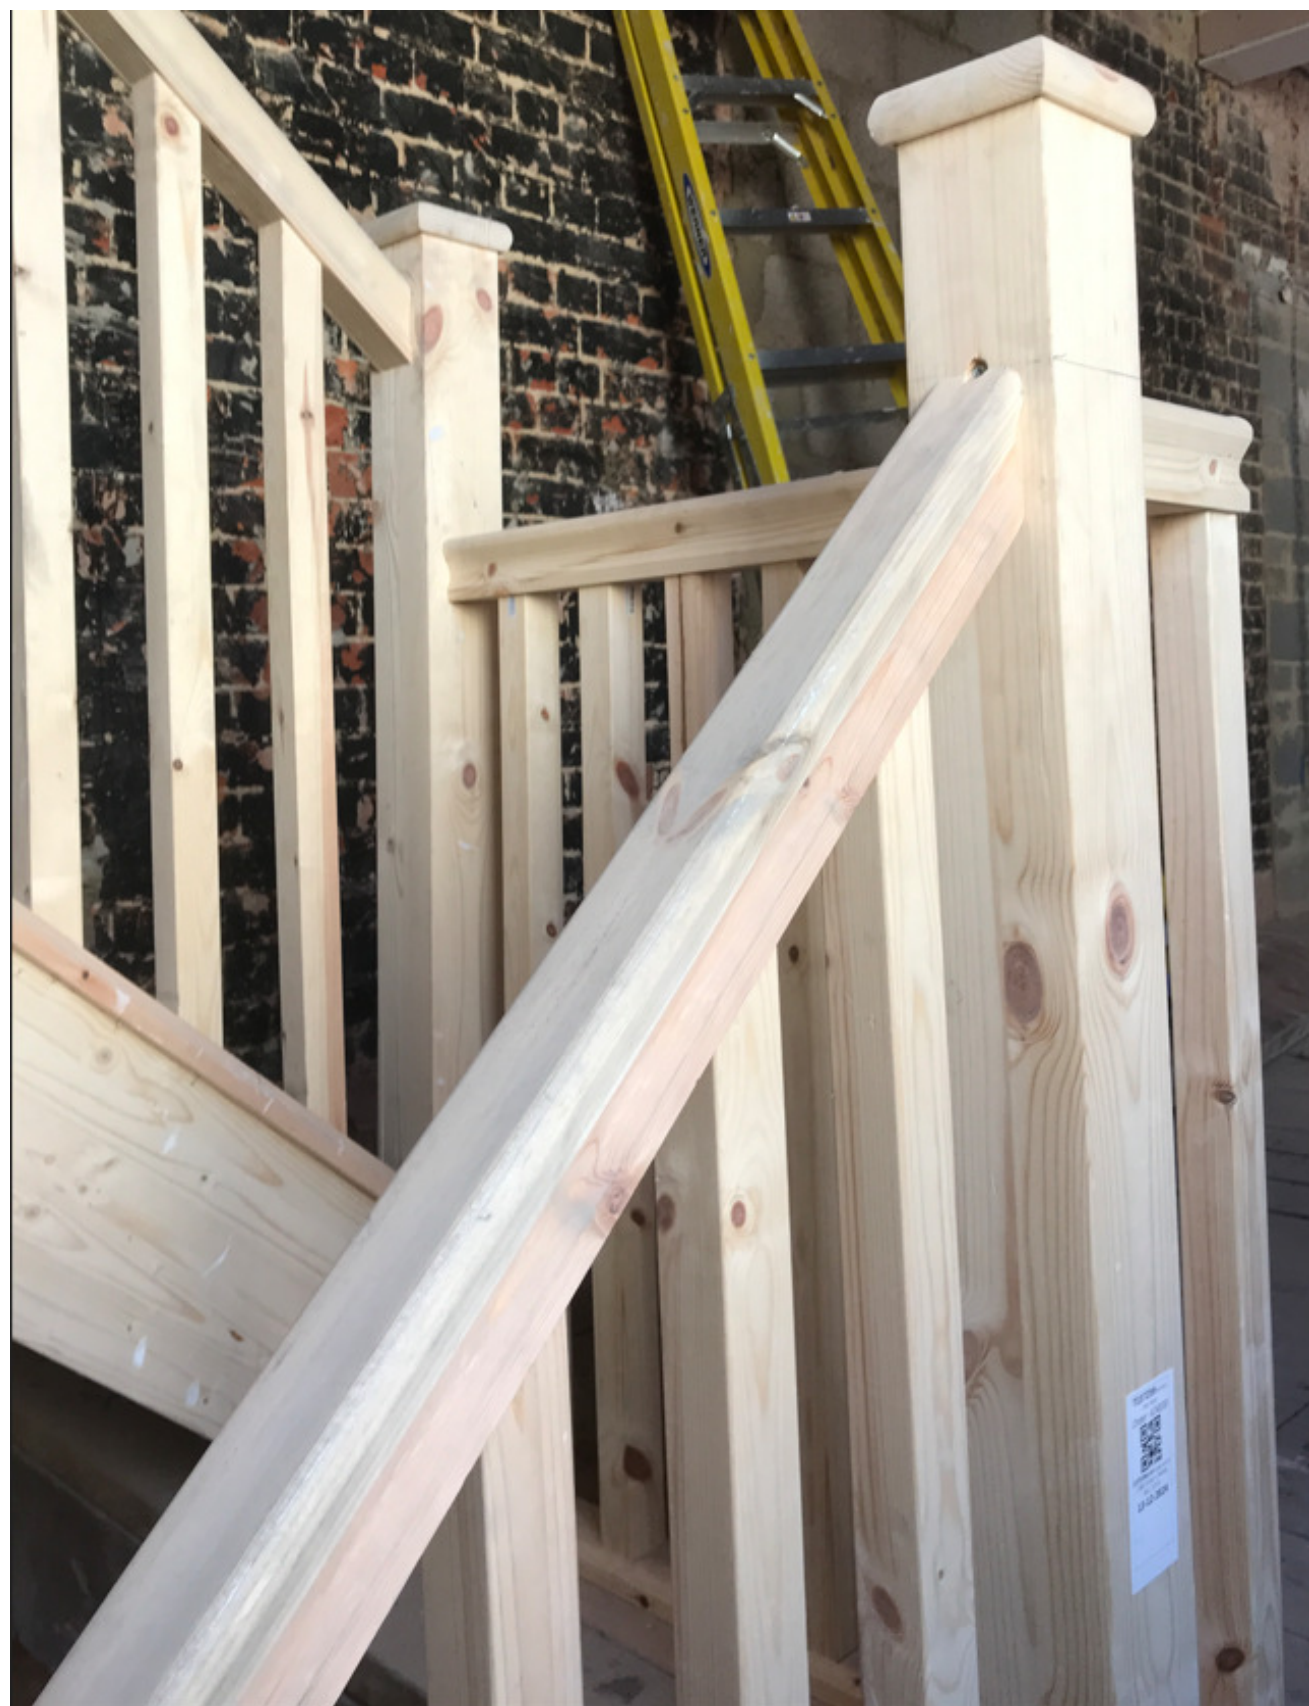
**Proposed Traditional Style – Solid Timber Staircases – Typical Details – Finish Dark Wood Stain:**

The proposal is to install a new staircase throughout the building, and then to Convert the existing First, Second & Third Floor Levels (previously Banking Offices) to 3No One Bedroom Apartments, ie one on each floor level.
