## Ecological Enhancement Plan

Premier Inn Reading Gateway, Gateway Proctor End South, Reading RG2 0GG

Whitbread Group PLC

External alterations to the existing hotel and Sui Generis (Drinking Establishment with expanded food provision) building to provide additional hotel bedrooms, reconfigured ancillary hotel restaurant and all associated works

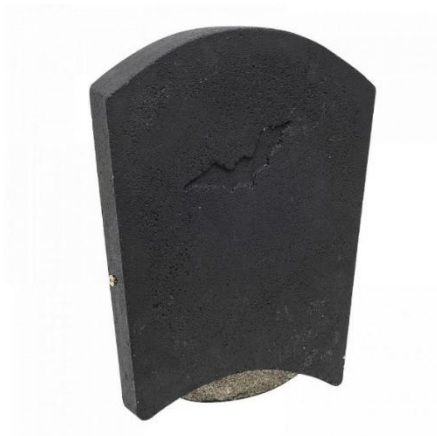
| Works | Specification |
|---|---|
| <b>Bat Boxes</b> | <p>One bat box is recommended to be installed on the retained building.</p> <p><b>Bat boxes specification:</b></p> <ul style="list-style-type: none"> <li>The recommended bat boxes will be constructed of woodcrete/ woodstone. Boxes of this construction are designed to require no maintenance and have a lifespan of 25 years plus.</li> <li>1x Beaumaris Bat Box (or similar alternative brand) is recommended on the building, as shown in <b>Figure 1</b>.</li> <li>Bat boxes should be positioned 3-5m above ground level facing in a south, southeast, or southwest aspect with a clear flight path to and from the entrance, away from artificial light.</li> </ul> <p><i>Figure 1: Beaumaris Bat Box (image credit <a href="https://www.nhbs.com/beaumaris-woodstone-bat-box">https://www.nhbs.com/beaumaris-woodstone-bat-box</a>)</i></p> <p><b>Recommended Management:</b></p> |

| | <p>The proposed bat boxes are designed to require no management or maintenance. Furthermore, preventing physical disturbance of bat boxes will increase the chances of occupation by roosting bats. However, it is recommended that the bat boxes are inspected annually for the first five years outside of the typical active season for bats (May to September inclusive) following installation. Bat boxes must be replaced if they are damaged, removed, or have fallen from their recommended location.</p> |

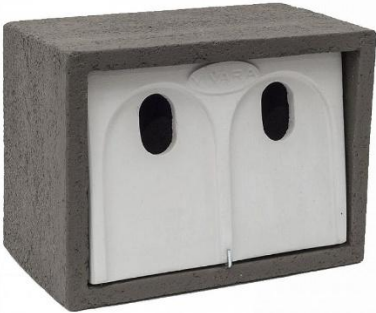
| <b>Bird Boxes</b> | <p>Two bird boxes are recommended to be installed on site, onto the façade of the converted building.</p> <p><b><i>Bird box specification:</i></b></p> <ul style="list-style-type: none"> <li>• The recommended bird boxes will be constructed of woodcrete/ woodstone. Boxes of this construction are designed to require no maintenance and a lifespan of 25 years plus.</li> <li>• 2x Vivara Pro WoodStone House Sparrow Nest Box (or a similar alternative brand) is proposed on the building, as shown in <b>Figure 2</b>.</li> <li>• Woodstone Nest Boxes should be positioned approximately 3m above ground level where they will be sheltered from prevailing wind, rain and strong sunlight.</li> <li>• Vivara Pro WoodStone Swift Nest Boxes should be positioned at the eaves of the building.</li> </ul> <div data-bbox="1008 766 1456 1133"> </div> <p><i>Figure 2: Vivara Pro WoodStone House Sparrow Nest Box (image credit: <a href="https://www.nhbs.com/">https://www.nhbs.com/</a> WoodStone House Sparrow Nest Box)</i></p> <p><b><i>Recommended Management:</i></b></p> <p>The proposed bird boxes are designed to require no management or maintenance. Furthermore, preventing physical disturbance of bird boxes will increase the chances of occupation by nesting birds. However, it is recommended that the bird boxes are inspected annually for the first five years outside of the typical nesting bird season (March to September inclusive) following installation. Bird boxes must be replaced if they are damaged, removed, or have fallen from their recommended location.</p> |
