## The Existing Buildings and Site

## Current Condition

## **The Proposals**

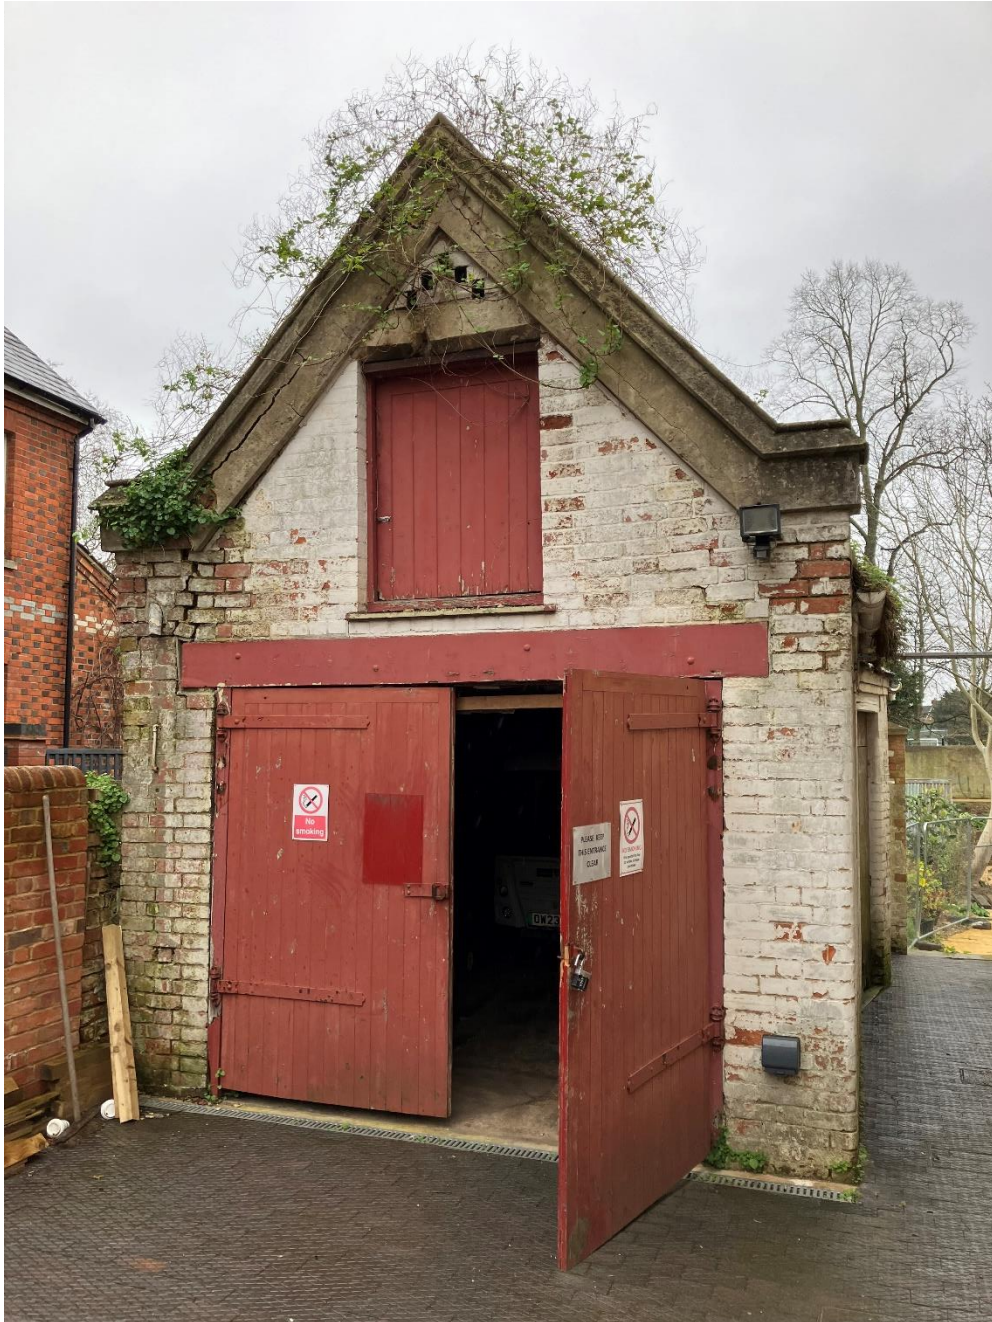
*The front elevation of the garage, facing Craven Road*

The garage is constructed of brick with a slate roof. Some of the brickwork has been painted. The front gable has a high level timber door and a rendered parapet wall. The side windows and door have been boarded up for security reasons.

The proposal is to strip the roof, temporarily prop the roof structure, replacing any defective timbers, and to take down the walls to a sound level and rebuild like-for-like. We hope to salvage as many of the bricks as possible for reuse, supplementing these with reclaimed imperial bricks to match the existing.

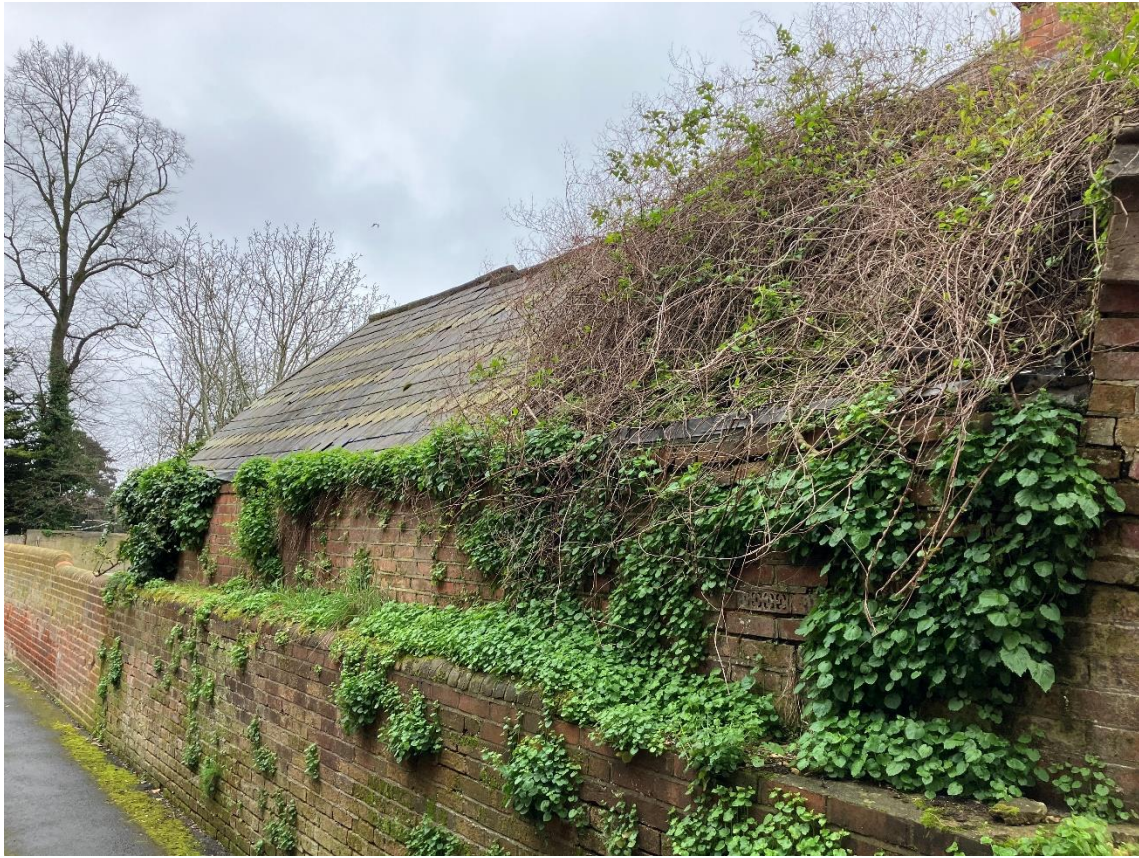
The boundary wall to the northern side with number 15 Craven Road has suffered too, and is leaning at an alarming angle over the driveway which accesses the parking area for the flats at number 15. This wall will be taken down and rebuilt under these proposals.

*The north elevation showing the boundary wall to number 15 and the general foliage surrounding the building*

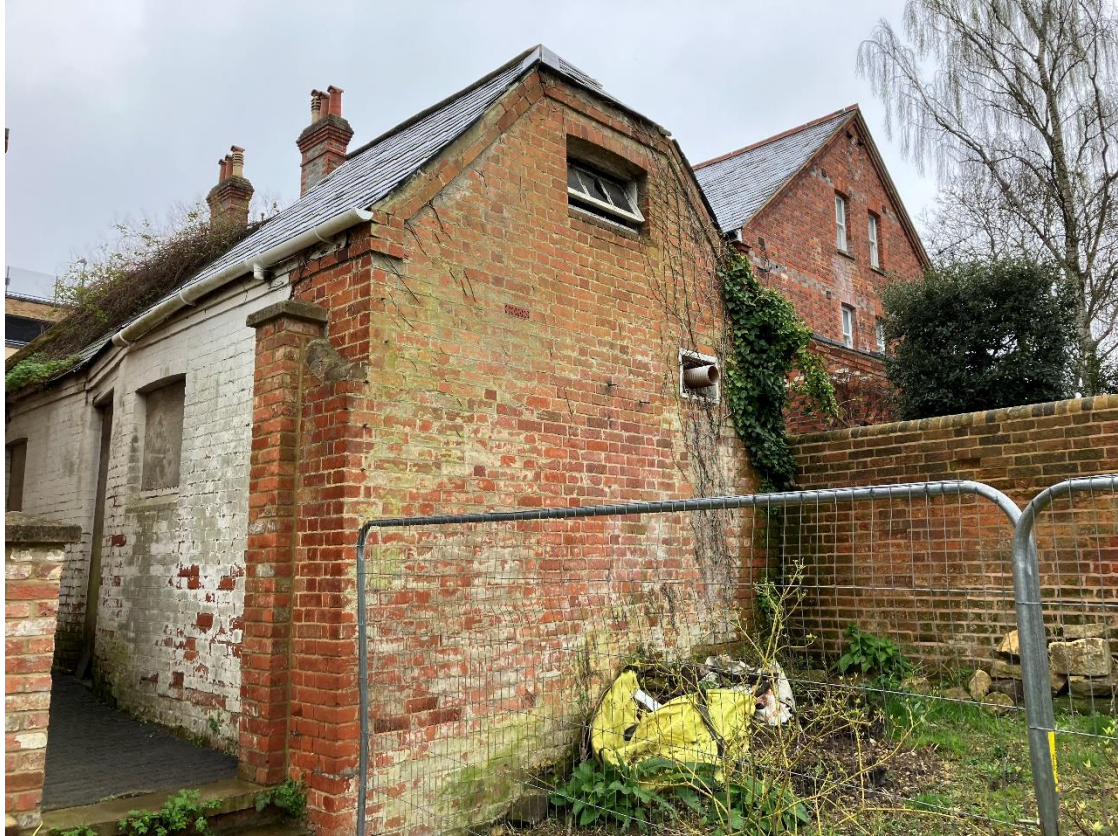
*The rear of the garage*

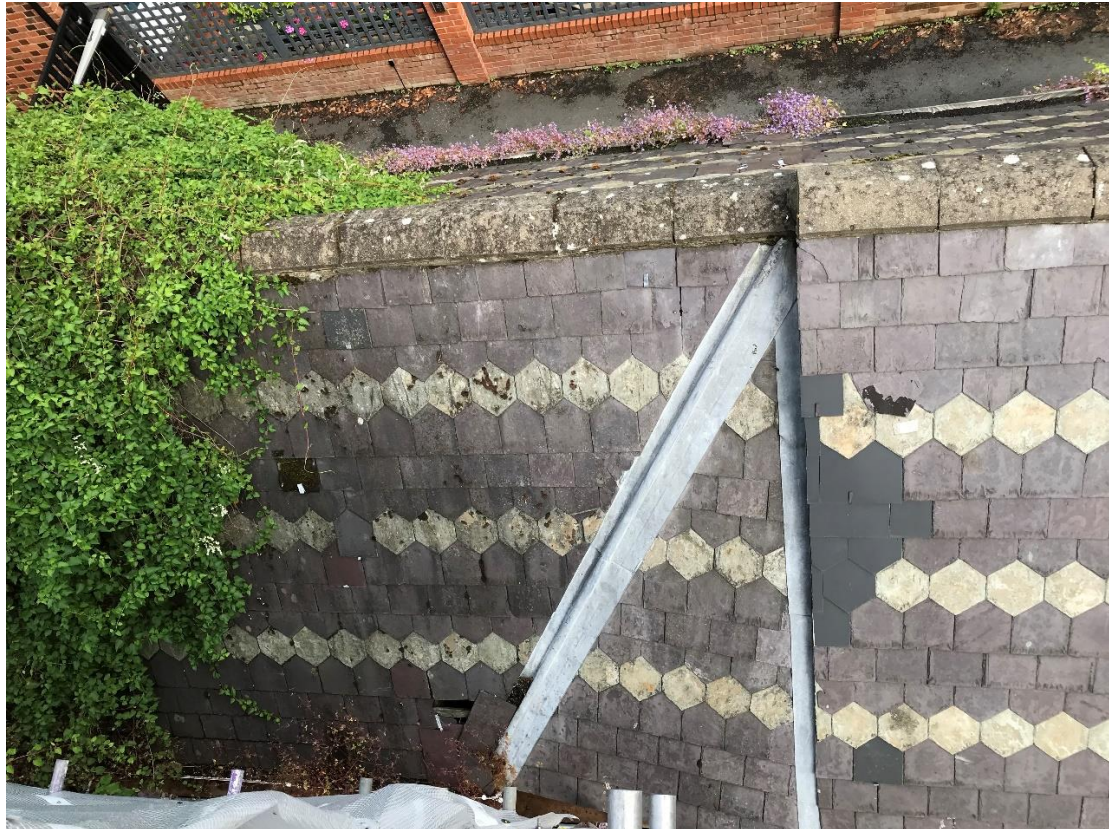
The roof is finished in slate and has the diamond pattern that can be found on the main house. There is much vegetation growing on the roof and from the eaves and guttering and it is clear that this is in part responsible for the structural problems the building has suffered.

*View of the roof*

Roof slates will be carefully removed, cleaned and stored. These will be refixed once the structural repairs have been completed, maintaining the feature banded slates as was done to the main house. Any replacement slates will be sourced to match and will be mixed with the existing to blend.

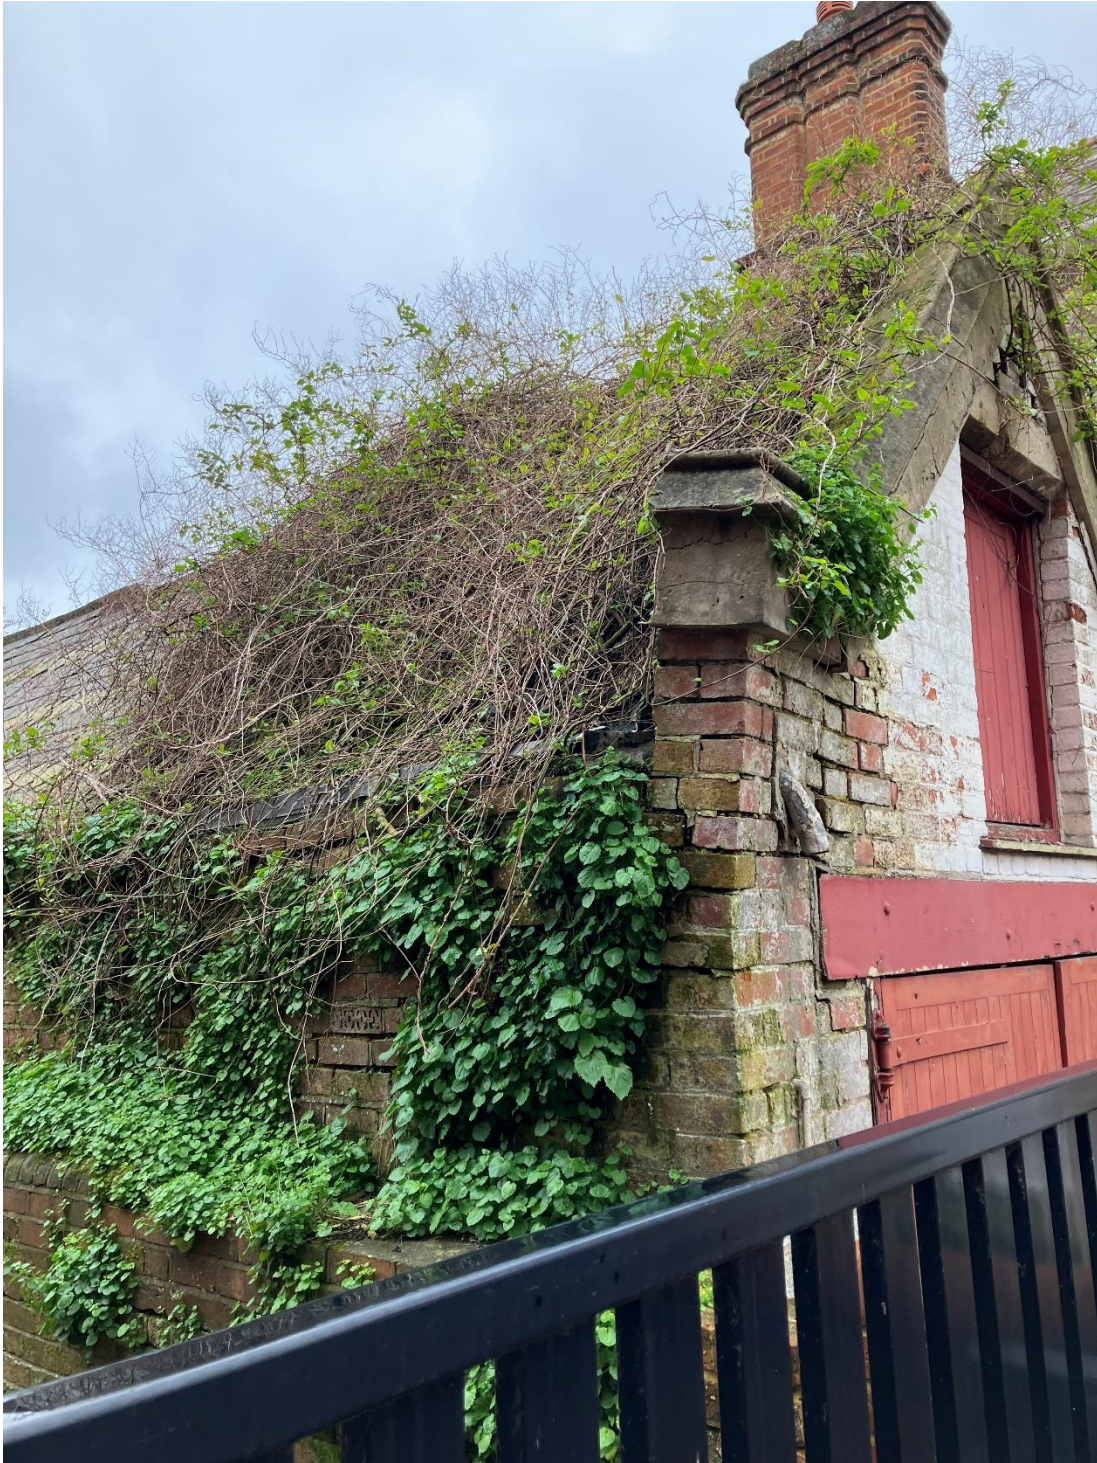
*The damage to the NW corner*
