## BS:5837 ARBORICULTURAL REPORT

ARBORICULTURAL SURVEY, ARBORICULTURAL IMPACT ASSESSMENT &  
METHOD STATEMENT

ZAINABIYA WELFARE FOUNDATION  
4-6 SCHOOL ROAD  
TILEHURST  
BERKSHIRE  
RG31 5AL

**Project:** Proposed construction of a single-story side / rear extension

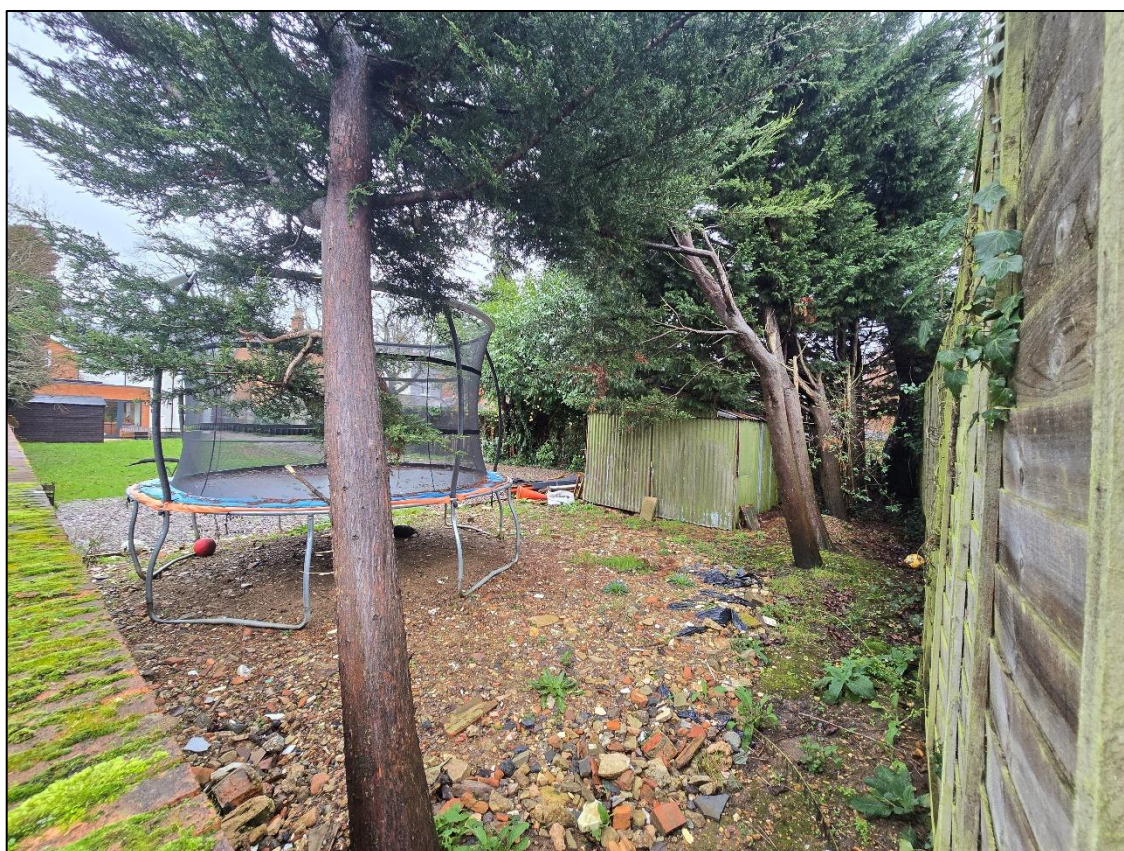
**Photo 1. Offsite topped Leylandii (H001) beyond the northeast boundary.**

| Ref. | Species | Structure | Measurements | Spread | General Observations | Retention Category | RPA | Summary | Photos |
|---|---|---|---|---|---|---|---|---|---|
| H001 | Leyland cypress<br>( <i>X Cuprocyparis leylandii</i> ) | Hedge | Height (m): 9<br>Stem Diam(mm): 200-300<br>Crown Clearance (m): 3<br>Life Stage: Over Mature<br>Rem. Contrib.: 20+ Years | N:2.5<br>E:2.5<br>S:2.5<br>W:2.5 | Unevenly cut lapsed hedging group growing offsite and formed of irregularly spaced individual plants. Poor form. Topping points obscured by fence. | C1,2 | Radius: 4.8m.<br>Area: 162 sq m. | Physiological Condition: Fair<br>Structural Condition: Poor<br>Public Amenity Value: Low<br>Inspection Limitations: Access | |

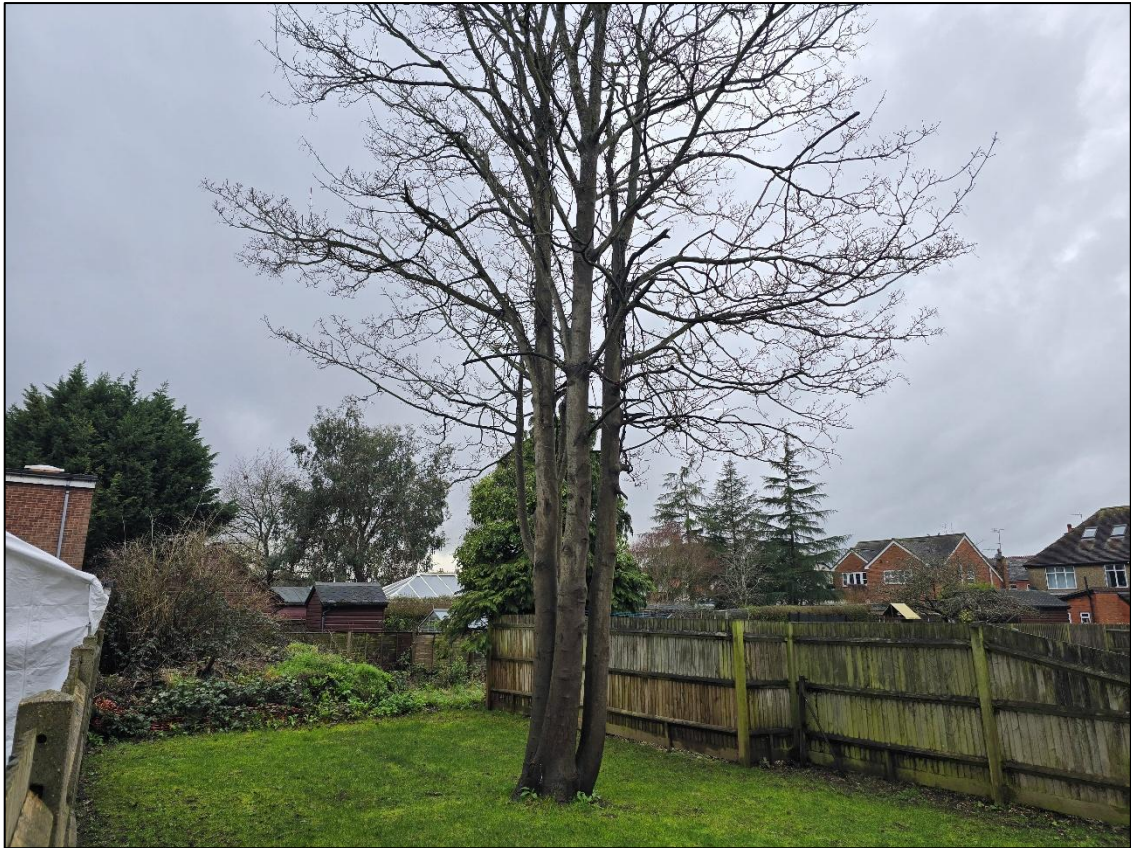
**Photo 2. Offsite multi-stem Sycamore (T002)**

Excavation of foundations within the RPA of T002 (Sycamore) shall be undertaken by hand using sterile hand tools only (e.g. spades, forks, trowels, brushes). Any roots present shall be cleanly pruned back to the edge of the trench using sharp secateurs or a handsaw.

| Ref. | Species | Structure | Measurements | Spread | General Observations | Retention Category | RPA | Summary | Photos |
|---|---|---|---|---|---|---|---|---|---|
| T002 | Sycamore<br>( <i>Acer pseudoplatanus</i> ) | Tree<br>4 stems | Height (m): 13<br>4 stems (mm): 300, 260, 110, 130<br>Crown Clearance (m): 4<br>Life Stage: Mature<br>Rem. Contrib.: 20+ Years | N:3<br>E:3<br>S:4<br>W:3.5 | 4.2m off boundary. Multi-stem from ground level. Compacted bark in fork with associated areas of necrotic bark at base. Dead ivy stems in crown. Multiple dead branch stubs in central crown. Bud density on live growth normal. | C1 | Radius: 5.2m.<br>Area: 85 sq m. | Physiological Condition: Fair<br>Structural Condition: Physical Defect<br>Public Amenity Value: Moderate<br>Inspection Limitations: Access | |

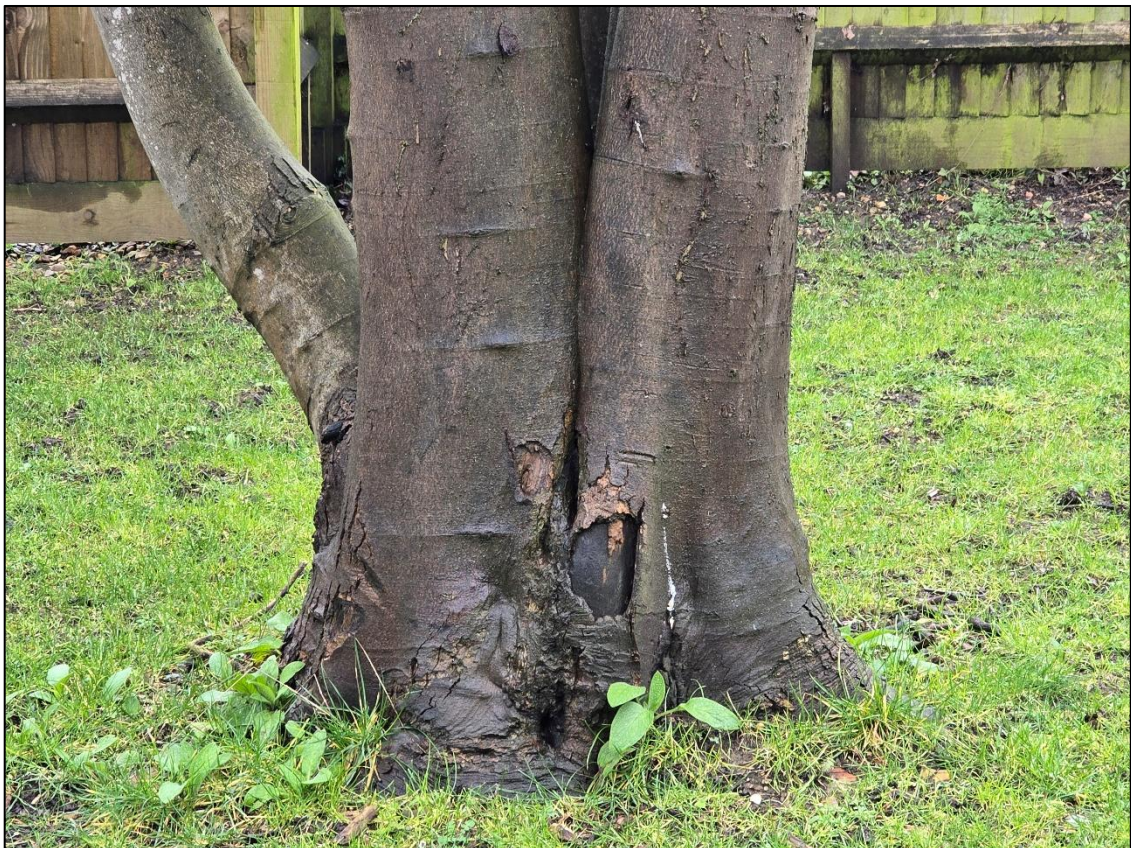
**Photo 3. Base of offsite multi-stem Sycamore (T002)**

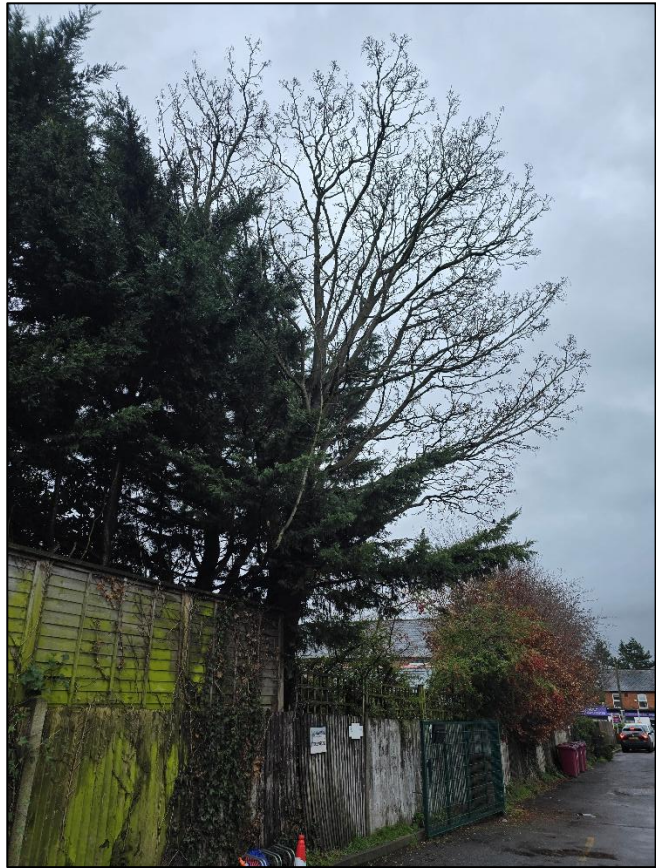
**Photo 4. Offsite Sycamore (T001)**

The proposed new side / rear extension is located outside of the root protection area of T001, a 'B' category Sycamore and provided the soft landscaped bed is protected during the build, the construction will not have any adverse impact on the tree.

| Ref. | Species | Structure | Measurements | Spread | General Observations | Retention Category | RPA | Summary | Photos |
|---|---|---|---|---|---|---|---|---|---|
| T001 | Sycamore<br>( <i>Acer pseudoplatanus</i> ) | Tree | Height (m): 14<br>Stem Diam(mm): 550<br>Crown Clearance (m): 4<br>Life Stage: Mature<br>Rem. Contrib.: 40+ Years | N:4<br>E:3<br>S:4.5<br>W:4.5 | Offsite tree. Swept lower trunk obscured by fence and dense vegetation. Compact oval crown. Bud density normal. | B1 | Radius: 6.6m.<br>Area: 137 sq m. | Physiological Condition: Good<br>Structural Condition: Unknown<br>Public Amenity Value: Moderate<br>Inspection Limitations: | |

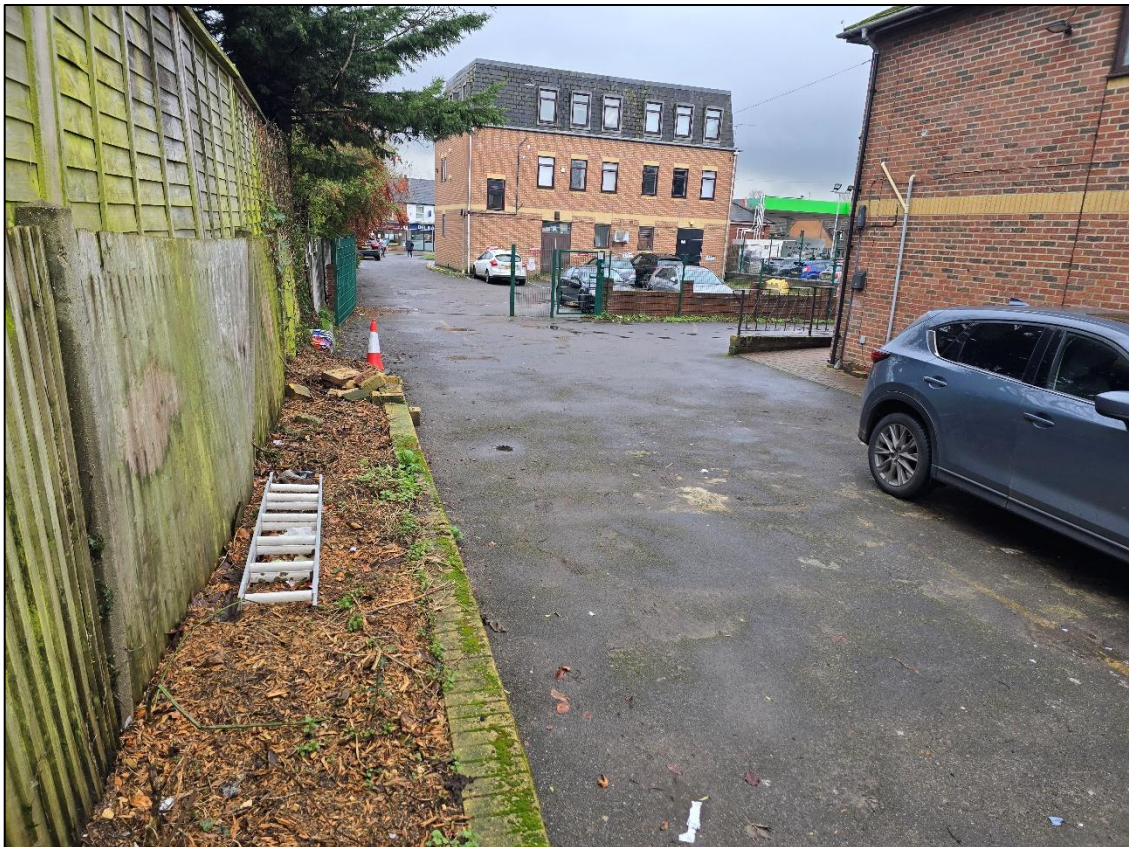
**Photo 5. Low-level soft landscaped bed along northeast boundary to be protected with temporary ground protection**

The narrow strip of soft landscaping along the northeast boundary where 'B' category T001 (Sycamore) is rooting will be protected during the building works with Temporary Ground Protection in accordance with BS:5837 (2012).

No works will commence, including construction or excavation, prior to the temporary ground protection being installed on the raised soft landscaped bed along the northeast boundary as indicated in the magenta hatch on the Tree Protection Plan.

The temporary ground protection will be constructed from rigid load bearing temporary roadway sheets such as 'euroboards' or similar or ply sheets a minimum of 15mm thick placed onto a bed of chipped bark a minimum of 60mm thick over a non-porous geo-textile membrane.
