A2 Site Investigation

# Scours Lane

Geotechnical and Geo-environmental Interpretative Report

53924-A2SI-XX-XX-RP-Y-0001-00

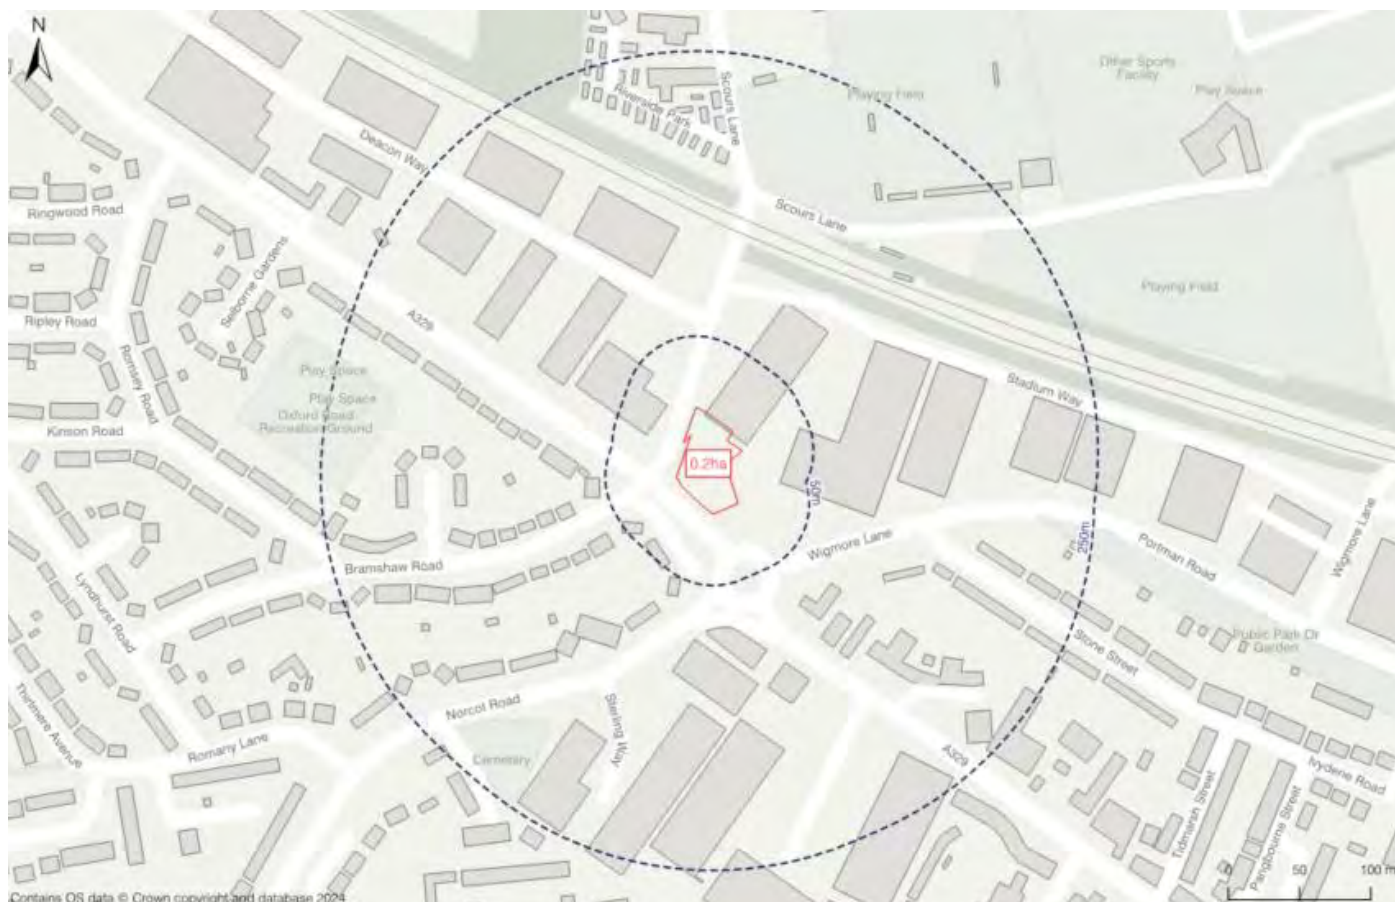
**Figure 2.1** Location of the site, red line reflects the site boundary used for this assessment. (Ashfield Ltd, 2024 Report No:205024-S01)

The development site is located on a plot of land adjacent to Scours Lane, Tilehurst, Reading, RG30 6AX as shown in Figure 2.1. The site is located at the approximate British National Grid coordinates of 468546E, 174544 and has an area of approximately 0.23 ha. The site is parcel of undeveloped land located within the southwestern corner of Stadium Way Industrial Estate and to the northeast of the junction between Scours Lane and Oxford Road. Vehicular access to the site is possible from the car park to the northeast side of the site. The remainder of the site is bound by low-rise wooden fencing. At the time of the investigation, there were nine deciduous trees located on the site.

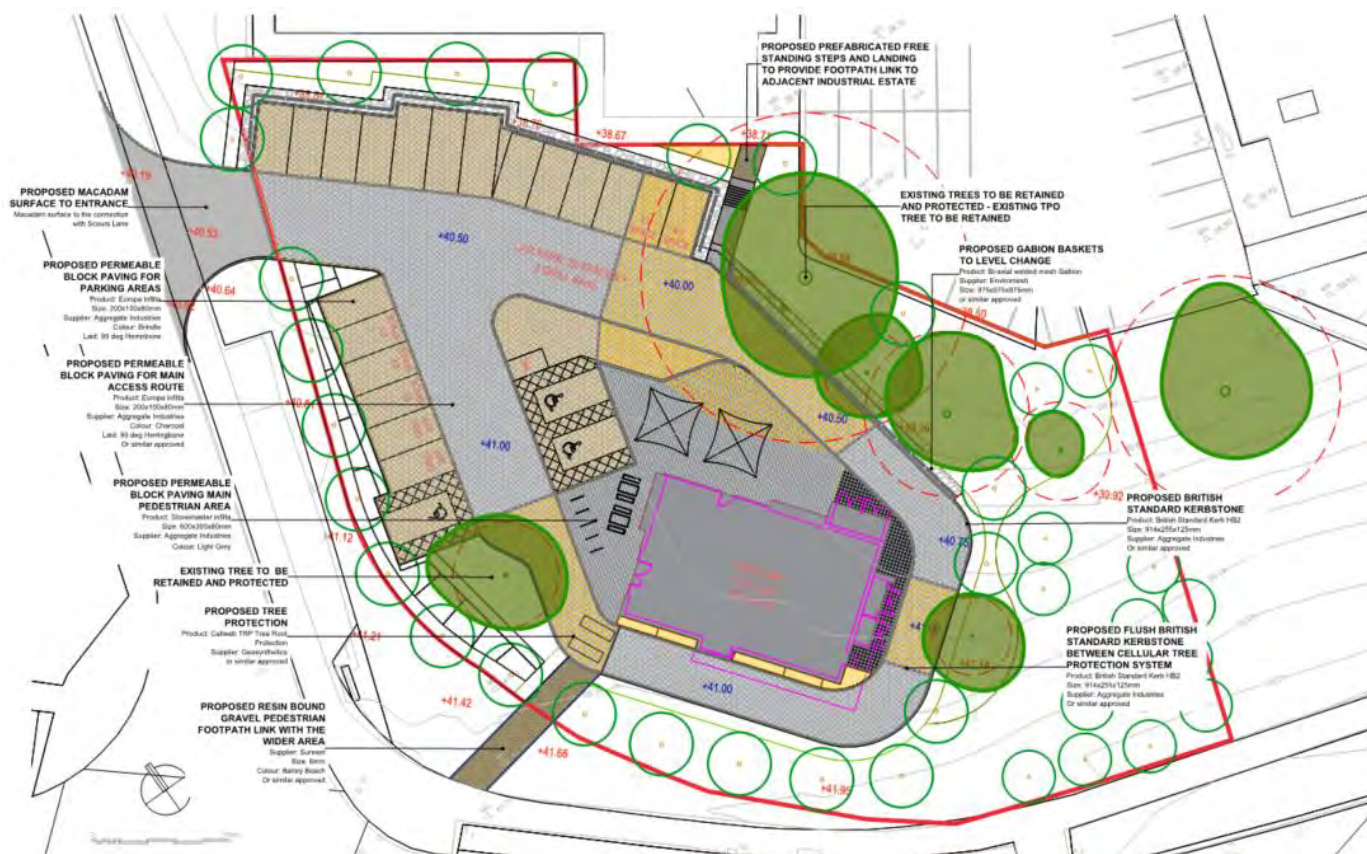
Figure 2.2 Location of the proposed development (Drawing ref: QD784.401; Quartet Design Landscape Architects, July 24)

The proposed development of the site comprises of the construction of a single-story drive through restaurant in the centre of the site with areas of hard standing surrounding the building to be used as a car park and an access road for the drive through service. Additionally, soft landscaped areas are proposed around the boundaries of the site, comprising of new and all existing trees. Figure 2.2 shows the proposed development of the site. It is understood that basement space is not proposed.

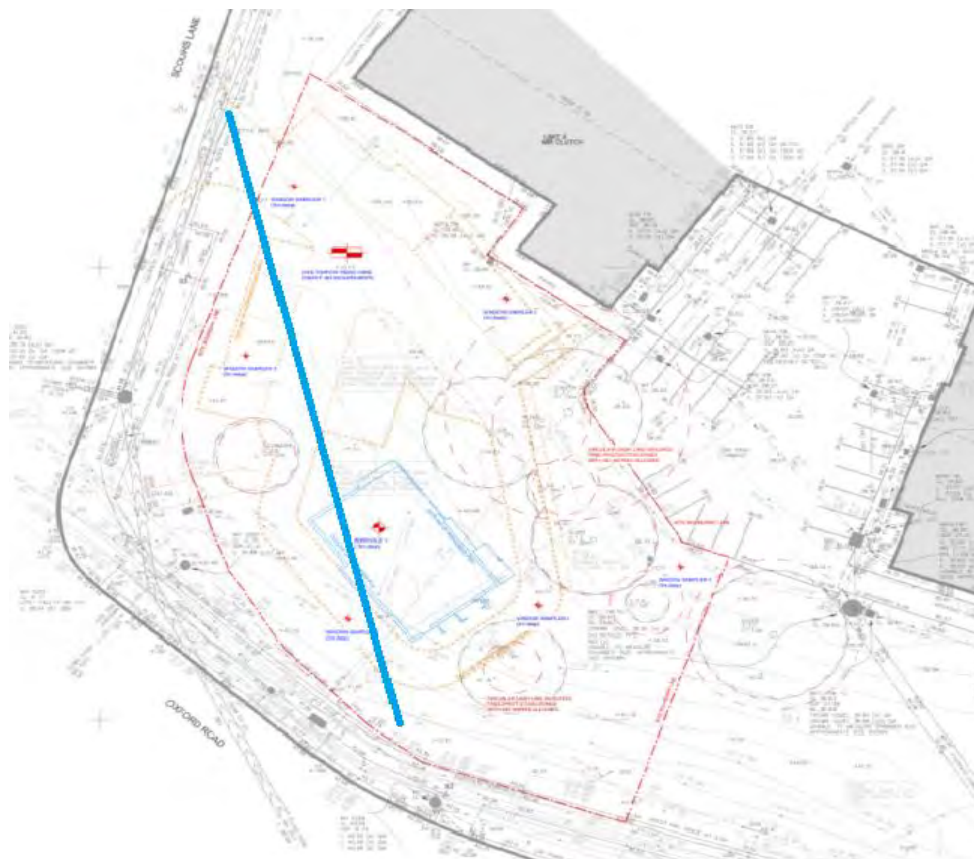
Figure 5.1 Geological cross-section (blue line represents the section presented in Figure 4.2)

Figure 5.1 and Figure 5.2 presents the geological section across the site.

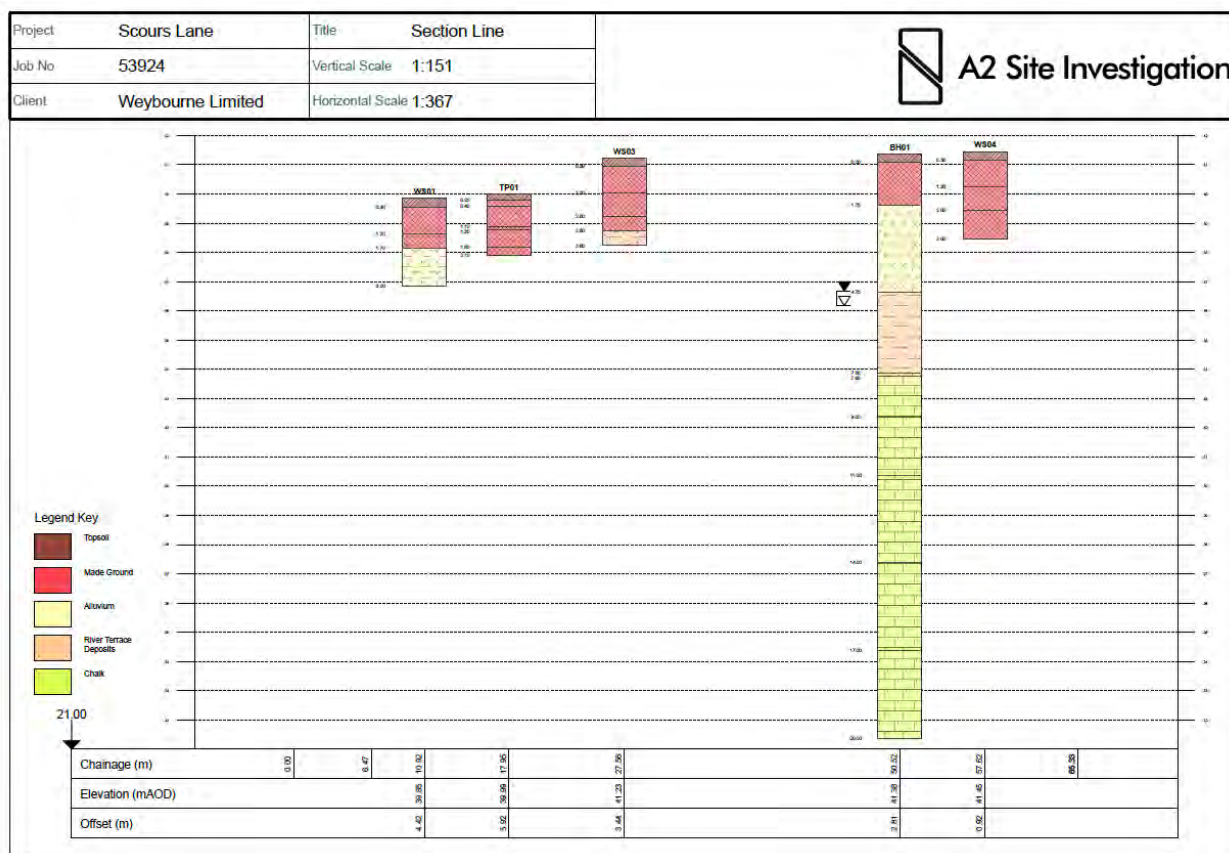
Figure 5.2 Geological cross-section

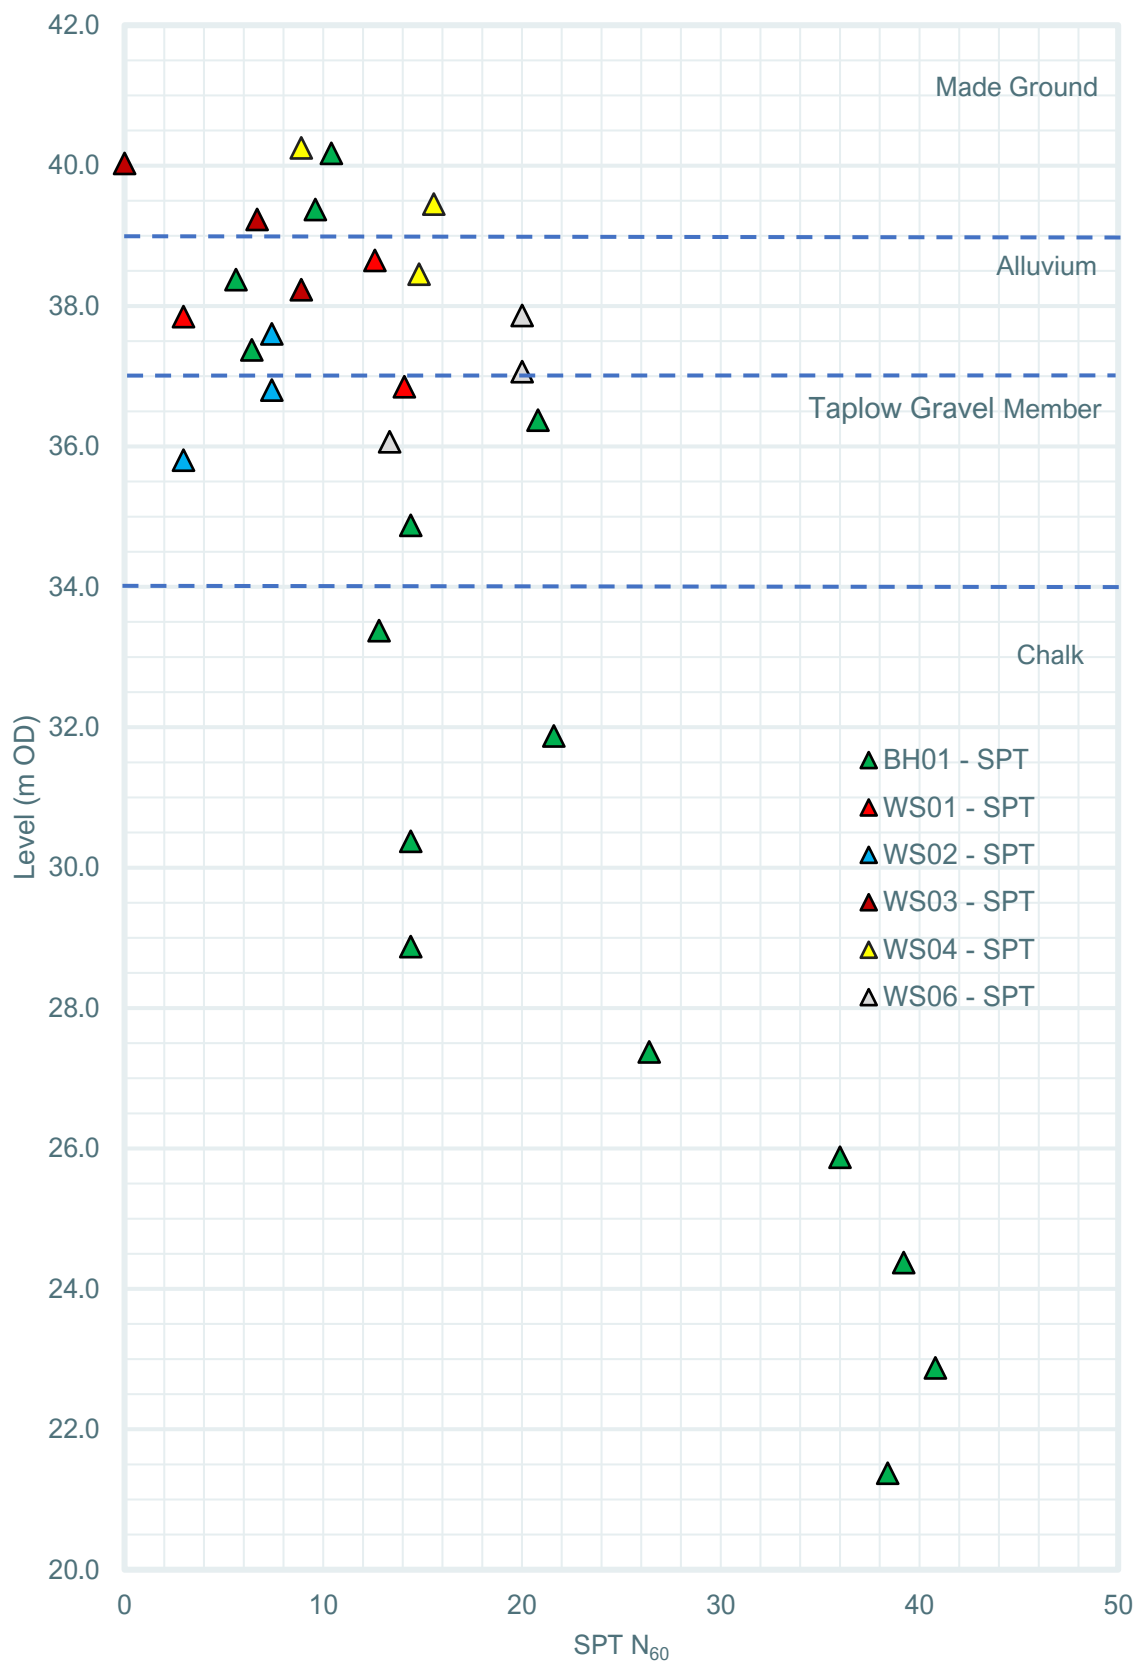
The SPT  $N_{60}$  results are plotted in Figure 5.3. Approximate interpreted strata boundaries marked by dashed lines – these are indicative only as the stratum boundaries are variable.

Figure 5.3 SPT  $N_{60}$  results
