**David Randall Tree Consultancy**

| Site: 63A Hamilton Road | 1:200 @ A3 |
| Drawing Title: Tree Protection Plan | August 2026 |

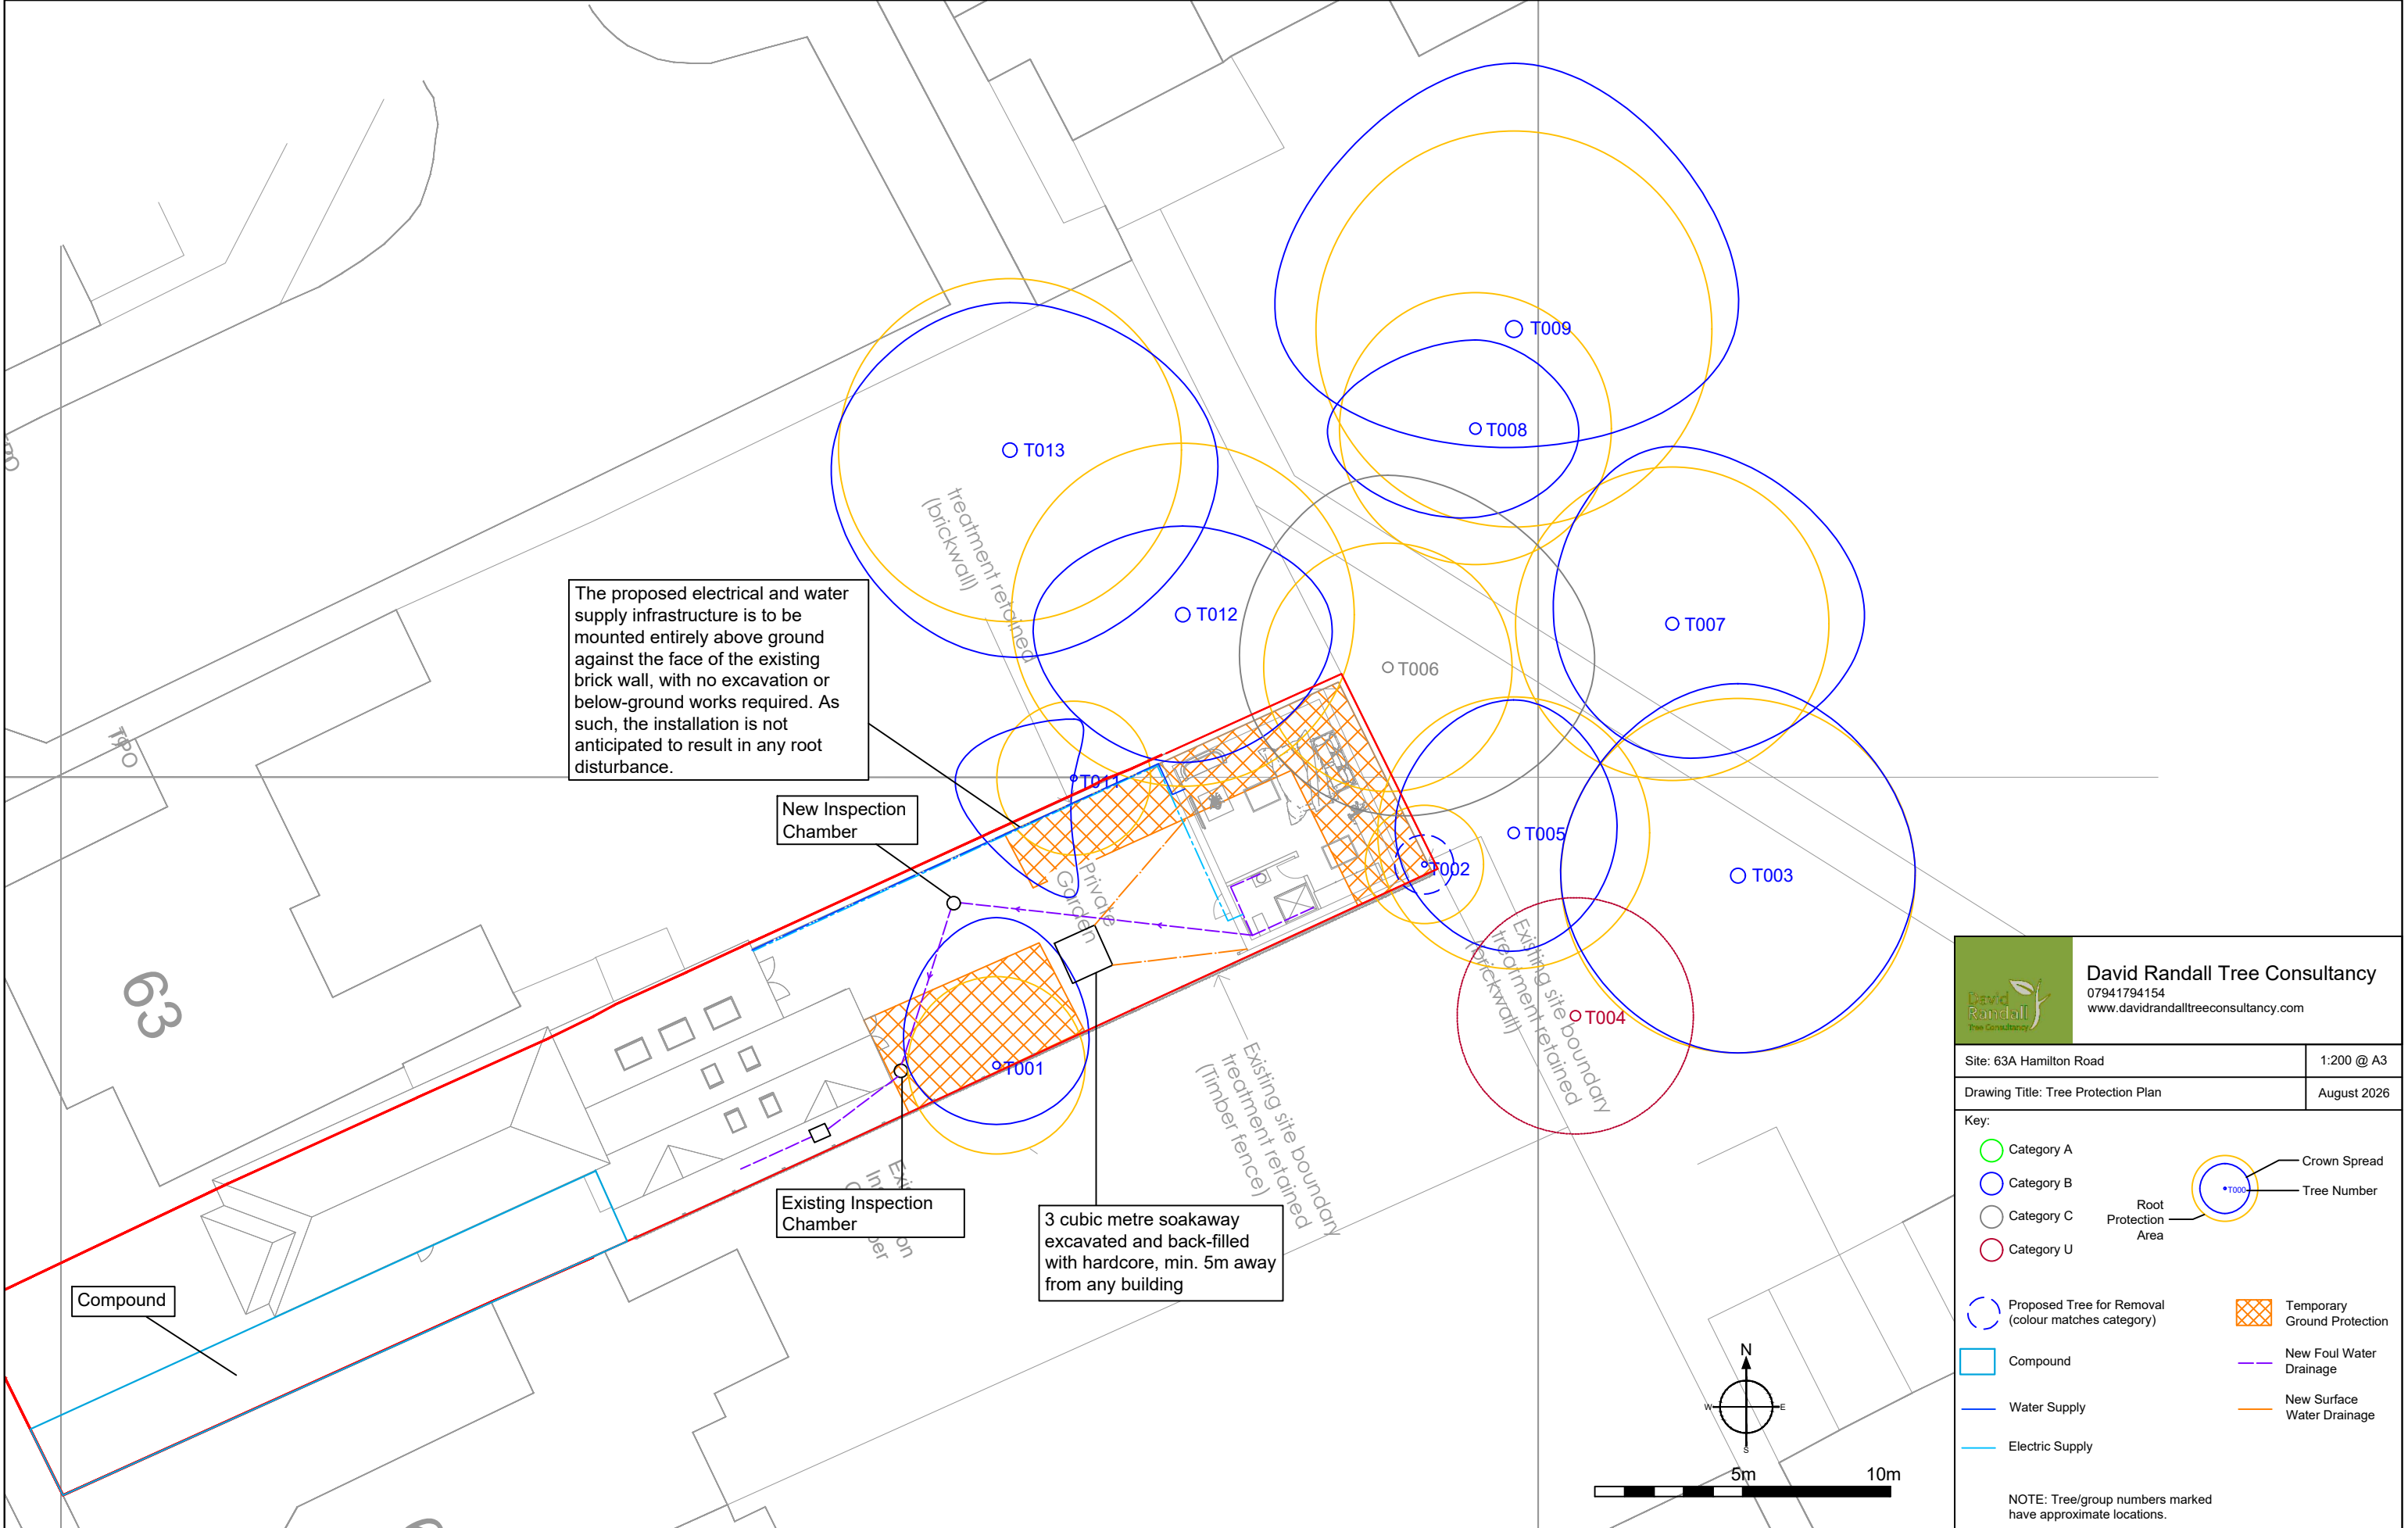
The proposed electrical and water supply infrastructure is to be mounted entirely above ground against the face of the existing brick wall, with no excavation or below-ground works required. As such, the installation is not anticipated to result in any root disturbance.

3 cubic metre soakaway excavated and back-filled with hardcore, min. 5m away from any building
