# Ground Investigation Report

Brunel Retail Park, Kiln Lane, Reading, RG2 0HS

Issue Date: 27 February 2020

REFERENCE: 19.1247/CB/LC

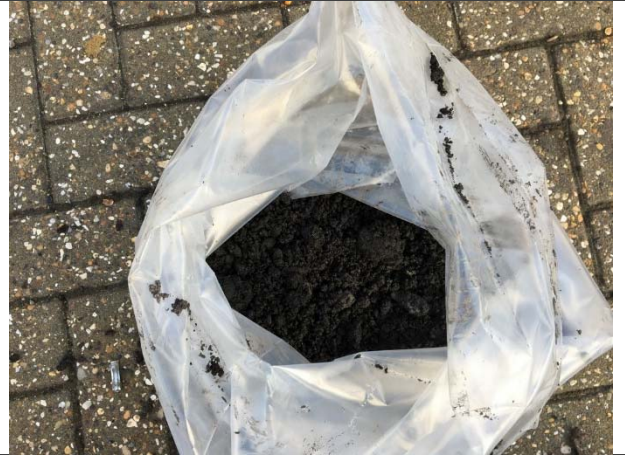
18: Sampled infilled material

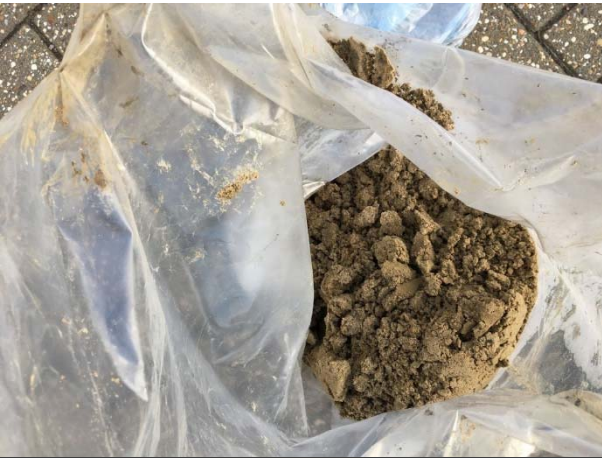
19: Sampled natural ground

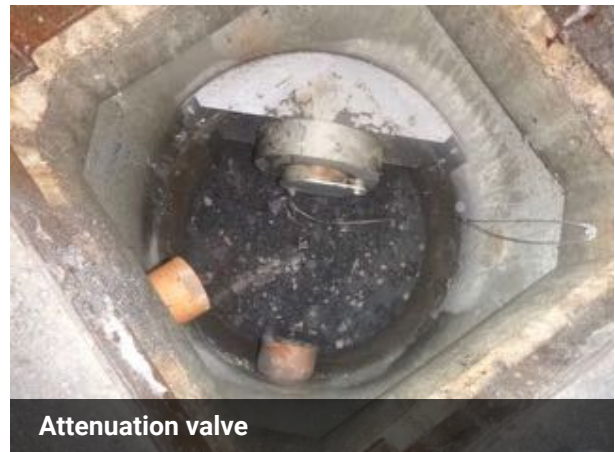
Below-ground drains run according to the plan at the end of this report. There is what appears to be a flow attenuation valve at MH16. This is designed to limit the flow of surface water, however, we can see no clear need for one at this location. It is not on a main part of the drainage system.

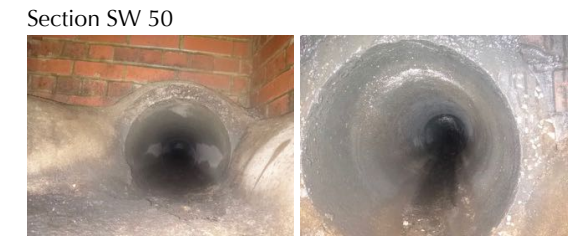
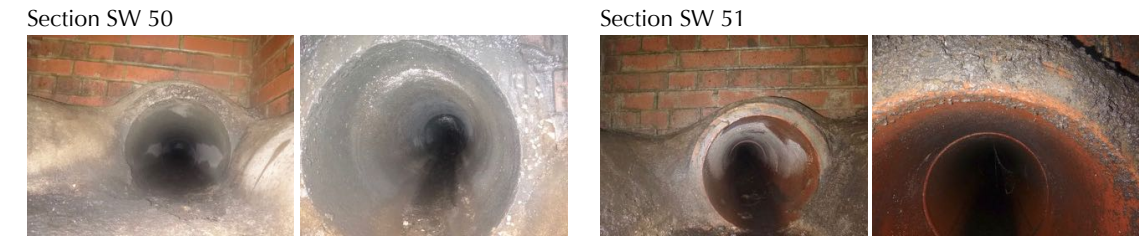
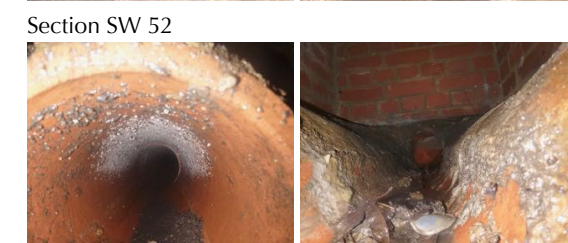
| Asset | Defect | Recommendation | Urgency | Cost |
|---|---|---|---|---|
| MH 10 | Silt | Clear with high pressure water jetting | Moderate | £0 |

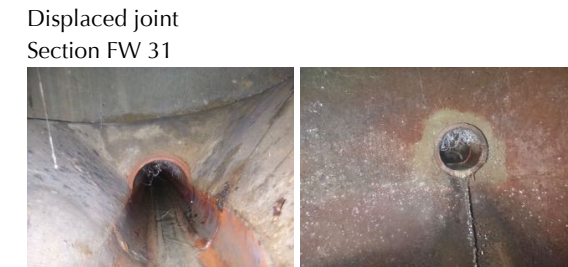
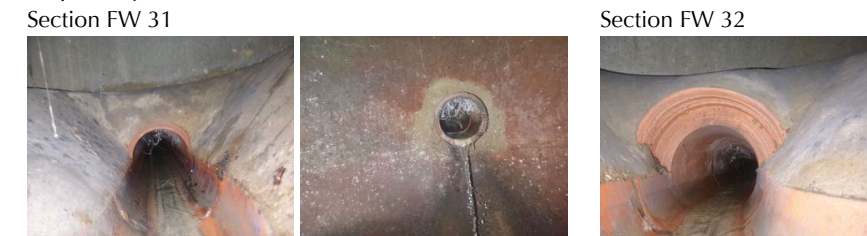
| MH 52 | Displaced joint | Repair by patch lining | Moderate | £600 |

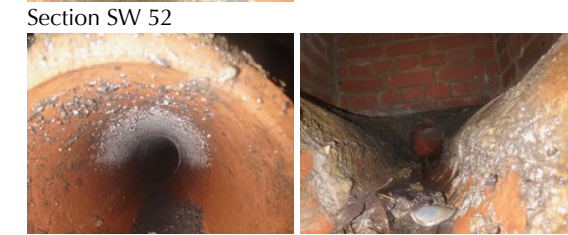
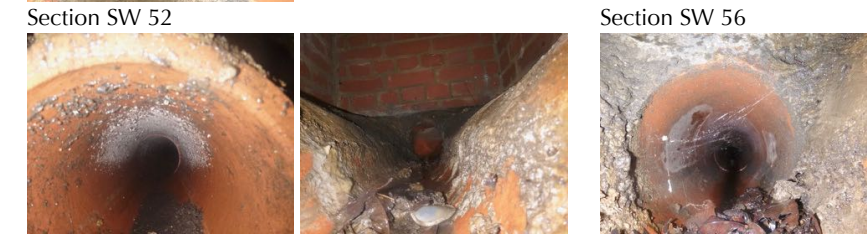
| MH 56 | Surface-water inspection chamber | No Budget Costs |

DEFECTS & RECOMMENDATIONS

No defects
