**68 Shinfield Road  
Reading  
Berkshire  
RG2 7DA**

# **Preliminary Bat Roost Assessment**

**Ref: R2508/a**

**May 2020**

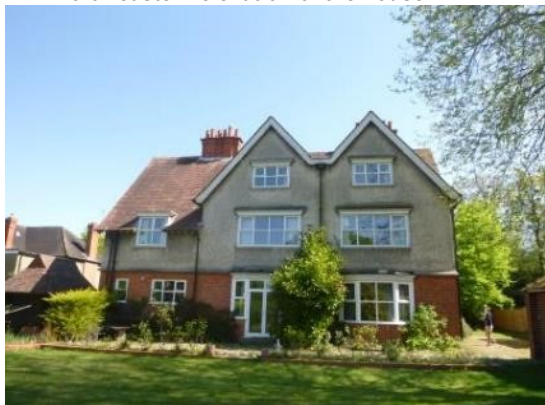
3. Western elevation of the house.

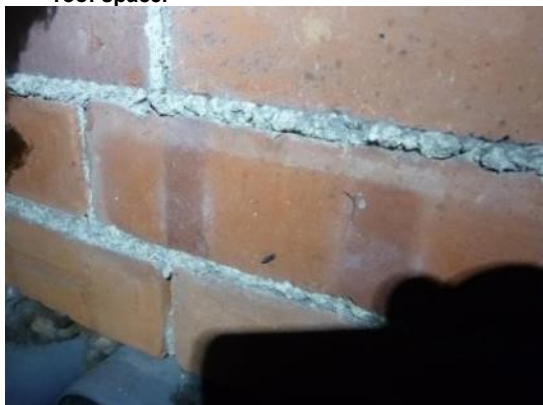
- 3.5.2** There were approximately 100 scattered medium bat droppings throughout the void, which were of a size and shape typical of long-eared bat species (*Plecotus* spp.). These droppings were found on fibreglass, floor boards and hanging from cobwebs on walls - four further medium-sized bat droppings were found toward the northern gable end: two on the loft hatch, one on the gable wall and one on floor boarding (**Photographs 62-68**). A concentration of 50-100 large bat droppings – of a size and shape most typical of serotine (*Eptesicus serotinus*) bats - were found on fibreglass at the south-eastern gable end (**Photograph 69**). No bats were visible in the void at the time of the survey.

**67. Medium-sized bat dropping hanging from wall of roof space.**
