# GEOSHIELD Verification Report

PROJECT REFERENCE:

GEO103260

Riverside Academy

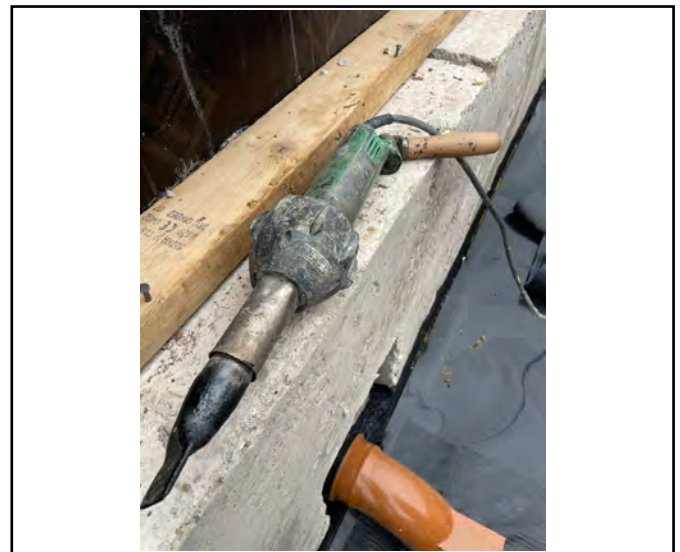
Photograph above shows  
a hot air leister used onsite.

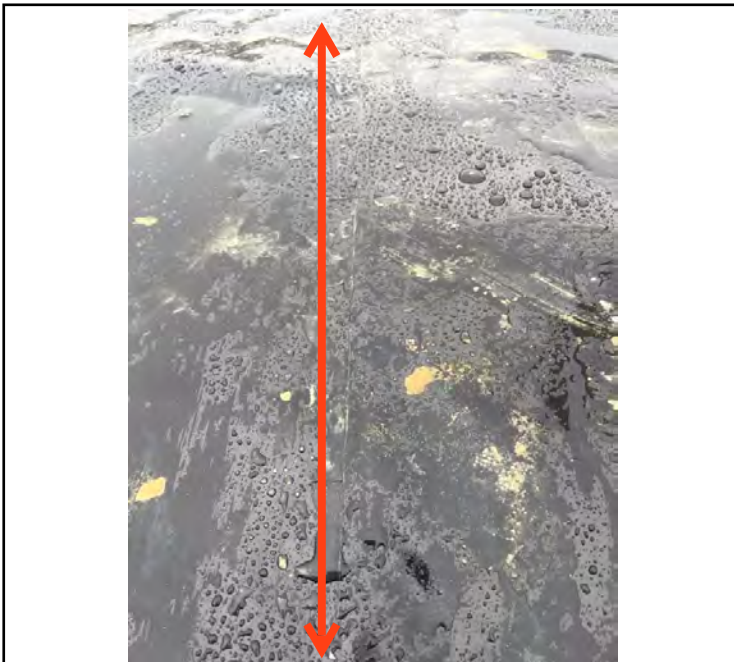
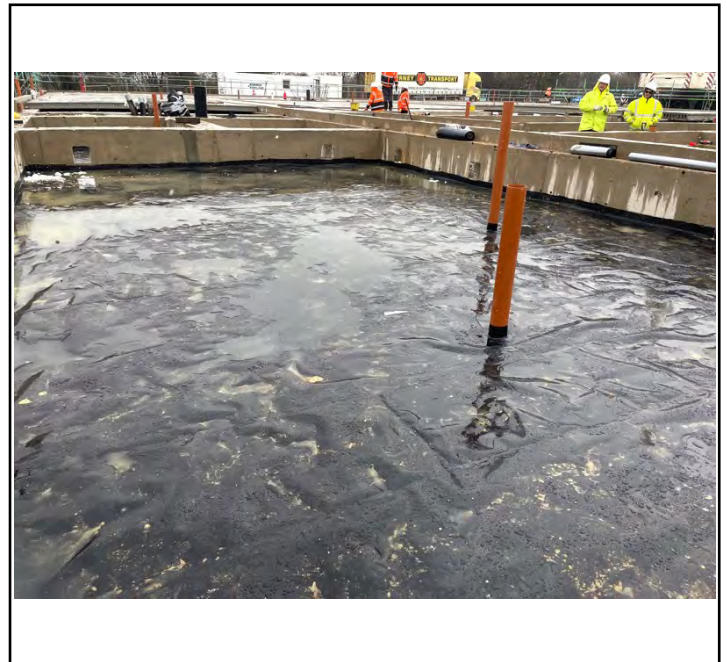
Juta Titan Flex gas resistant membrane, all lap joints have been successfully welded using

a hot air leister and silicone roller, ensuring a minimum 100mm overlap between the two

adjacent sheets of membrane as shown in the above photograph on the left. The photo

above on the right displays an overview photo of where today's installation took place.

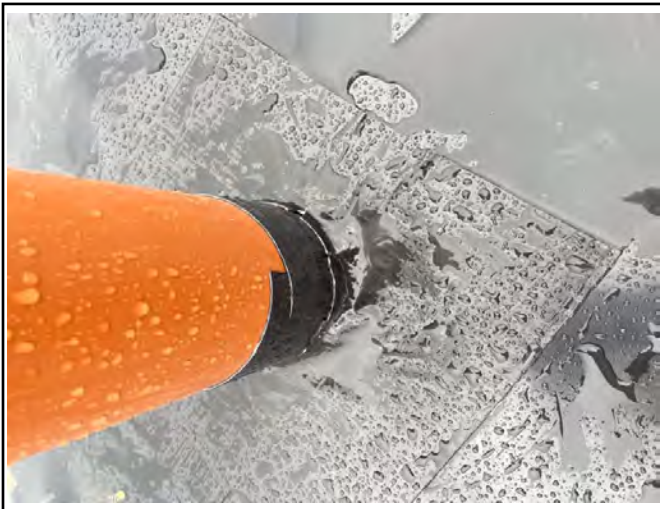
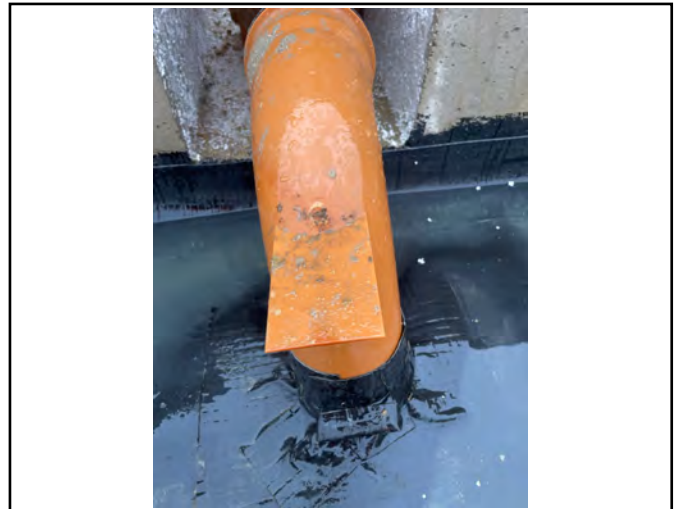
During today's verification visit to the above referenced areas several pipe penetrations and below basal layer probes required sealing and verification. Juta Titan Tank has been installed tightly around the neck of the pipes and probes lapping onto the Juta Titan Flex

gas resistant membrane. The photograph on the left above displays a successfully sealed pipe penetration that has been sealed in accordance with manufacturers specification and design detail. The photograph above on the right shows a below basal layer probe that has been installed by Prestige Air beneath a sub blinded sand floor and sealed in the same way as all the pipe penetrations.

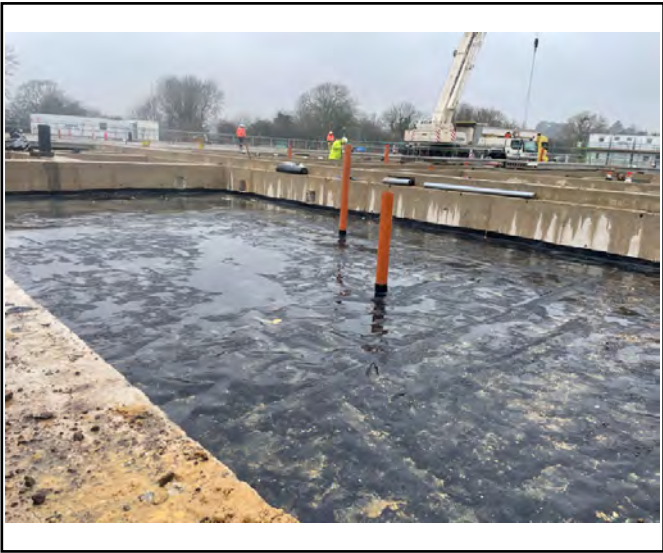
Alternate overview photograph  
of an area requiring verification.

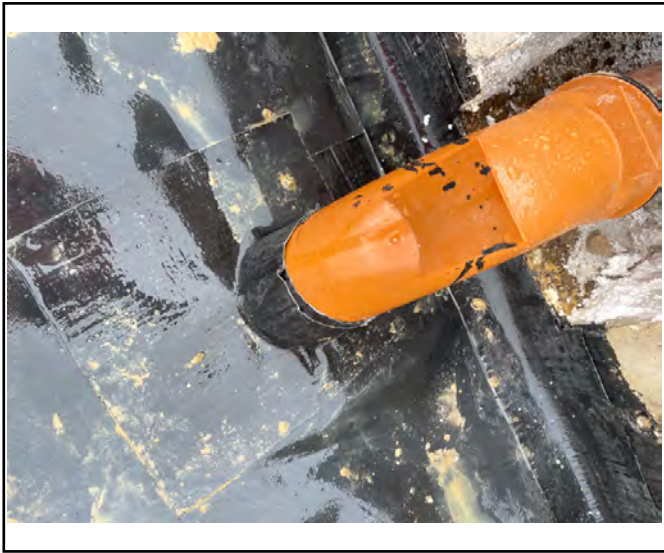
Below Basal Layer Probe  
installation.

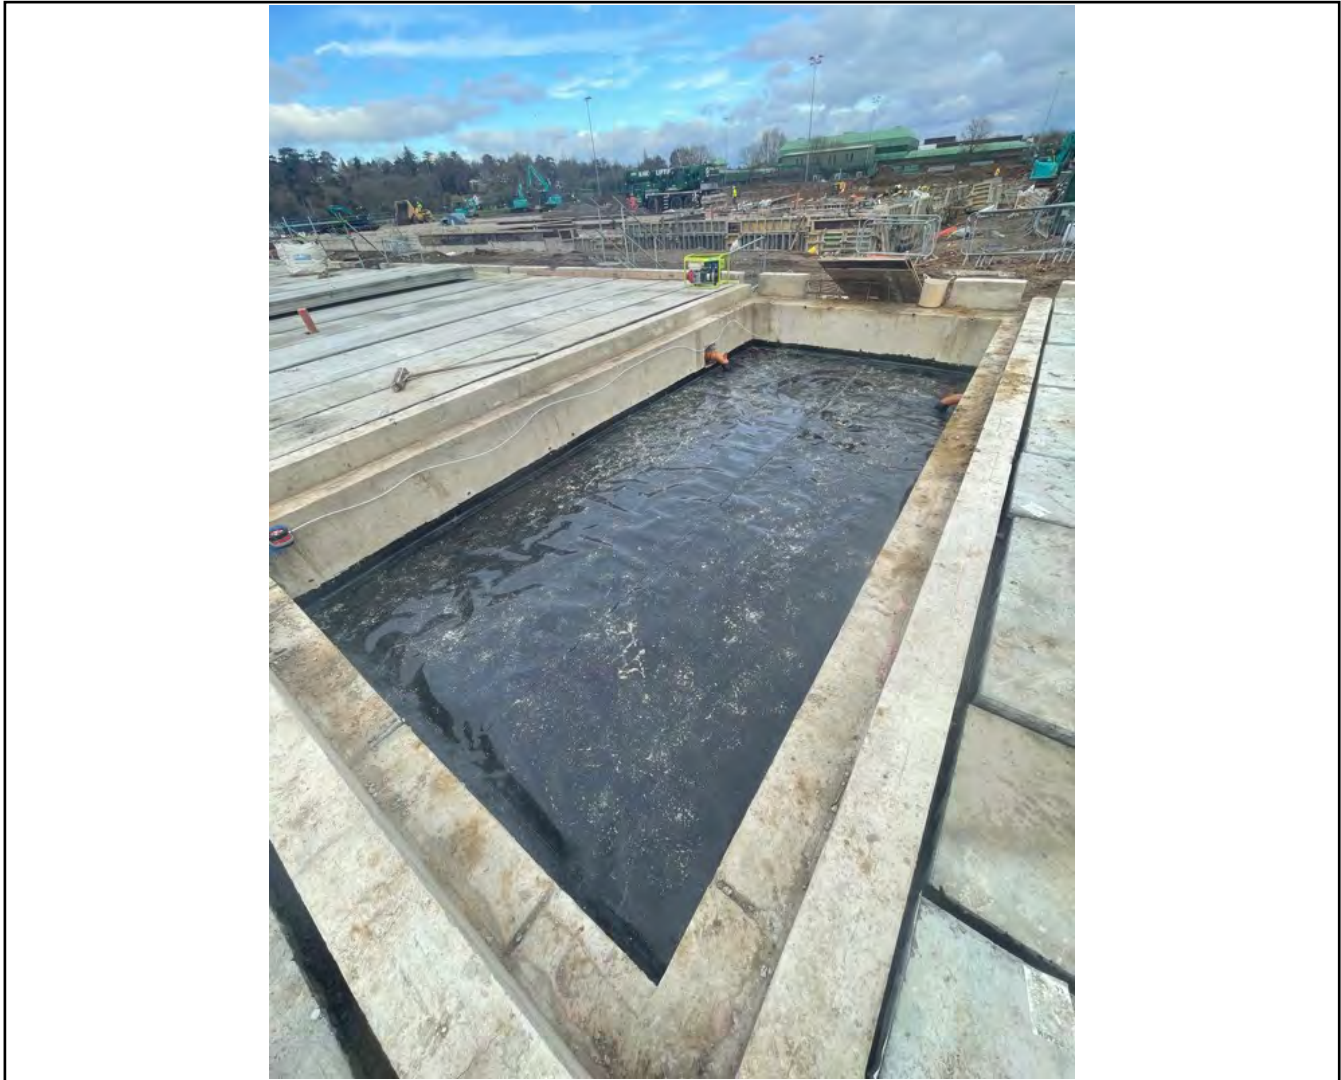
Basal Layer membrane - Gridlines; L-N/13-14

Overview photograph of the area verified during this visit.

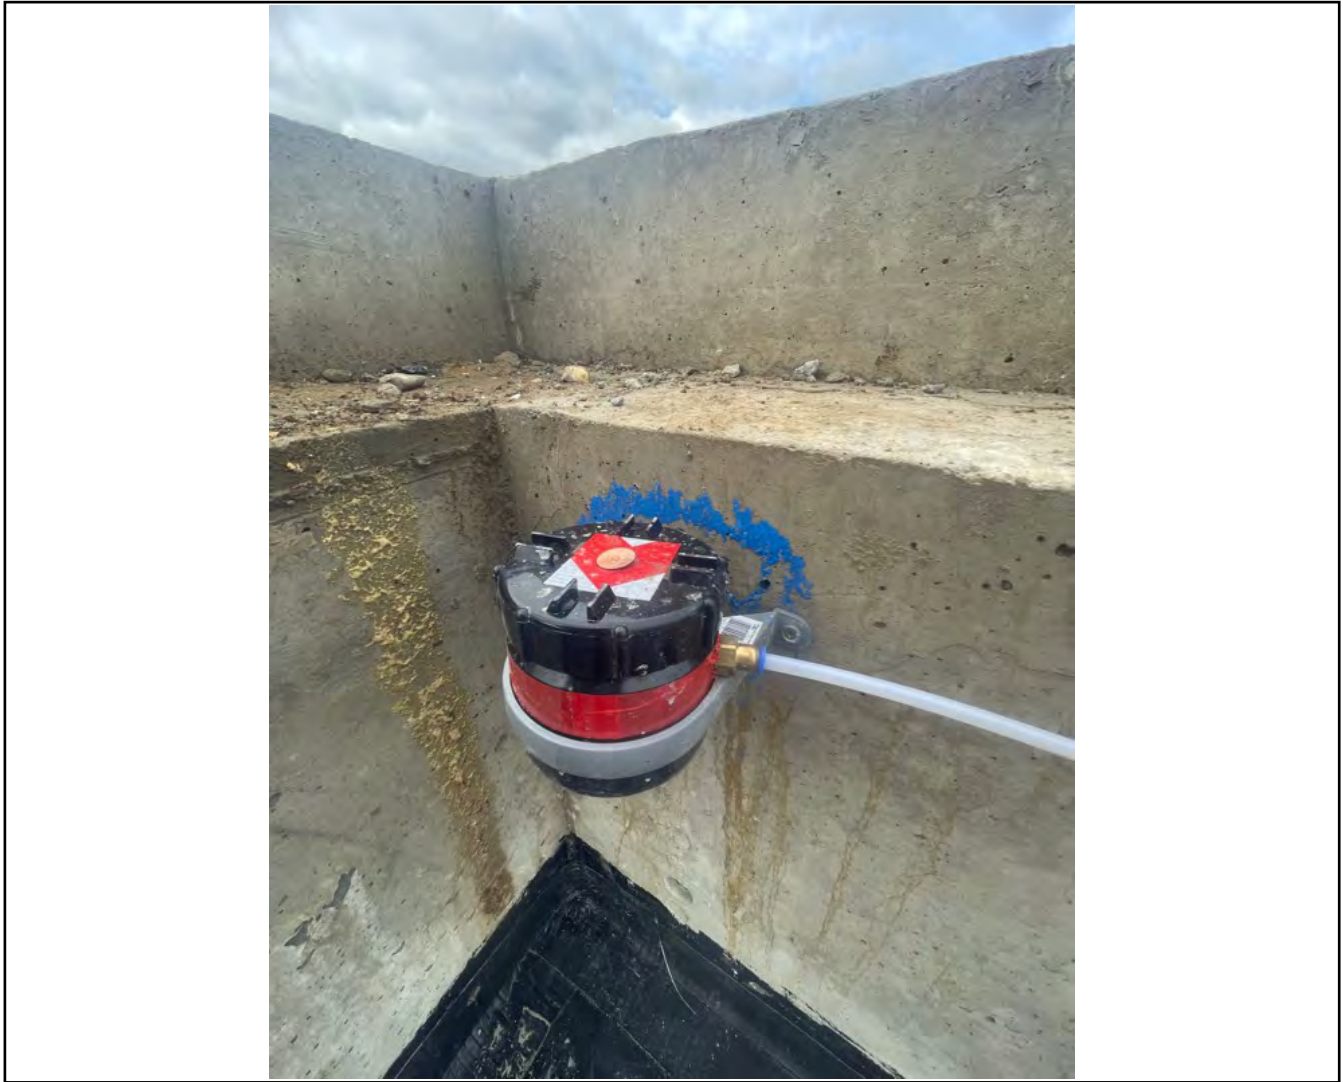
Above Basal Layer - Probe 7.

Overview photograph of the area verified during this visit.

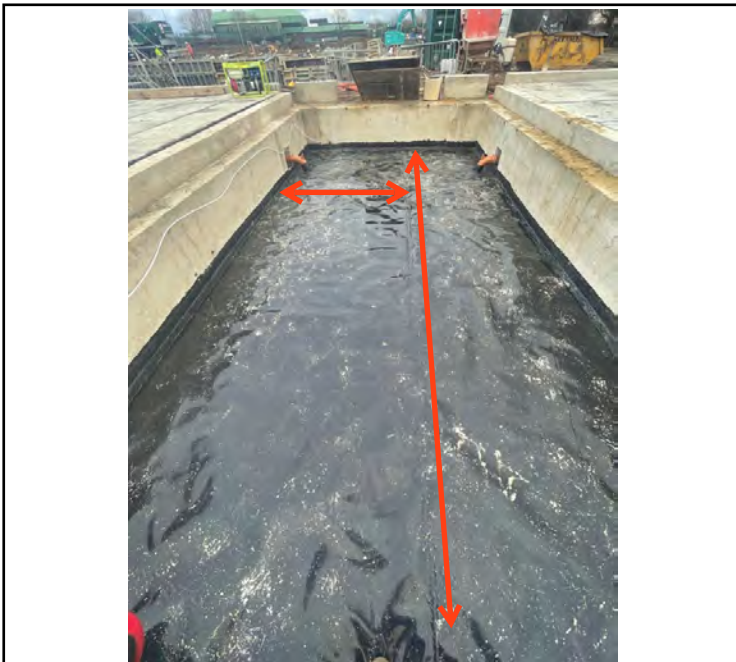
Juta Titan Flex has been installed across the sand blinded substrate. All overlaps between the sheets of membrane have been successfully welded using a hot air tool and silicone roller as highlighted in the photograph below on the left.

The Juta Titan Flex membrane has been lined tightly too the concrete perimeter walls.

Alternate overview photos displayed above, installed in accordance with BS8485:2019.

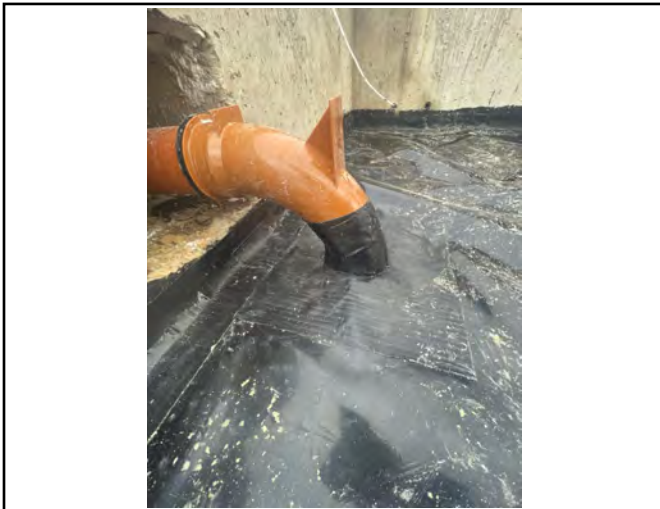
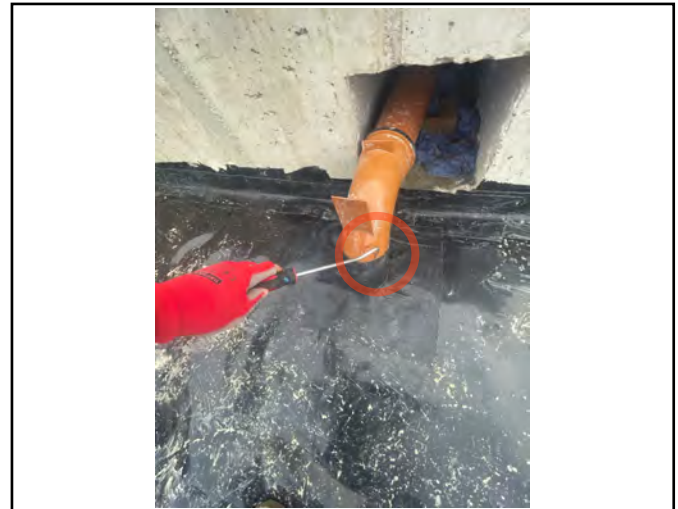
Within the area a couple of pipe penetrations required sealing to create a continuous seal across the area. The Juta Titan Flex has been cut tightly around each pipe penetration and sealed accordingly.

The pipe penetrations have been successfully sealed in accordance to manufactures specification using Juta Titan Tank - gas resistant self adhesive membrane to a good NVQ standard. These were also subjected to thorough pick&probe testing as shown in the photo above on the right. Complete adherence has been achieved throughout.

No faults identified. Tested and verified in accordance with CIRIA 735.

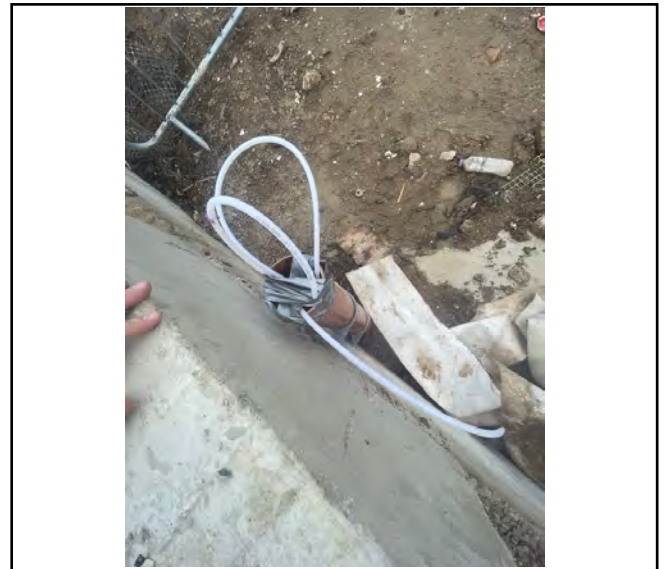
The final above basal layer probe (7) has been installed within the area. The probe pipe has been mechanically fixed upon the concrete perimeter at a horizontal angle.

This eliminates any sharp angles within the probe pipe which could possibly affect...

...the ground gas monitoring in the future. The probe has been installed to the

markup set out by the Fenton engineer to Geoshields design drawing.

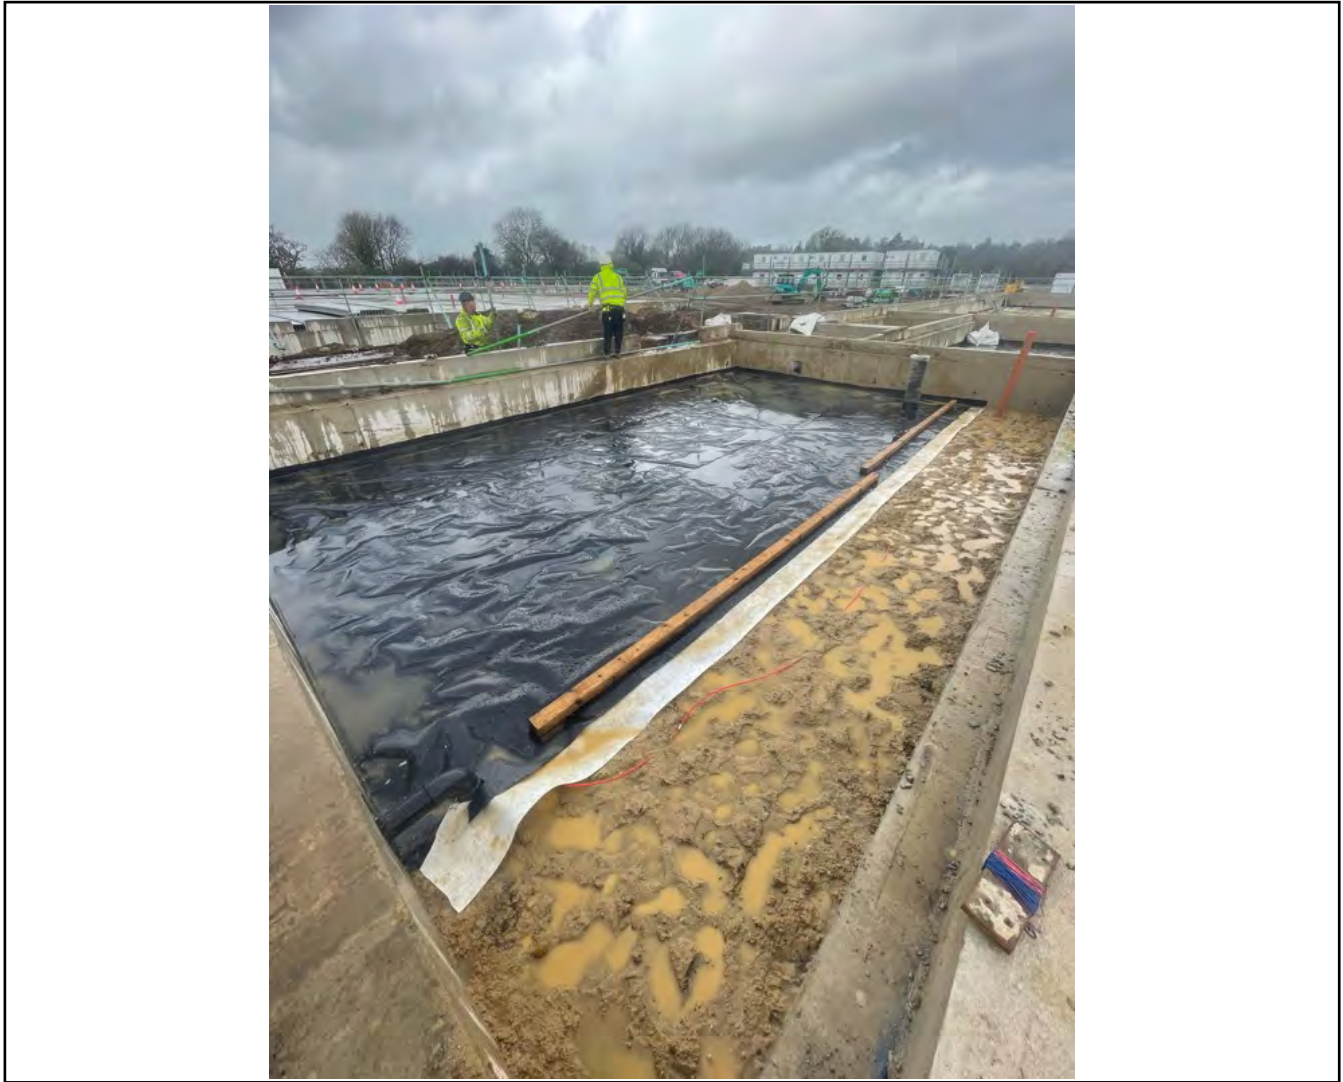
East Block Basal Layer- Q-R/12-13 (incomplete).

Overview photograph of the area verified during this visit.

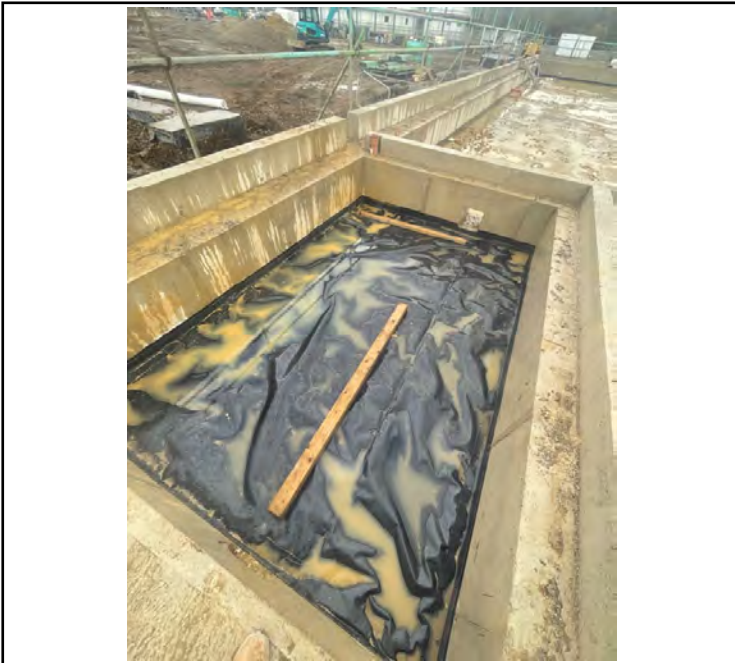
Juta Titan Flex has been installed across the sand blinded substrate. Overlaps between the sheets of Titan Flex have been successfully welded using a hot air tool and silicone roller in accordance to BS8485:2019 guidance.

The Juta Titan Flex membrane has been lined tightly too the concrete perimeter walls as shown in the alternate overview photographs shown above.

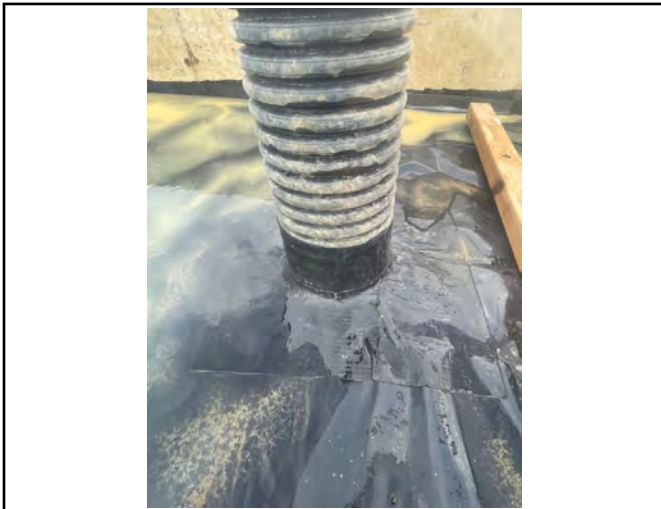
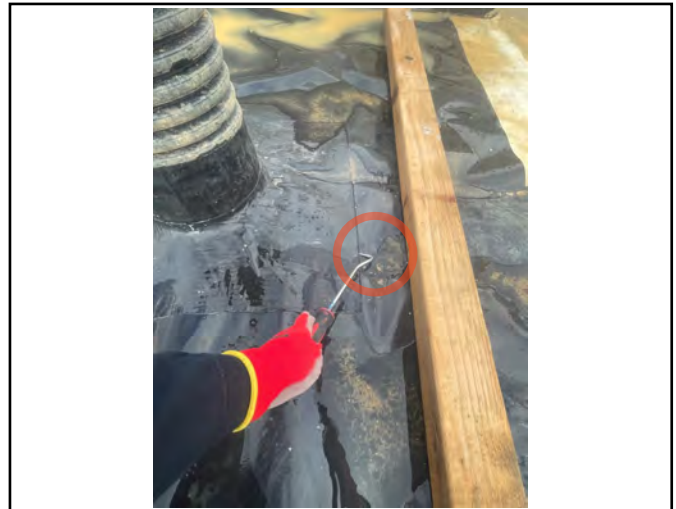
Within the area referenced a single pipe penetration required sealing to create a continuous seal across the area. The Juta Titan Flex has been cut tightly around each pipe penetration eliminating voided spaces and sealed accordingly.

The pipe penetration has been successfully sealed in accordance to manufacturers specification using Juta Titan Tank - gas resistant self adhesive membrane to a good NVQ standard. The pipe was also subjected to thorough pick&probe testing as shown in the photo above on the right. Complete adherence has been achieved throughout.

No faults identified. Tested and verified in accordance with CIRIA 735.

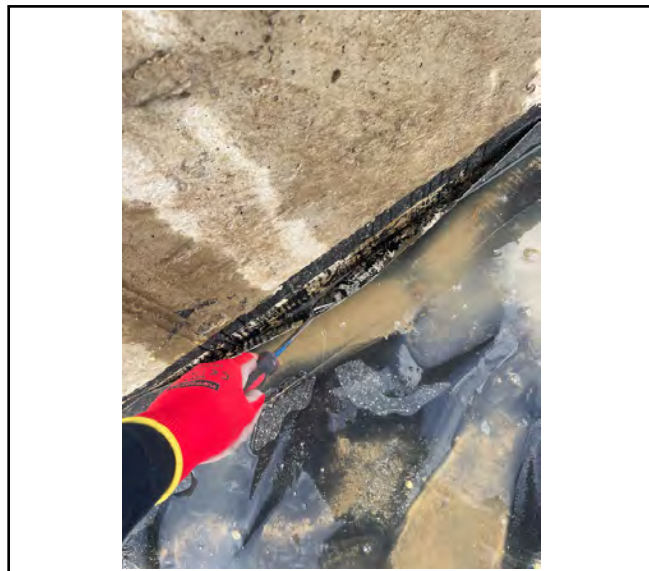
The photograph above on the right shows one of several sections of retrofit perimeter detailing not sealed upon the primed perimeter due to excessive water ingress jeopardising the seal, areas will require further inspection once remediated.

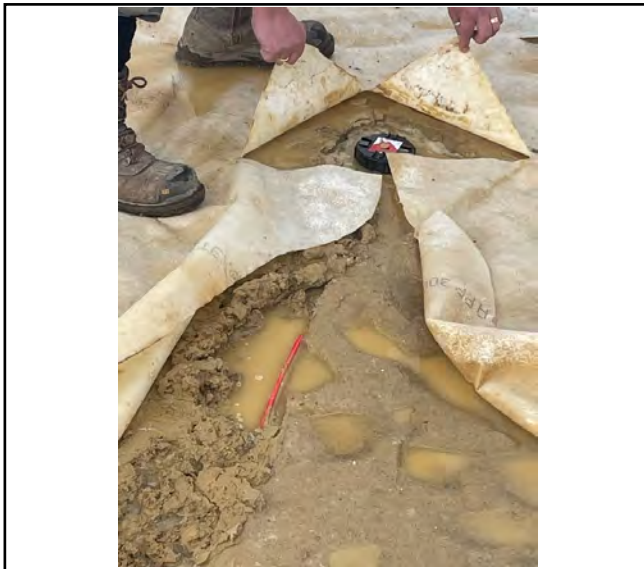
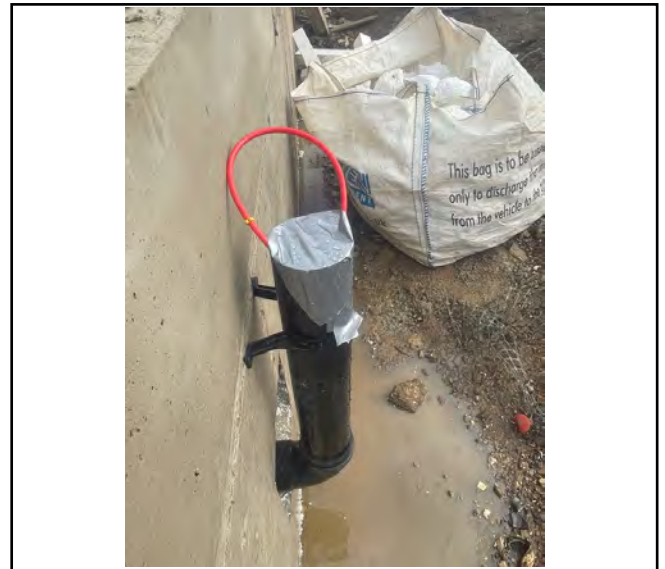
The below basal layer probes have been installed within the area. The probe pipe has been buried within the soft sand blinded substrate providing adequate protection as shown in the photograph below on the left.

The probe positions are as per the Geoshield design drawing set out by Fentons Engineer. However, the probe pipe route has deviated a little due to the conflict with various areas of the structure. The probe pipe has returned vertically immediately outside the block in accordance to Geoshields method statement as shown on the right.

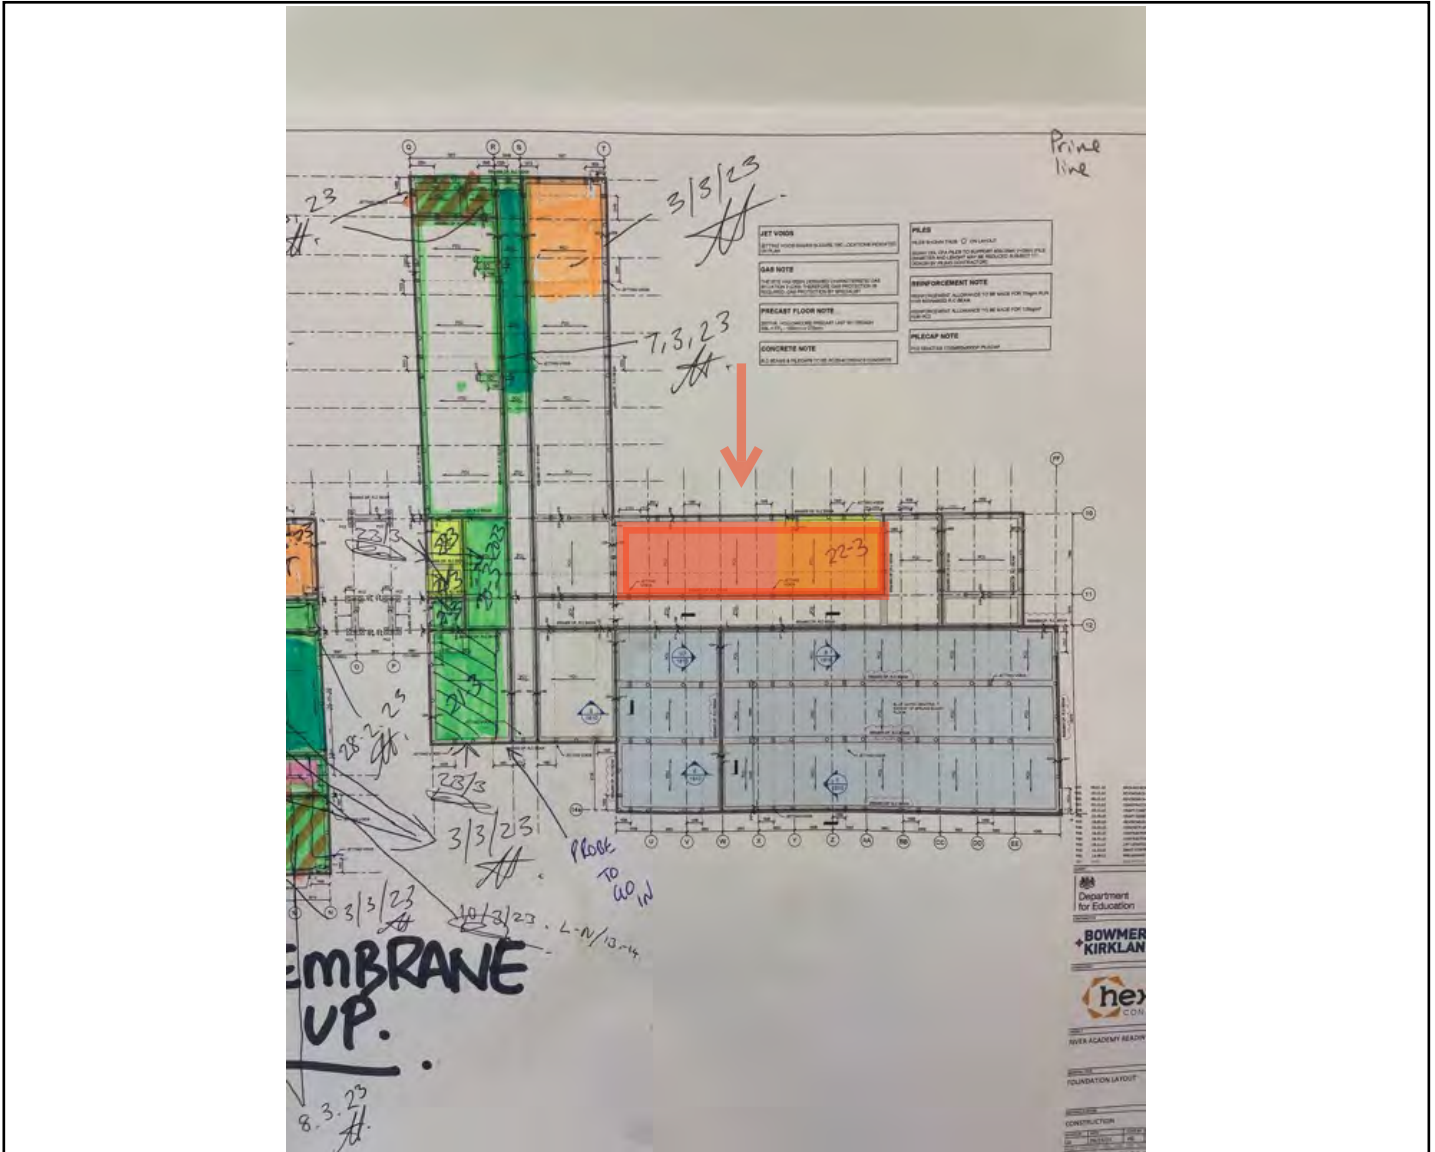
## VERIFICATION LAYOUT

The above photograph displays a layout plan of the proposed East Block.

Highlighted red above is where verification took place.

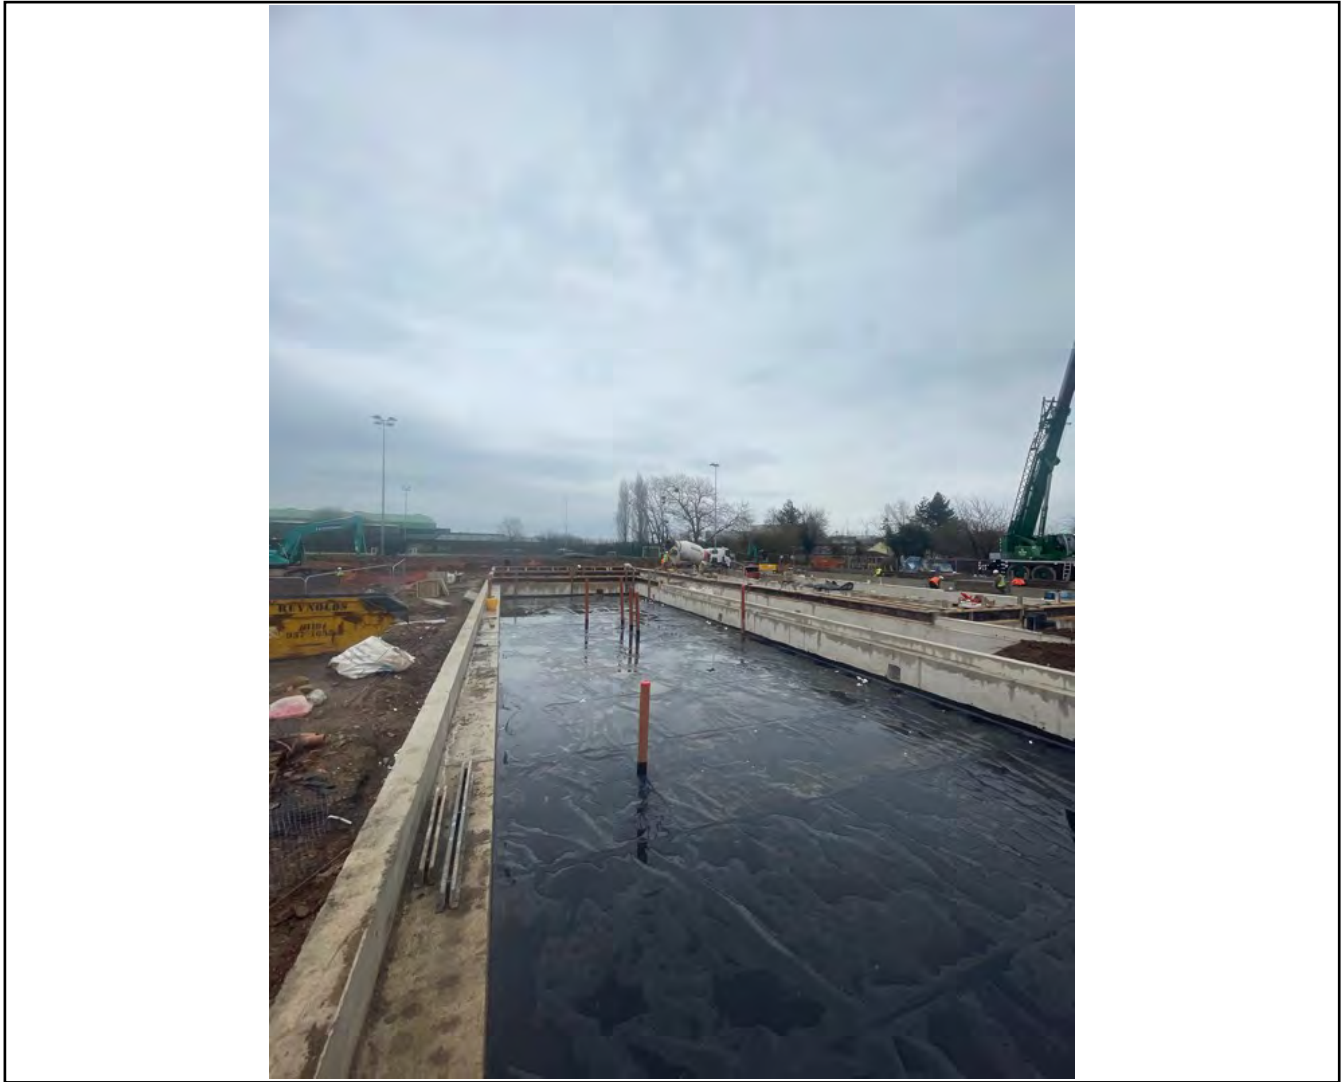
East Block Basal Layer Membrane - GLs A-T/10-11

Overview photograph of the area verified during this visit.

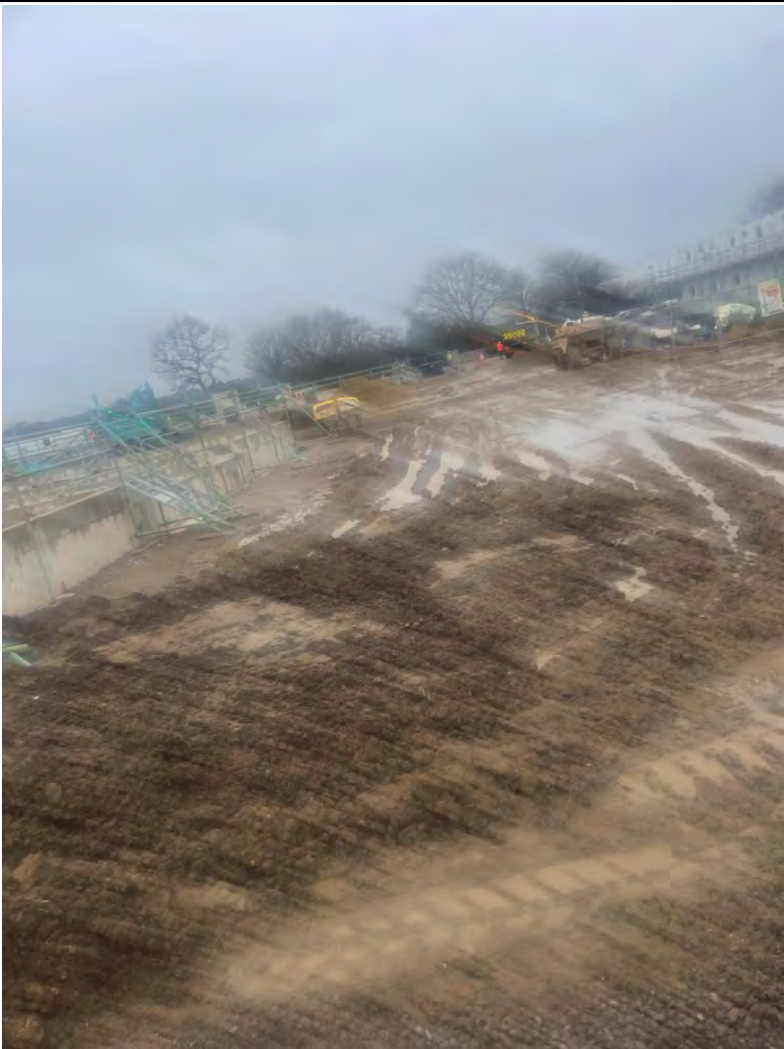
RESTRICTIONS AND LIMITATIONS: Insufficient Access-

There was insufficient access to the area requiring verification during this visit. No access was available for the work vehicle to enable non-destructive airlance integrity testing to be conducted. Alternatively, thorough pick&probe tests were conducted.

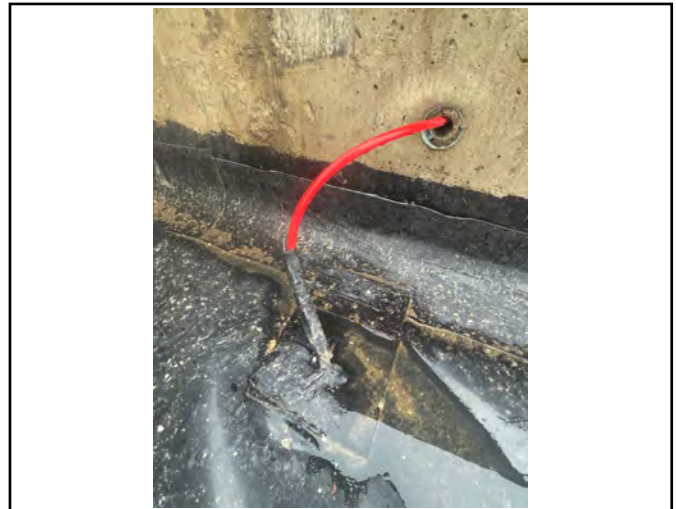
continuous seal across the area. The Juta Titan Flex has been cut tightly around each

pipe penetration eliminating voided spaces and sealed accordingly.

The pipe penetrations have been successfully sealed in accordance to manufacturers

specification using Juta Titan Tank - gas resistant self adhesive membrane to a good

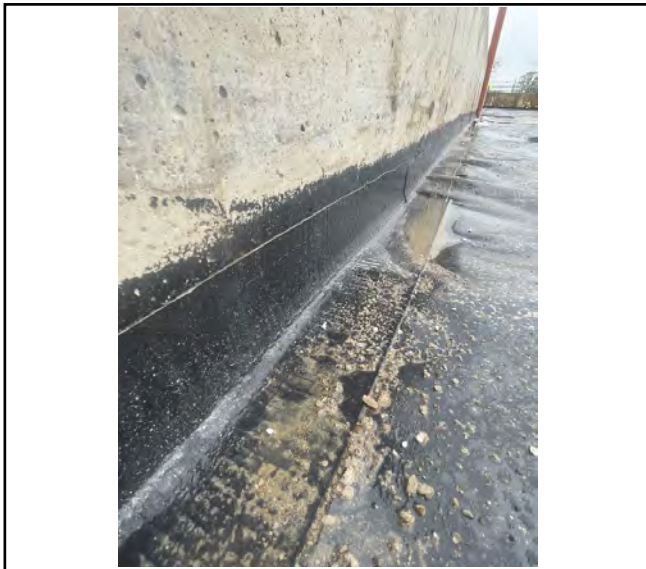
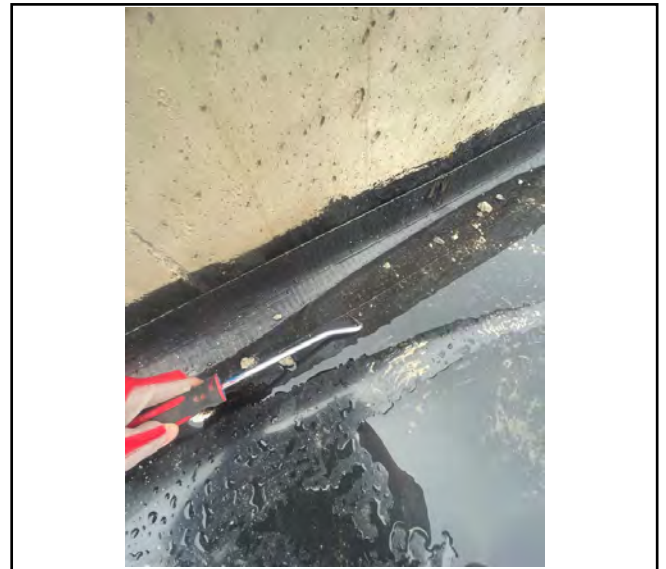
This has been achieved via retrofit detail carried out in accordance to design details

using Juta Titan Tank membrane.

Close up perspective of a successful retrofit detail shown in the photograph above on

the left, all areas have been primed prior to application to help aid in adherence.

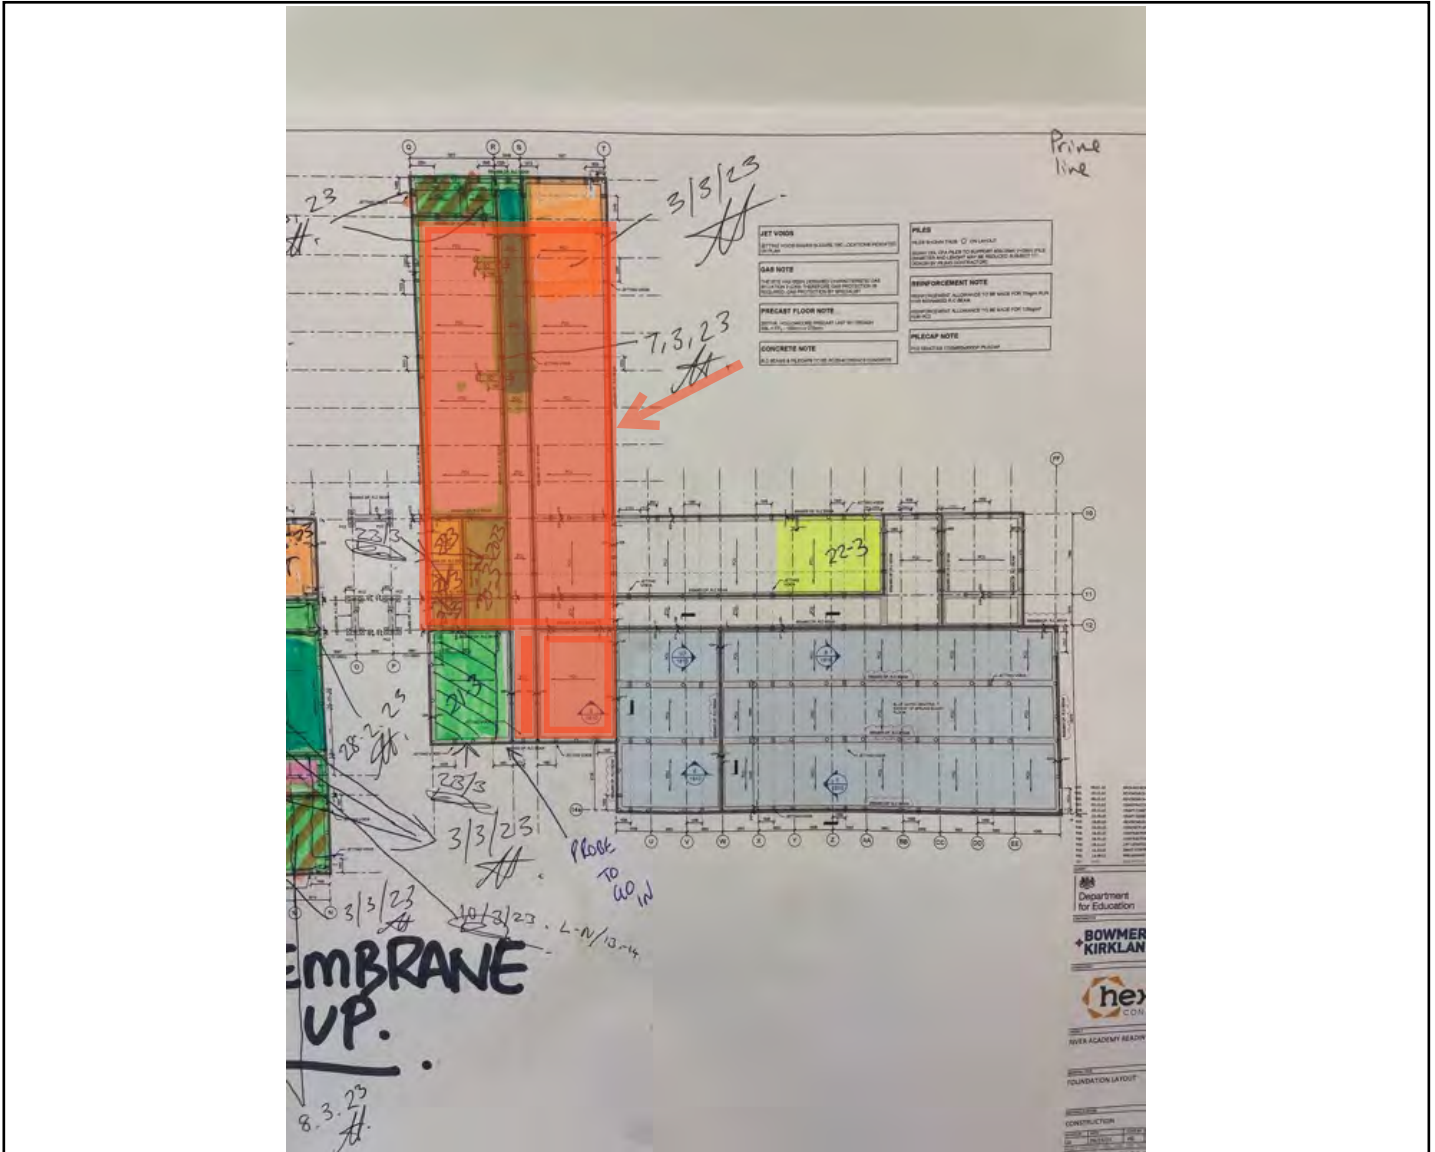
## VERIFICATION LAYOUT

The above photograph displays a layout plan of the proposed East Block.

Highlighted red above is where verification took place.

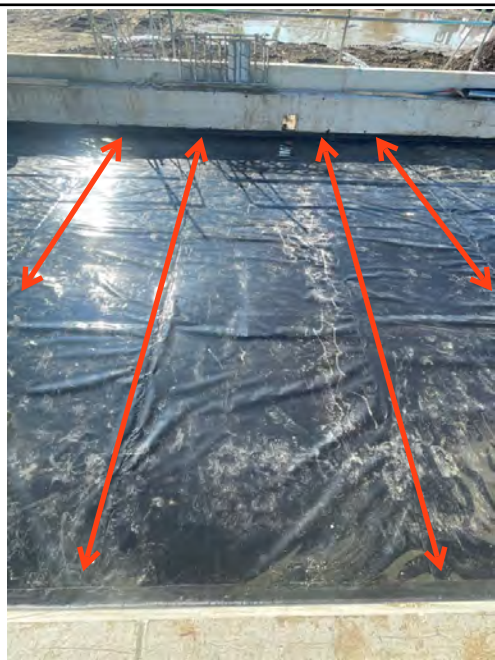
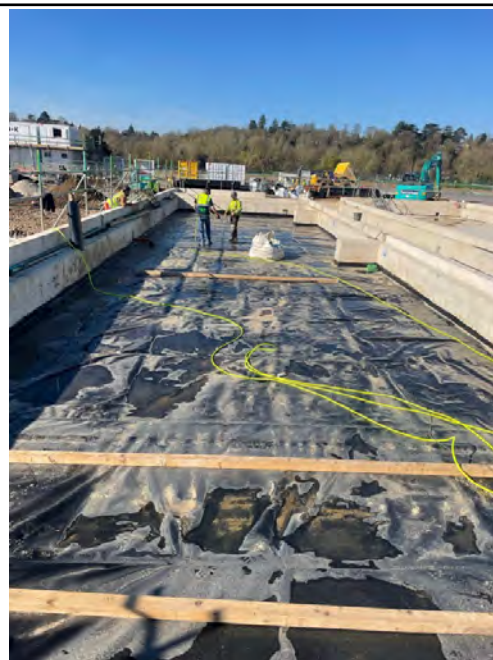
Juta Titan Flex has been installed across the blinded substrate to another basal section within east block. All overlaps between sheets of Juta Titan Flex have been welded using a hot air tool and silicone roller in accordance to BS8485:2019 guidelines.

The annotations on the photograph on the left highlight consistently welded lap joints.

The photograph above on the right displays an alternate overview of the area verified.

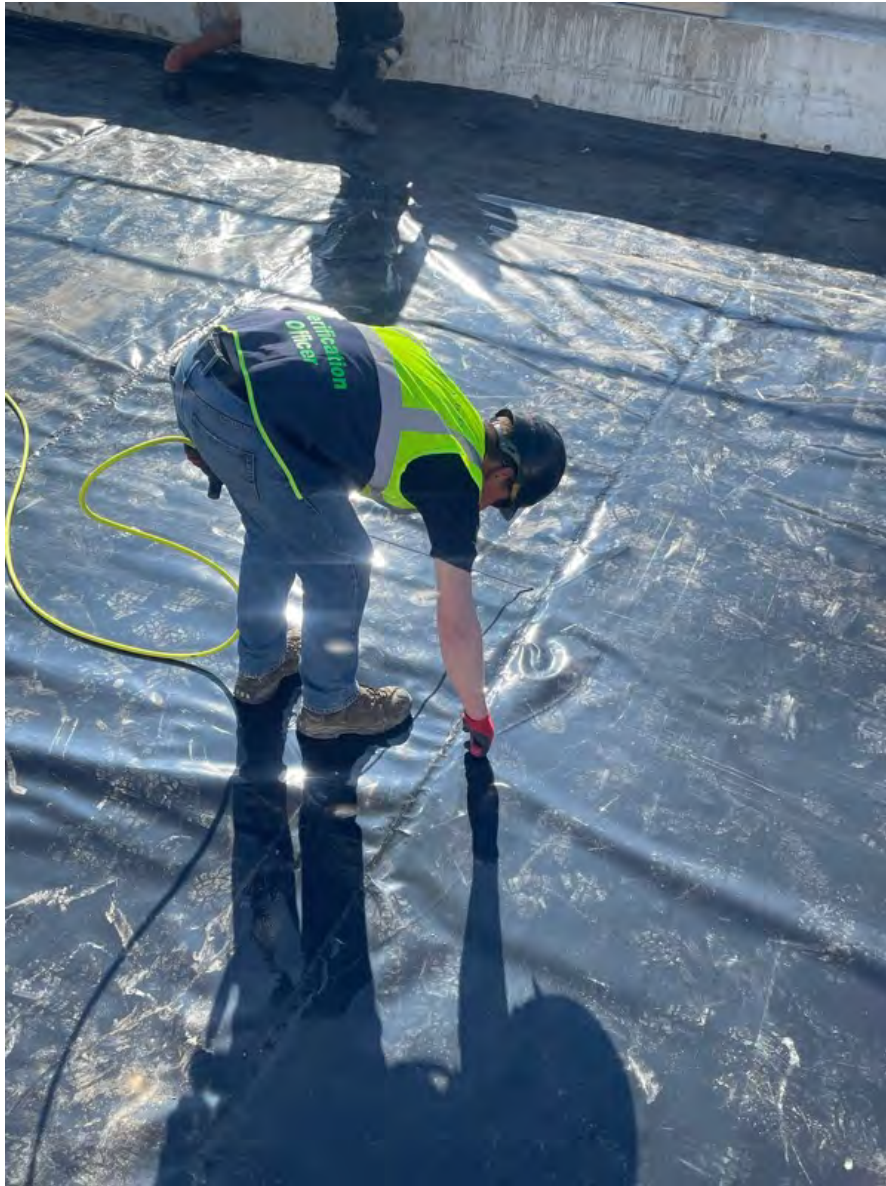
## VERIFICATION ITEM ONE

The above photograph displays a mechanical point stress test also known as the pick and probe test being conducted upon a consistently welded lap joint.

This was one of two testing procedures carried out during this verification visit.

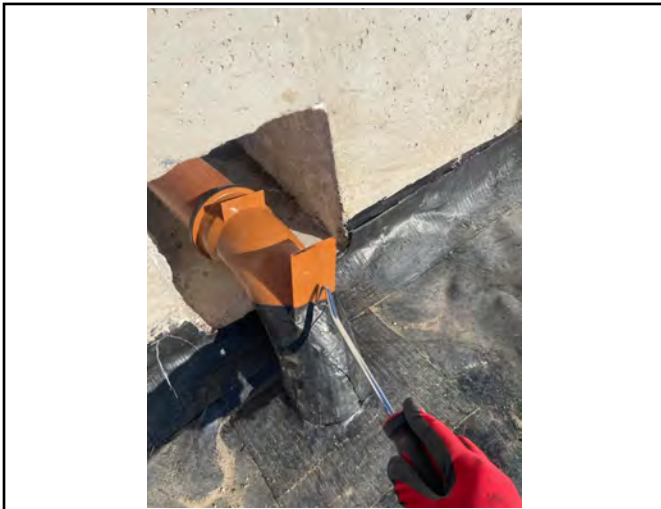
Within the area referenced several pipe penetrations required sealing to create a continuous seal throughout the areas. The Juta Titan Flex has been cut tightly around each pipe penetration eliminating voided spaces and sealed accordingly.

The pipe penetrations have been successfully sealed in accordance to manufactures specification using Juta Titan Tank - gas resistant self adhesive membrane to a good NVQ standard following the petal and 300mm tophat sequence which can be seen in the photographs above, each pipe penetration was also subjected to the pick&probe test as shown above. No faults were identified. Verified in accordance with CIRIA735.

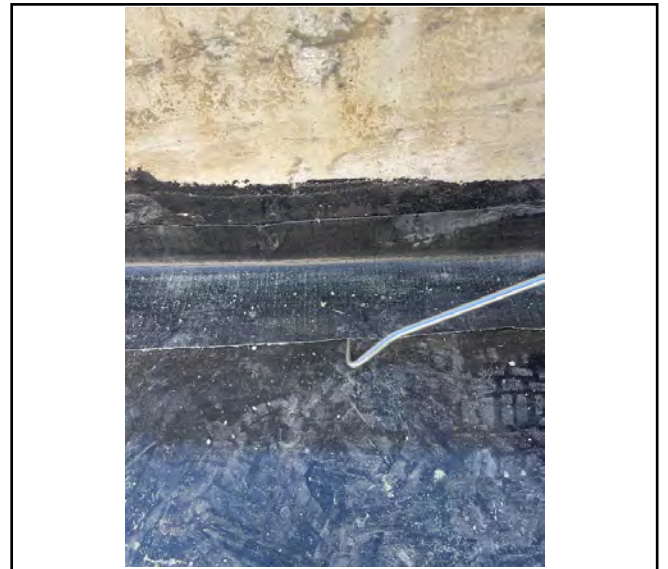
This has been achieved via a retrofit detail carried out in accordance to design details

using Juta Titan Tank membrane. All surfaces of the concrete have been primed prior...

...to application to help aid in adherence of the Juta Titan Tank.

All Juta Titan Tank works have been thoroughly heated down with rolled pressure

to the retrofit detailing identified no faults or defects.

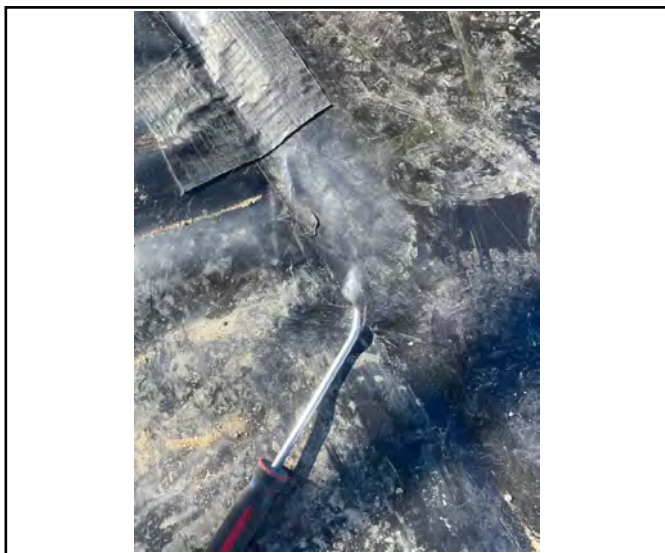
Fault identified.

Installer carrying out patch repair

Remediated on-site.
