# GEOSHIELD Verification Report

PROJECT REFERENCE:

GEO103260

Riverside Academy

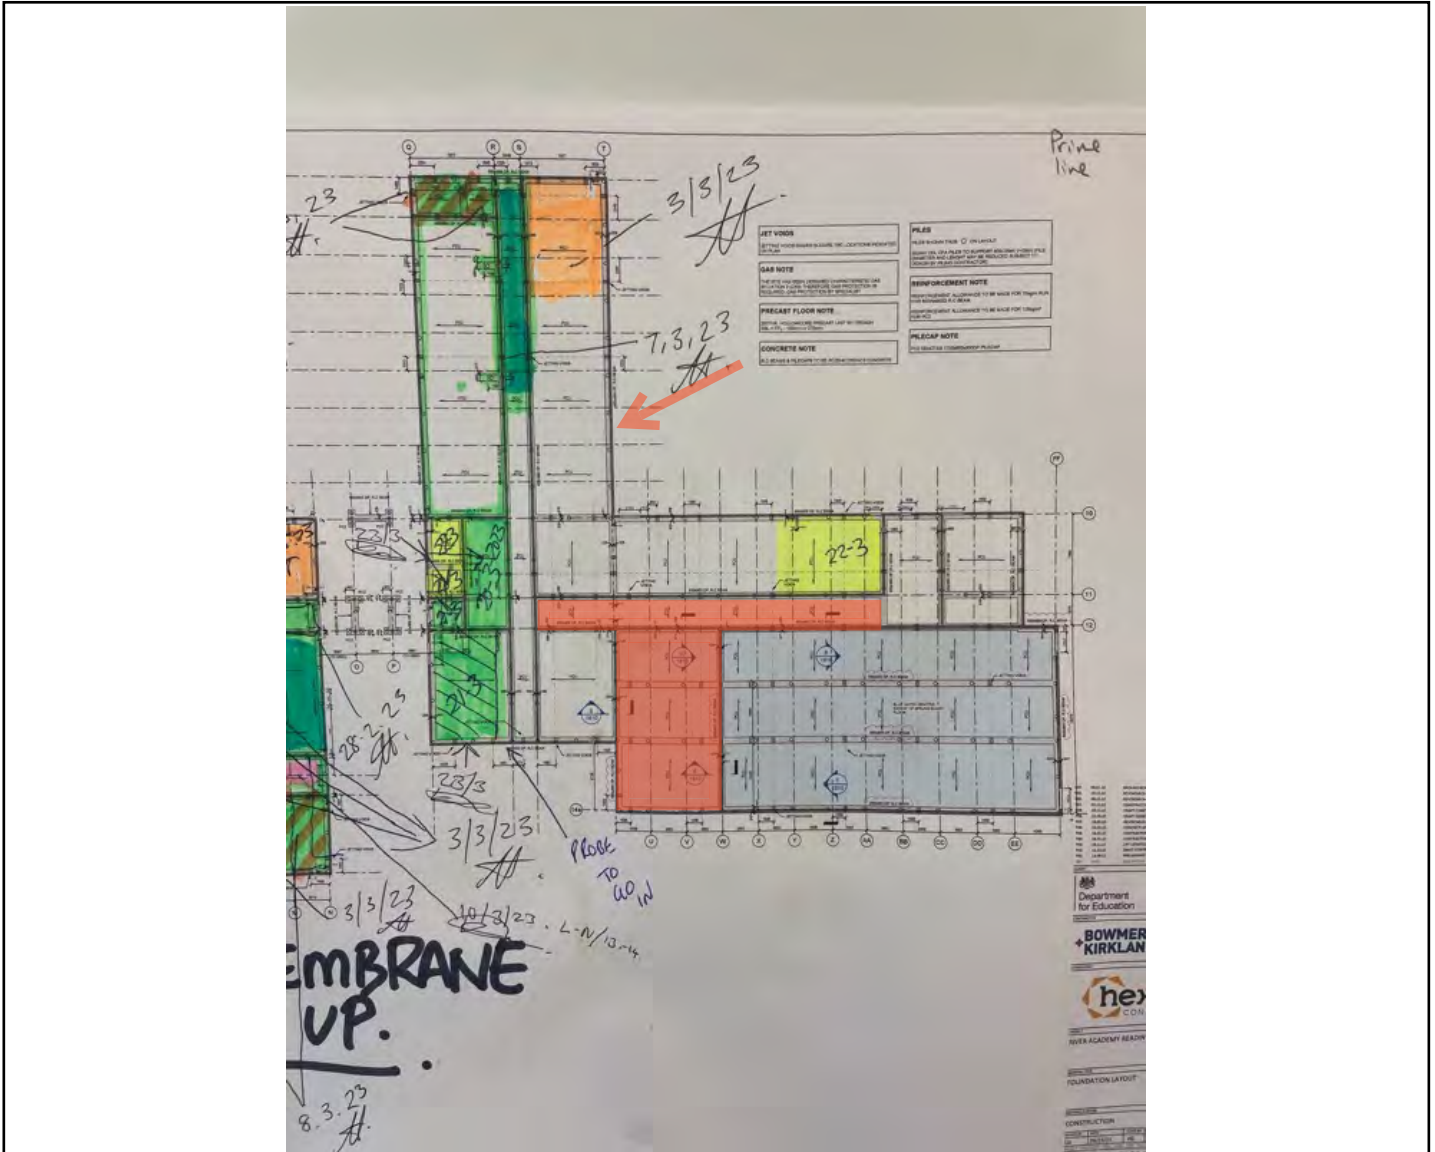
The above photograph displays a layout plan of the proposed East Block.

Highlighted red above is where verification took place.

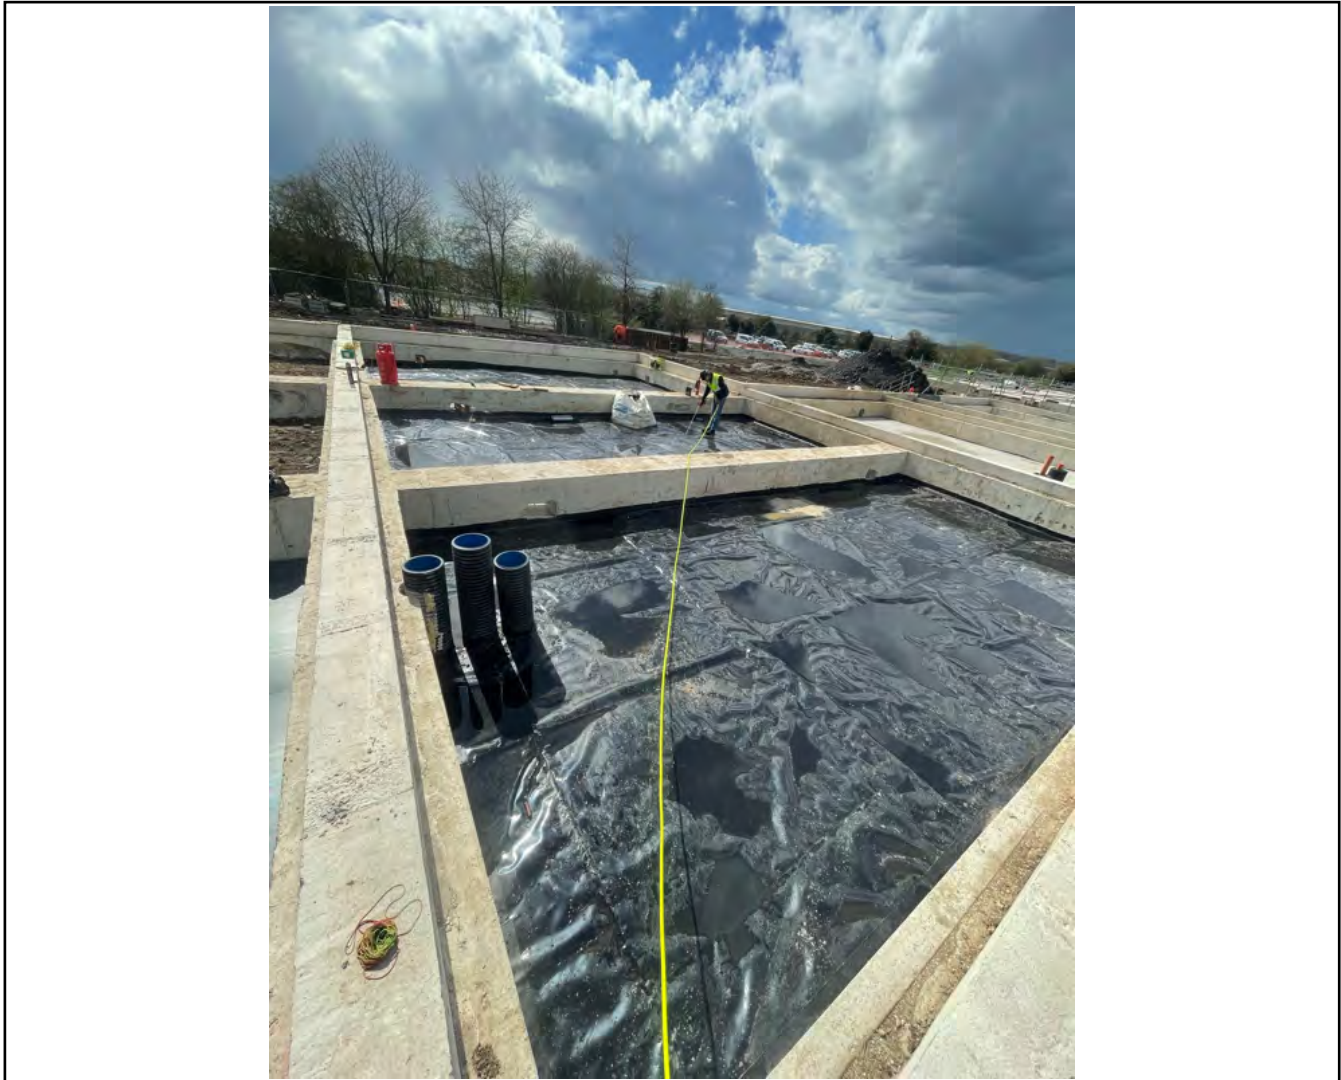
East Block Basal Layer Membrane - GLs T-W/12-13 & S-AA/11-12

Overview photograph of the area verified during this visit.

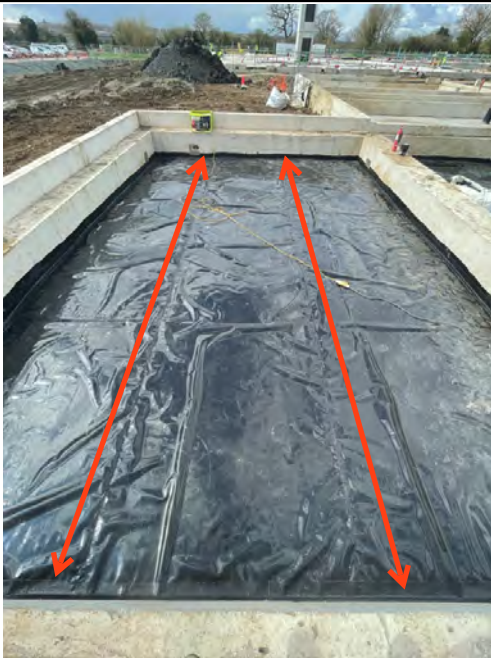
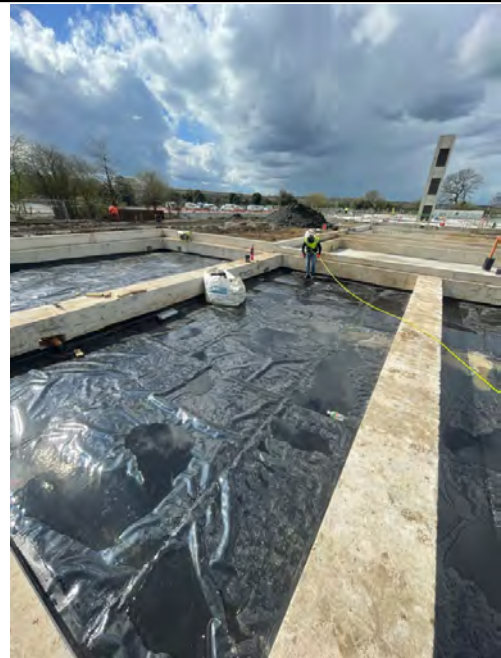
Juta Titan Flex has been installed across the blinded substrate to further basal sections within east block. All overlaps between sheets of Juta Titan Flex have been welded using a hot air tool & silicone roller upon a 150mm overlap conforming to manufacturers...

...specification. The photograph on the left highlights consistently welded lap joints.

The photograph above on the right displays an alternate overview of the area verified.

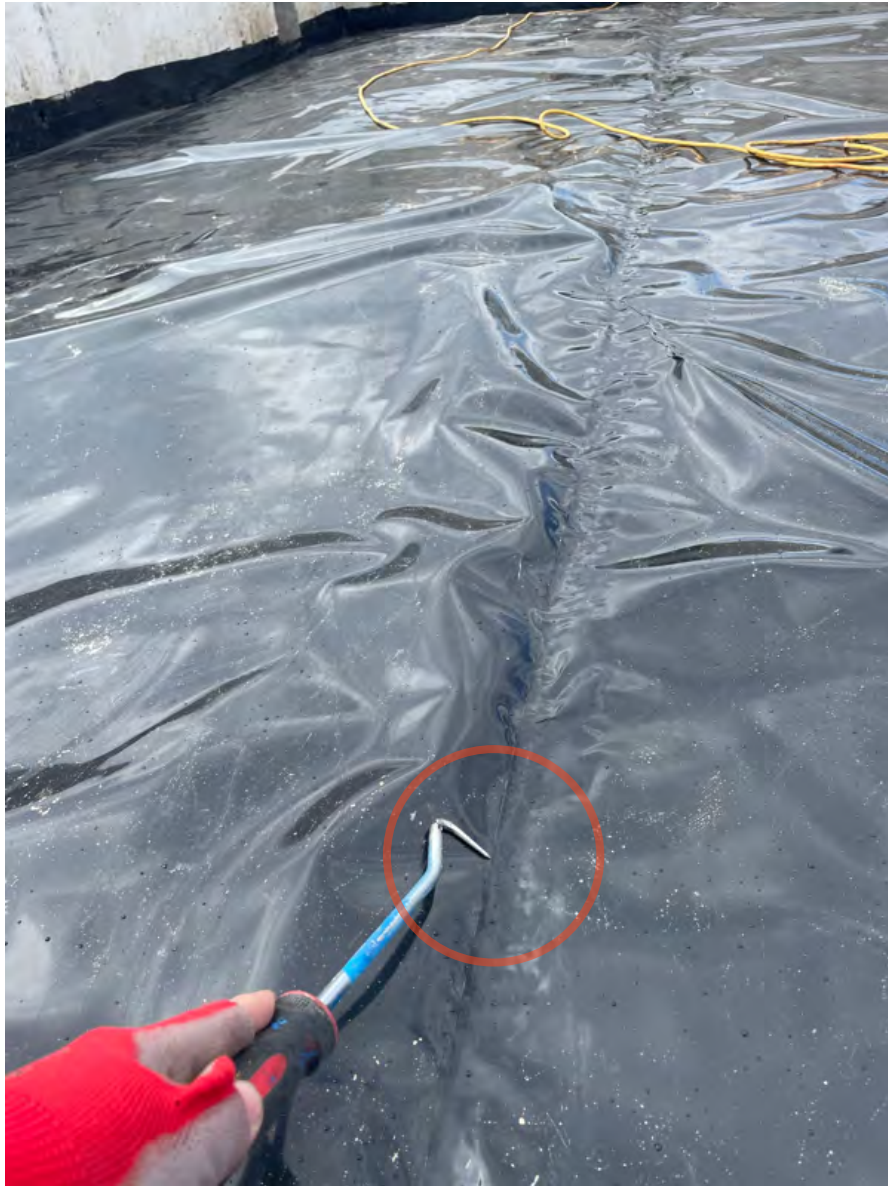
The above photograph displays a mechanical point stress test also known as the pick and probe test being conducted upon a consistently welded lap joint.

This was one of two testing procedures carried out during this verification visit.

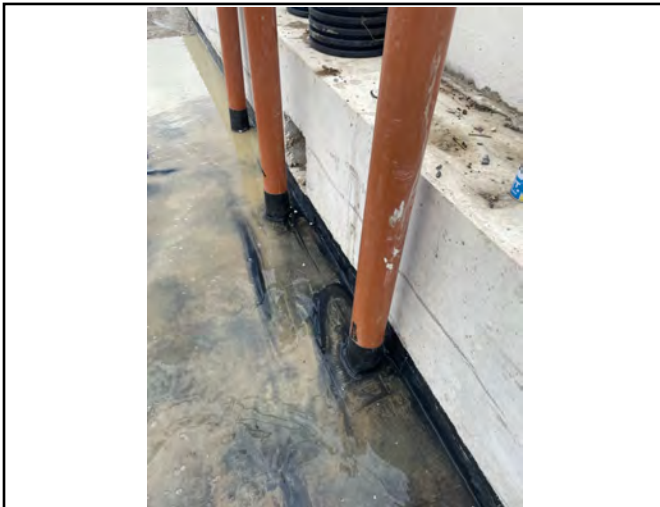
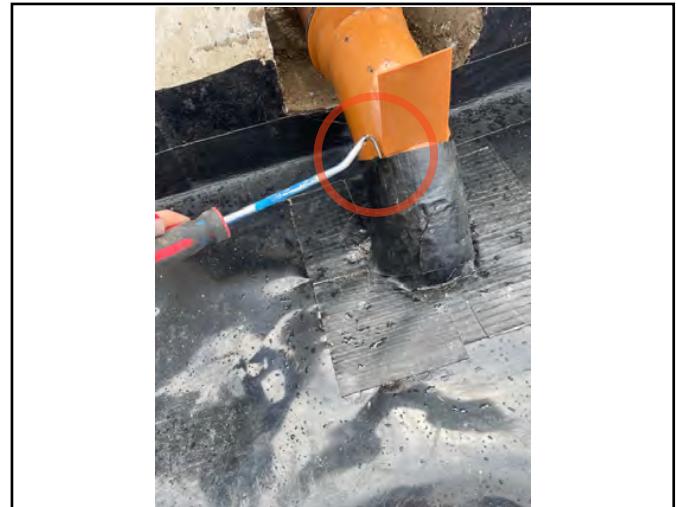
Within the area referenced several pipe penetrations required sealing to create a continuous seal throughout the areas. The Juta Titan Flex has been cut tightly around each pipe penetration eliminating voided spaces and sealed accordingly.

The pipe penetrations have been successfully sealed in accordance to manufactures specification using Juta Titan Tank - gas resistant self adhesive membrane to a good NVQ standard following the petal and 300mm tophat sequence which can be seen in the photographs above, each pipe penetration was also subjected to the pick&probe test as shown above. No faults were identified. Verified in accordance with CIRIA735.

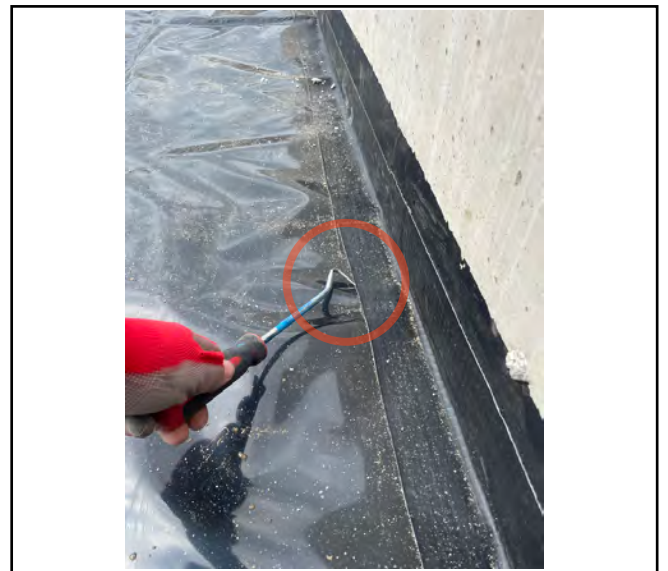
This has been achieved via a retrofit detail carried out in accordance to design details

using Juta Titan Tank membrane. All surfaces of the concrete have been primed prior...

...to application to help aid in adherence of the 'Titan Tank' as highlighted on the left.

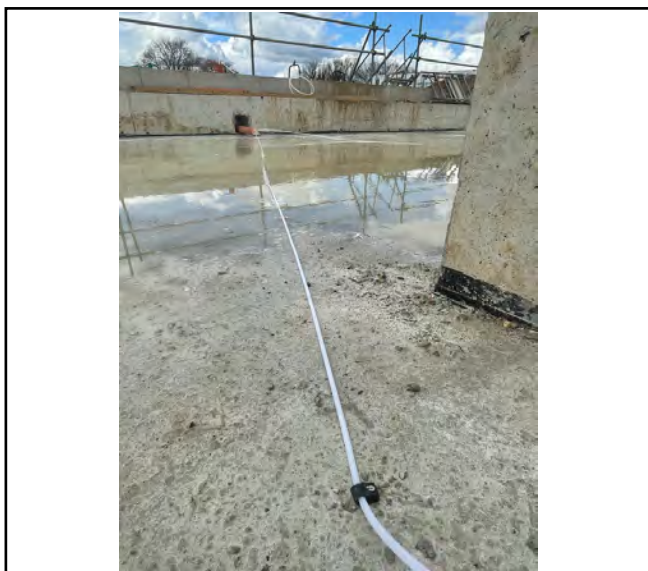
The probes referenced above have been successfully installed by the specialists from Prestige Air. The probe centres have been marked out by Fentons Engineer as per Geoshields design. The probe pipe routes have been altered due to route disruptions.

The probe routes have been fixed upon the concrete blinding as shown in the photograph above on the left. No vicious angles were present ensuring an accurate reading is achieved. The probe pipe has been returned through pipe work externally and returned immediately horizontally as per the method statement.

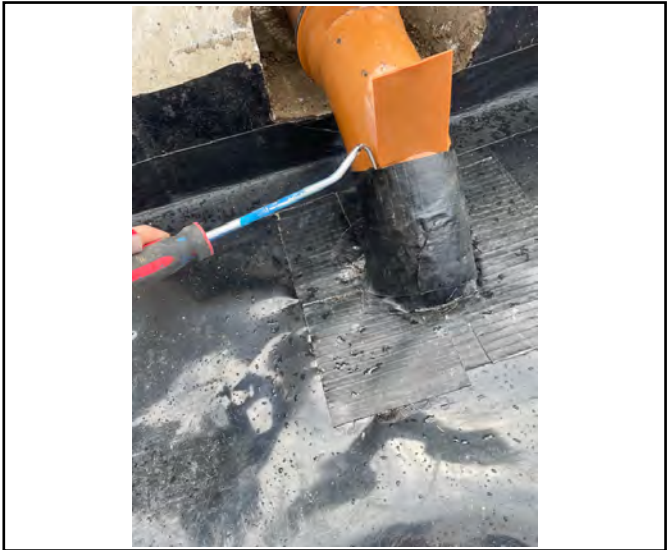
Pick&probe testing to sealed pipe.

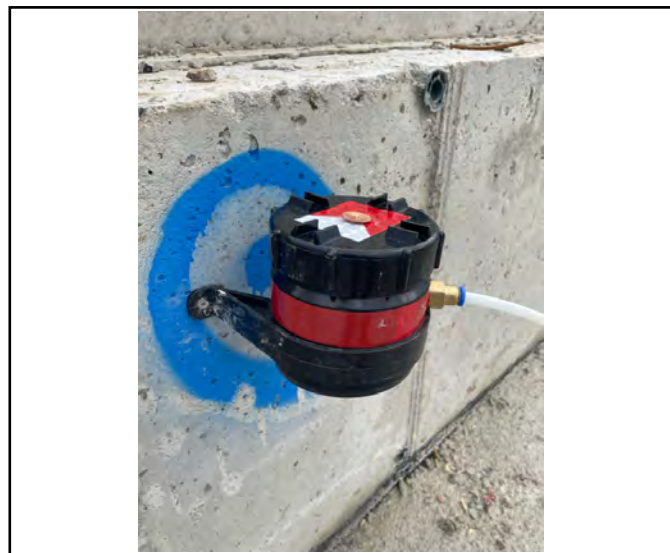
ABL probe fixed to engineers

mark up.

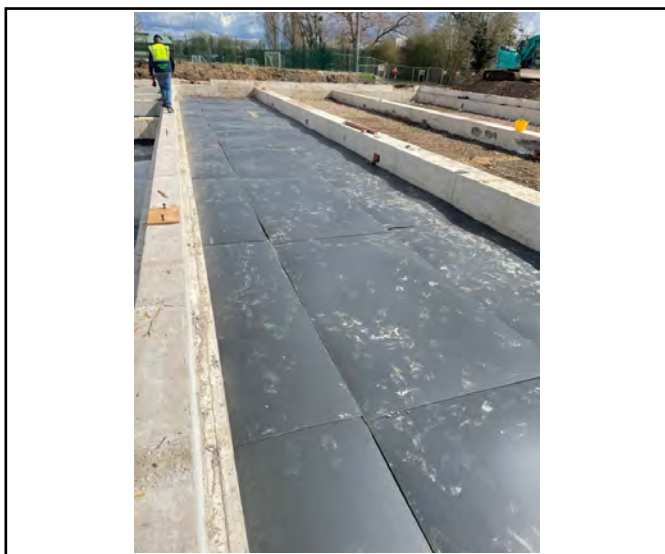
Preparation for next section.

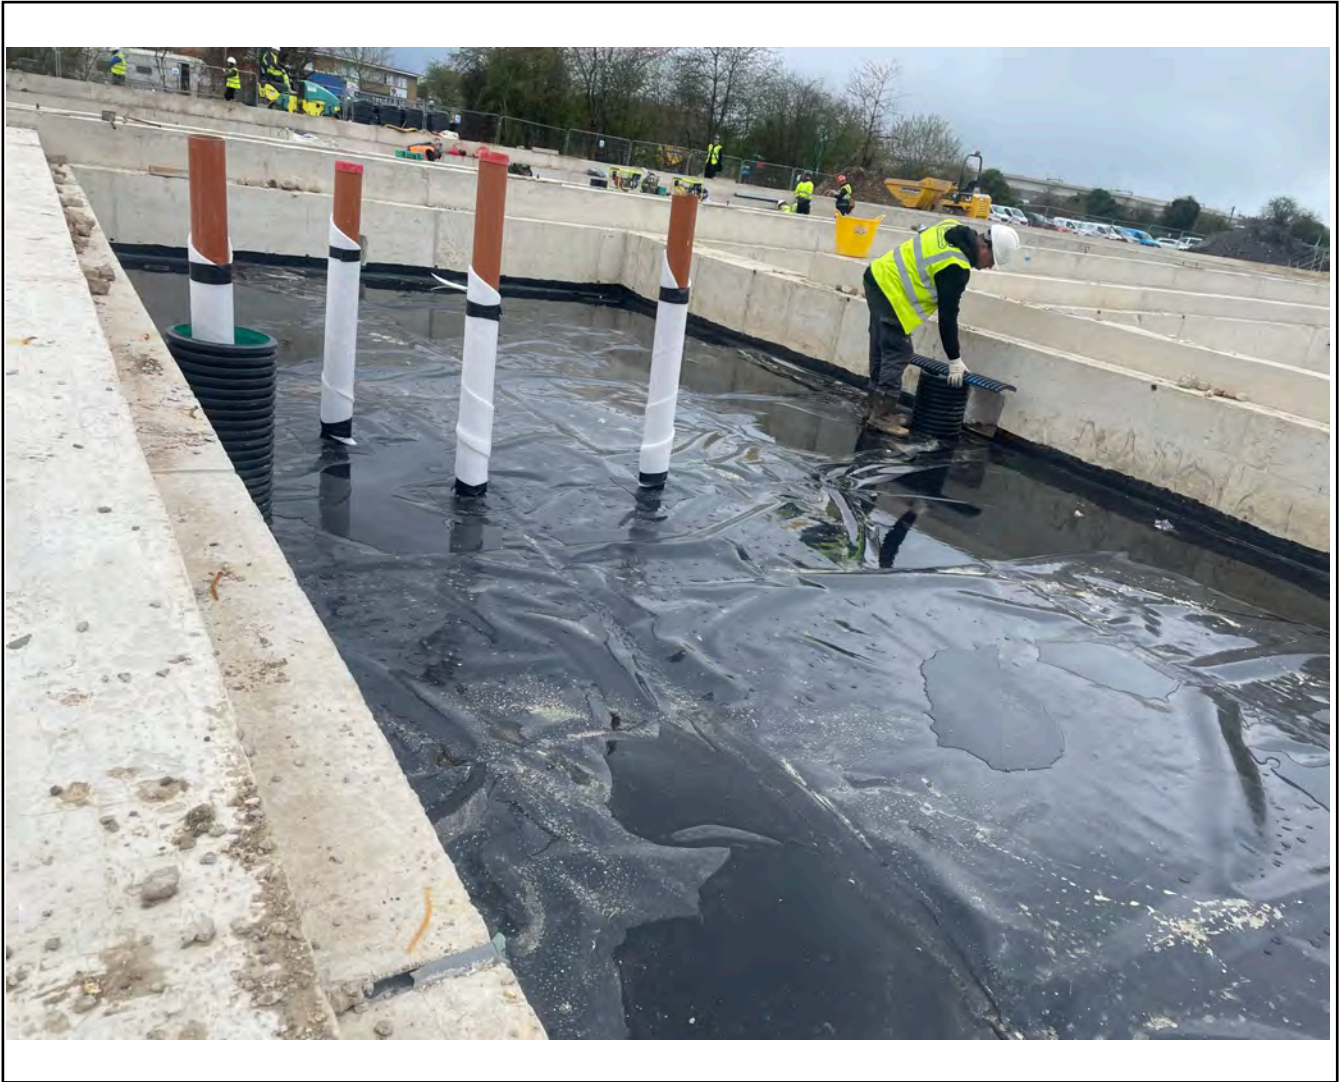
East Block Basal Layer Membrane -GLs: 10-12/BB-EE + 12/Z-EE

Overview photograph of the area verified during this visit.

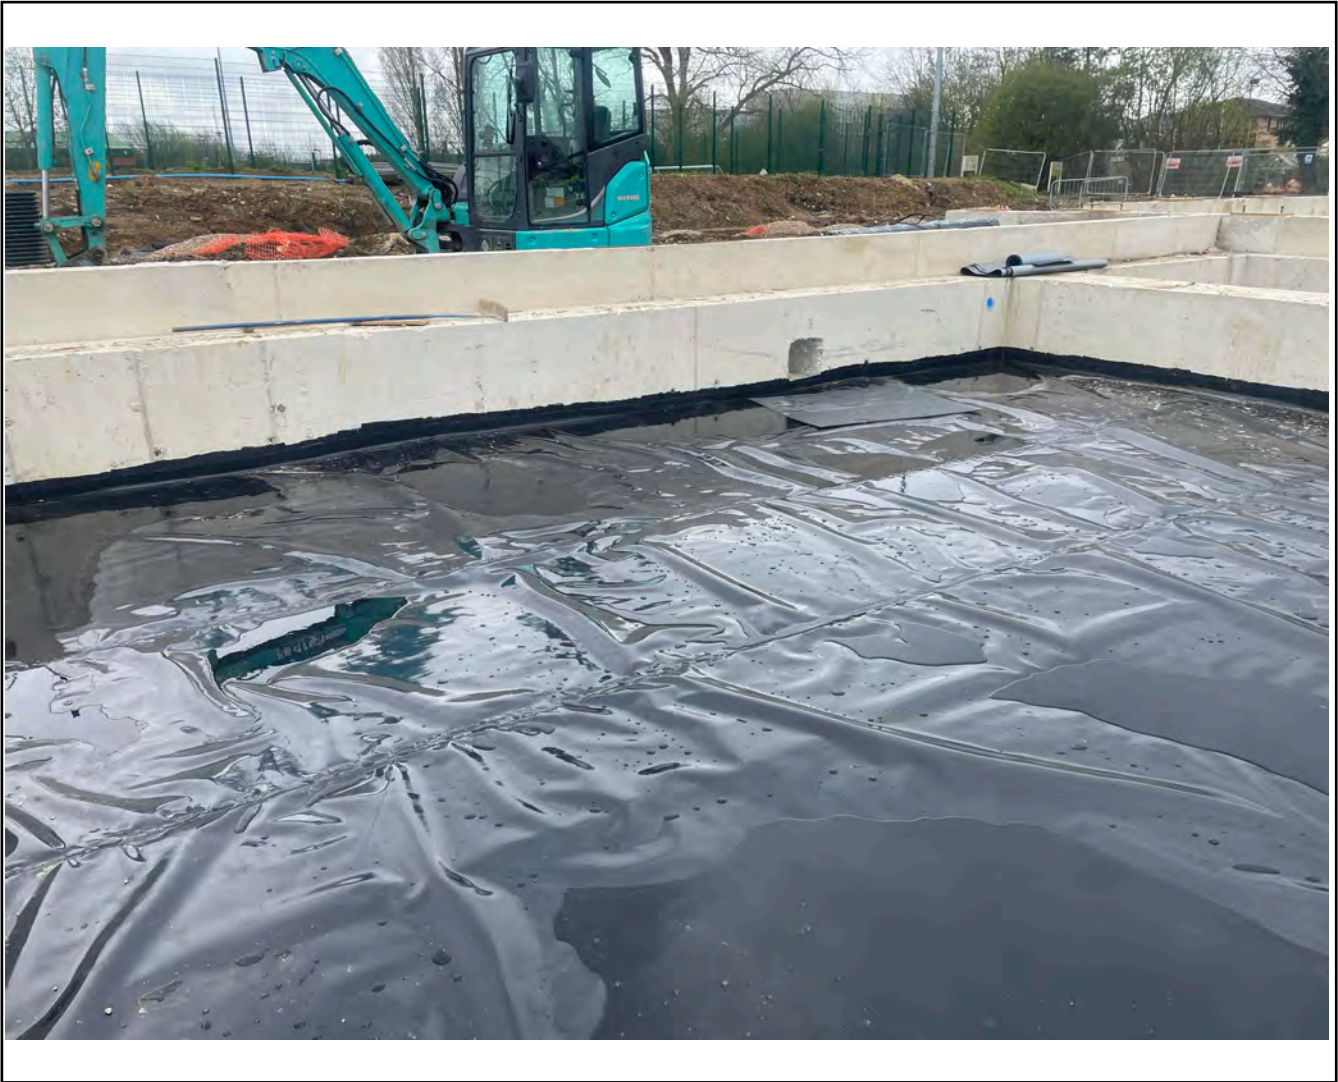
East Block Basal Layer Membrane -GLs: 10-12/BB-EE + 12/Z-EE

Overview photograph of the area verified during this visit.

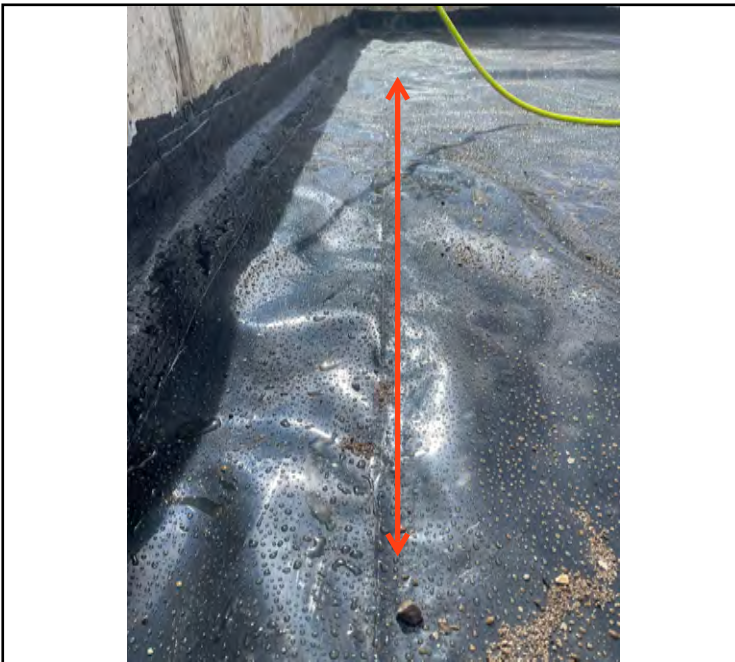
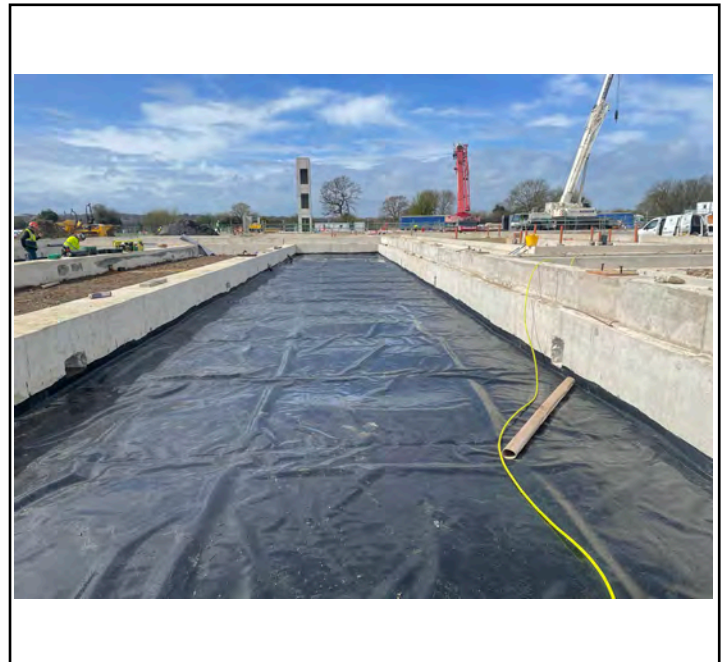
Juta Titan Flex has been installed across the blinded substrate to further basal sections within east block. All overlaps between sheets of Juta Titan Flex have been welded using a hot air tool & silicone roller upon a 150mm overlap conforming to manufactures...

...specification. The photograph on the left highlights consistently welded lap joints.

The photograph above on the right displays an alternate overview of the area verified.

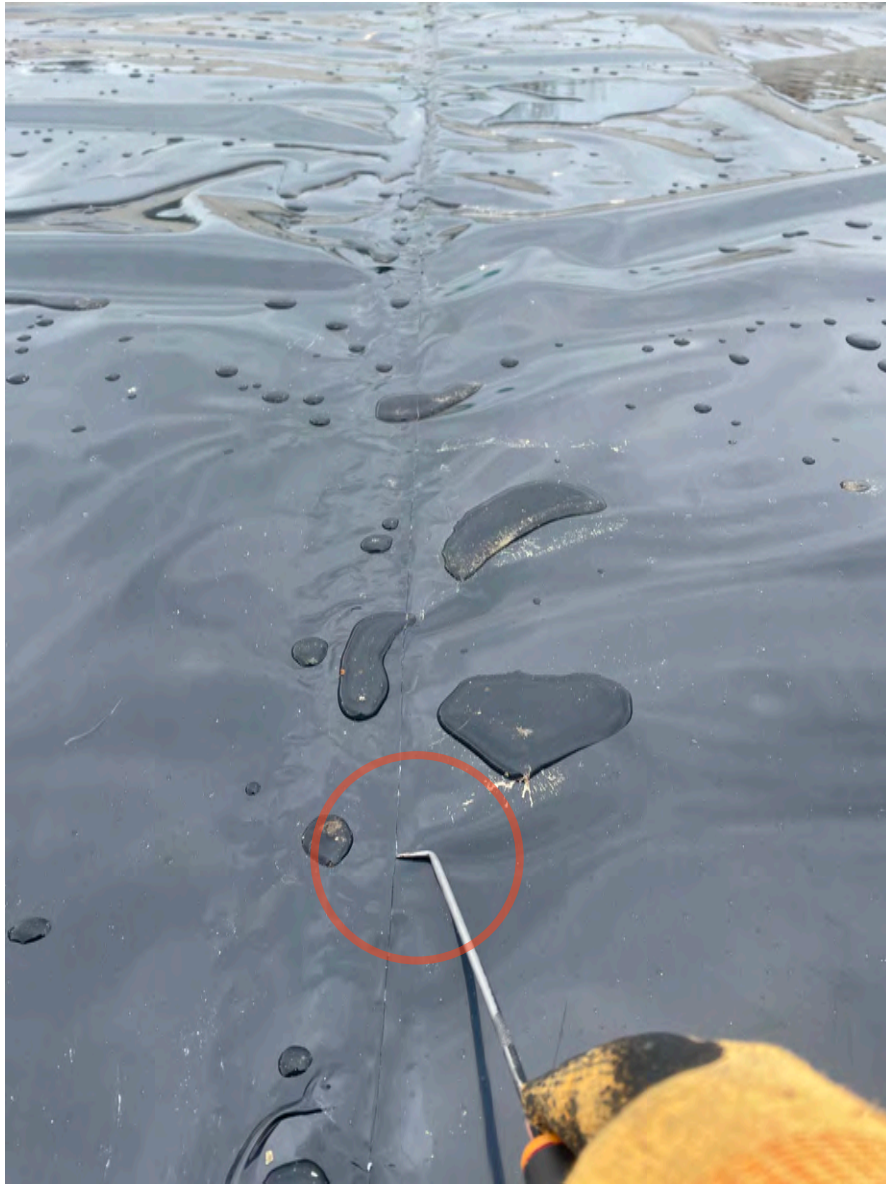
The above photograph displays a mechanical point stress test also known as the pick and probe test being conducted upon a consistently welded lap joint.

This was one of two testing procedures carried out during this verification visit.

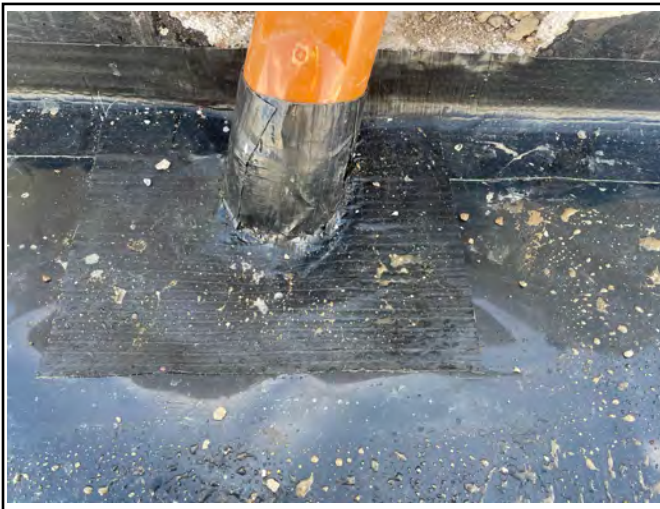
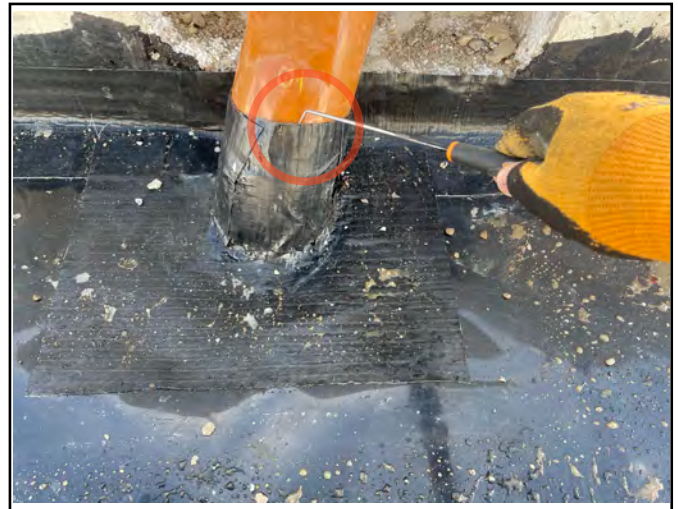
Within the area referenced several pipe penetrations required sealing to create a continuous seal throughout the areas. The Juta Titan Flex has been cut tightly around each pipe penetration eliminating voided spaces and sealed accordingly.

The pipe penetrations have been successfully sealed in accordance to manufactures specification using Juta Titan Tank - gas resistant self adhesive membrane to a good NVQ standard following the petal and 300mm tophat sequence which can be seen in the photographs above, each pipe penetration was also subjected to the pick&probe test as shown above. No faults were identified. Verified in accordance with CIRIA735.

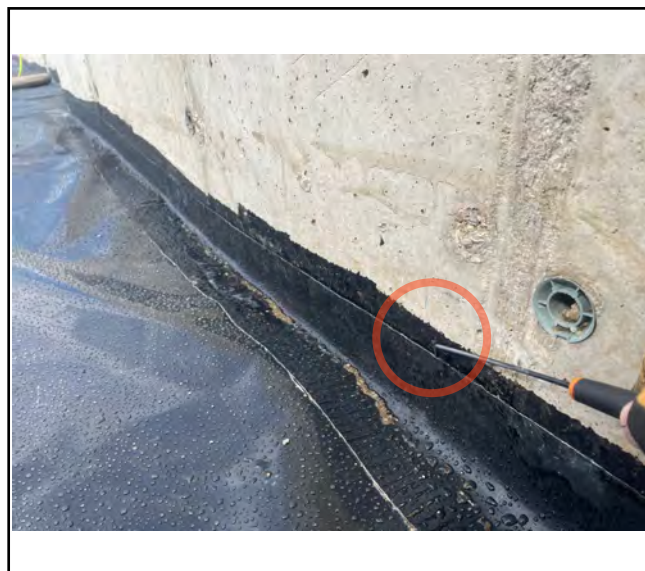
This has been achieved via a retrofit detail carried out in accordance to design details

using Juta Titan Tank membrane. All surfaces of the concrete have been primed prior...

...to application to help aid in adherence of the 'Titan Tank' as highlighted on the left.

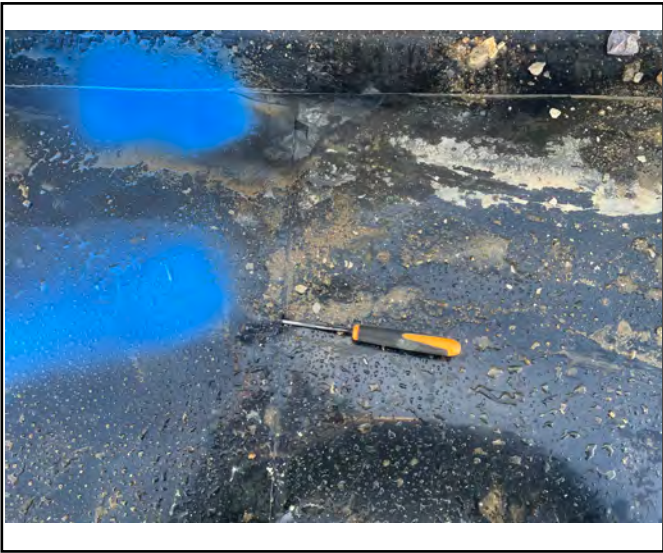
Faults identified.

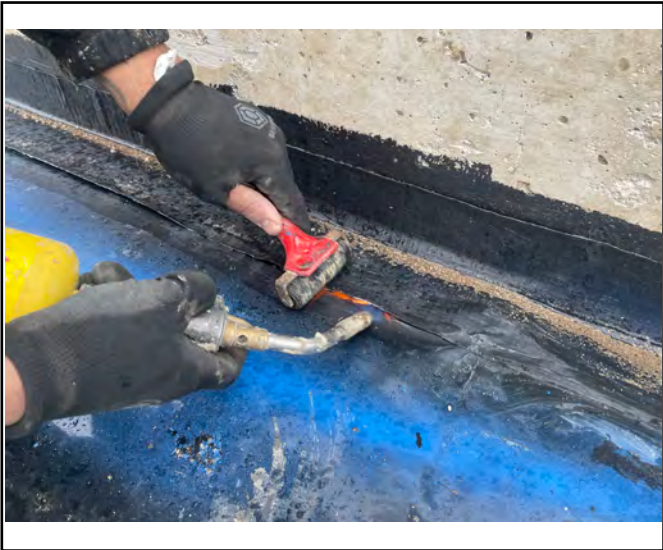
Heat applied to remediated area.

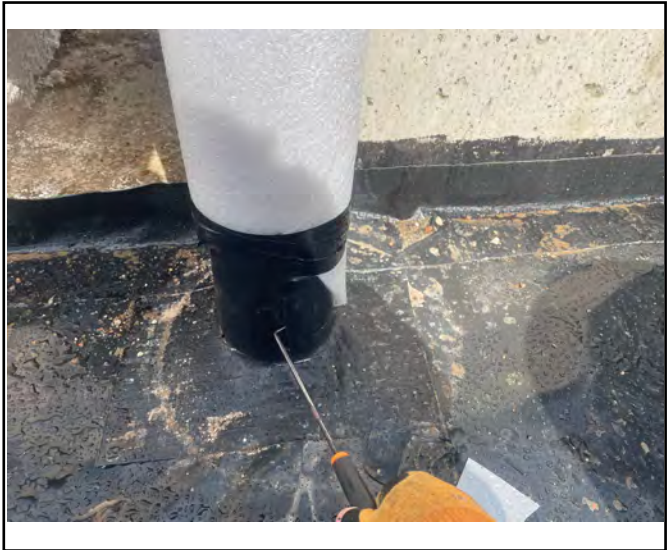
Pick&probe testing to sealed pipe.

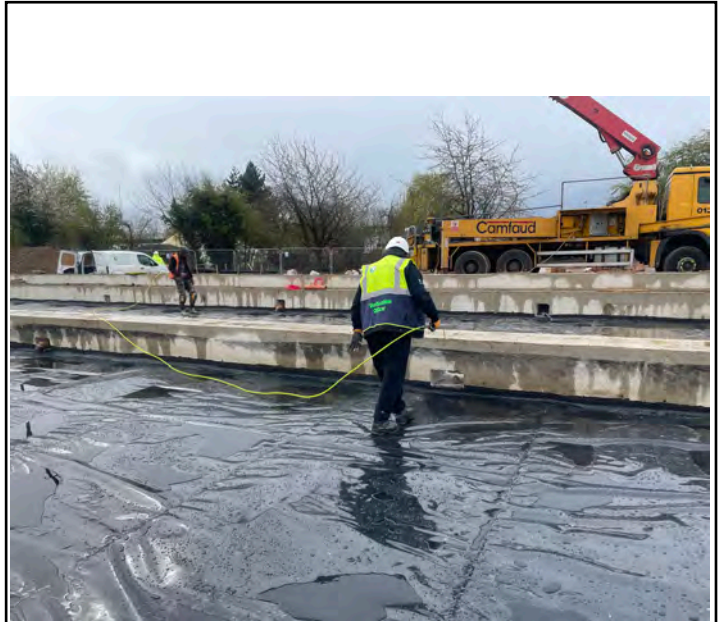
Airlance integrity testing to welded lap joint.

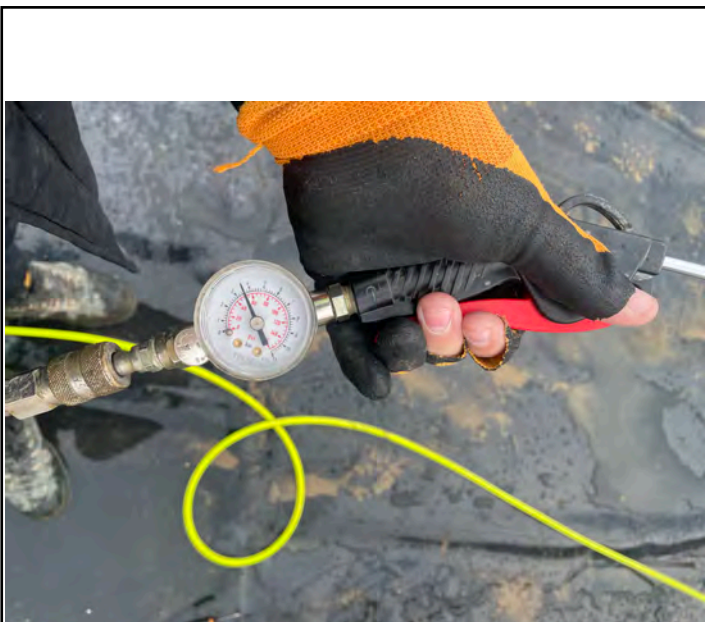
Airlance integrity testing to 55psi

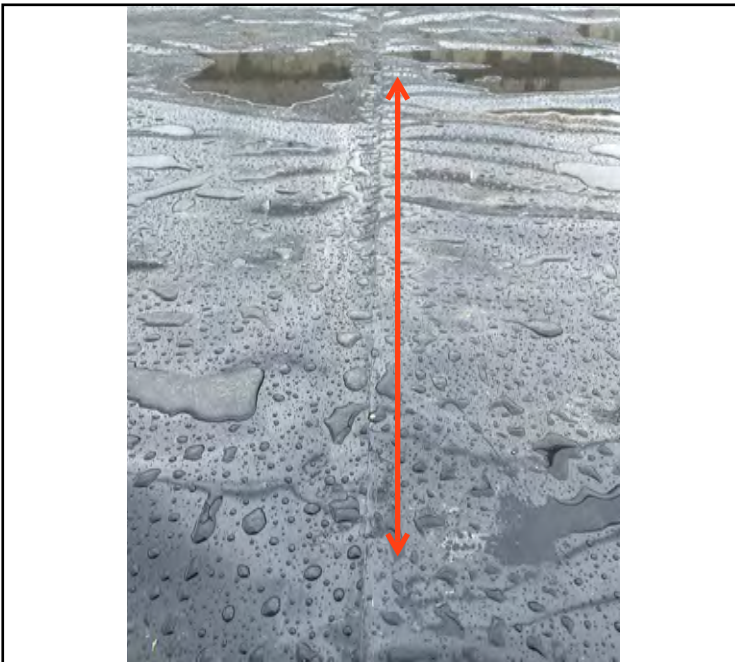
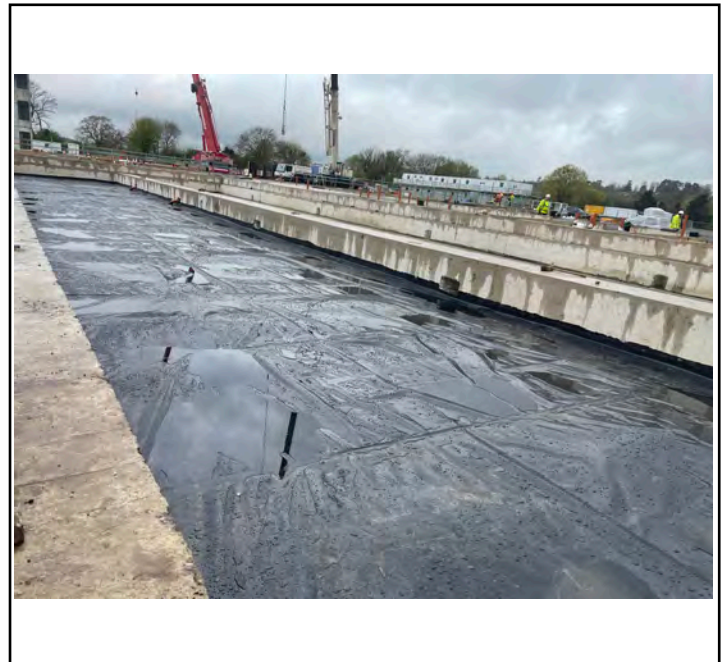
weld is achieved. The photograph on the left highlights a consistently welded lap joint.

The photograph above on the right displays an alternate overview of the area verified.

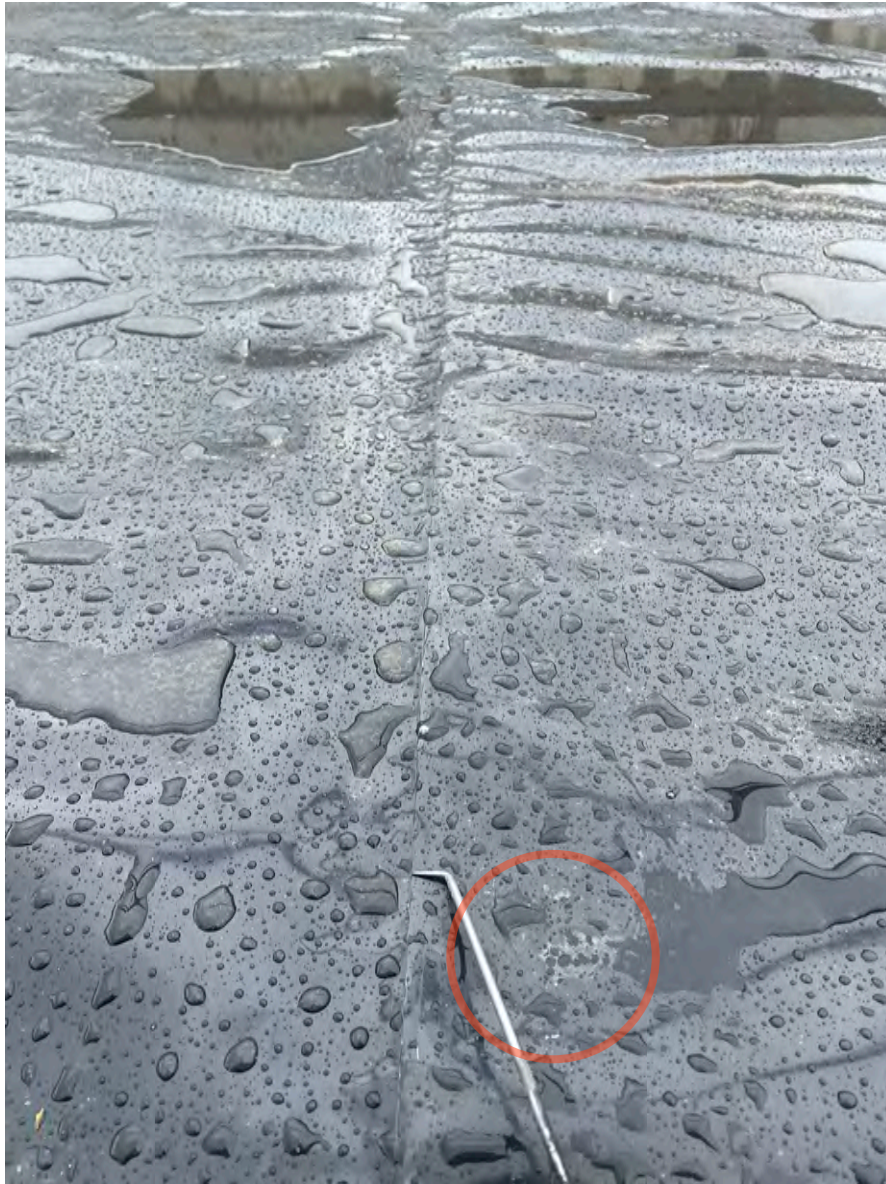
The above photograph displays a mechanical point stress test also known as the pick and probe test being conducted upon a consistently welded lap joint.

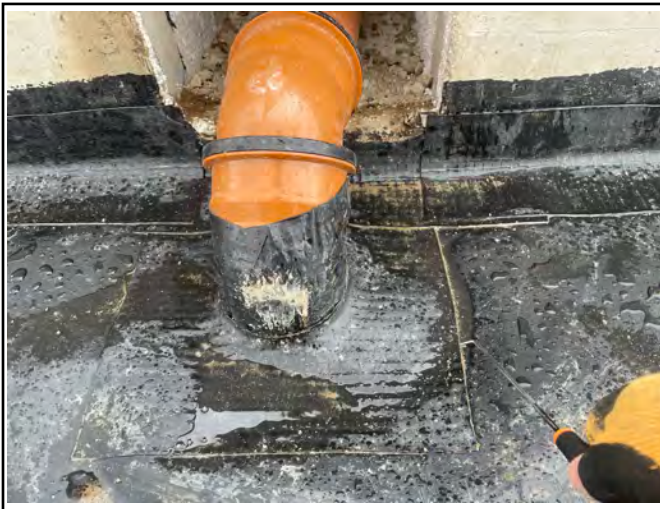
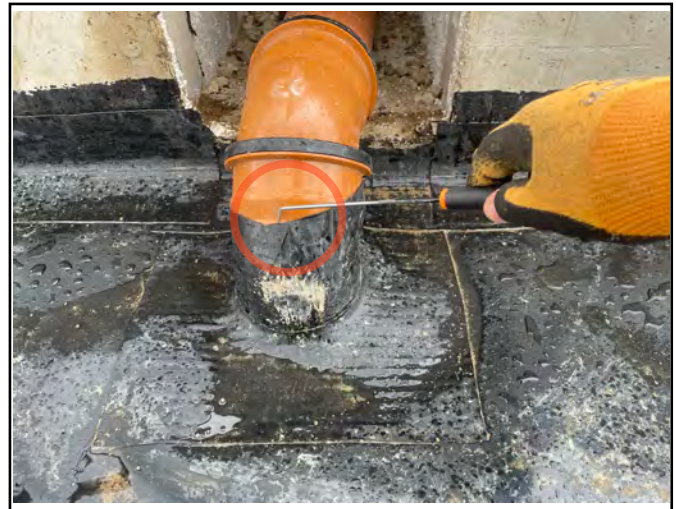
The pipe penetrations have been successfully sealed in accordance to manufactures specification using Juta Titan Tank - gas resistant self adhesive membrane to a good NVQ standard following the petal and 300mm tophat sequence which can be seen in the photographs above, each pipe penetration was also subjected to the pick&probe test as shown above. No faults were identified. Verified in accordance with CIRIA735.

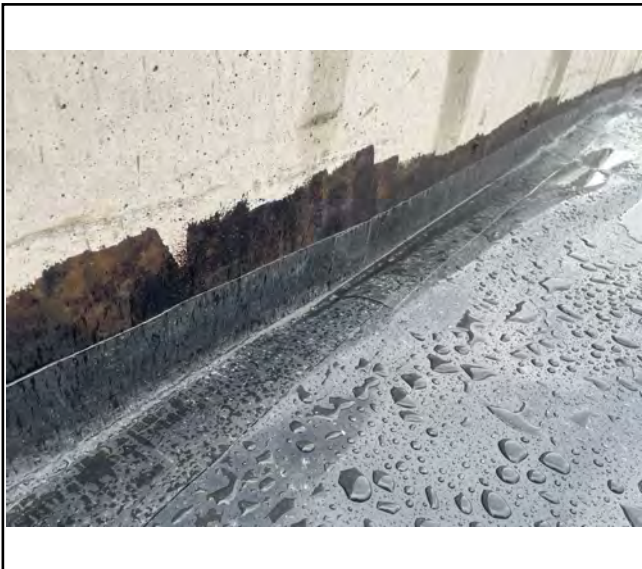
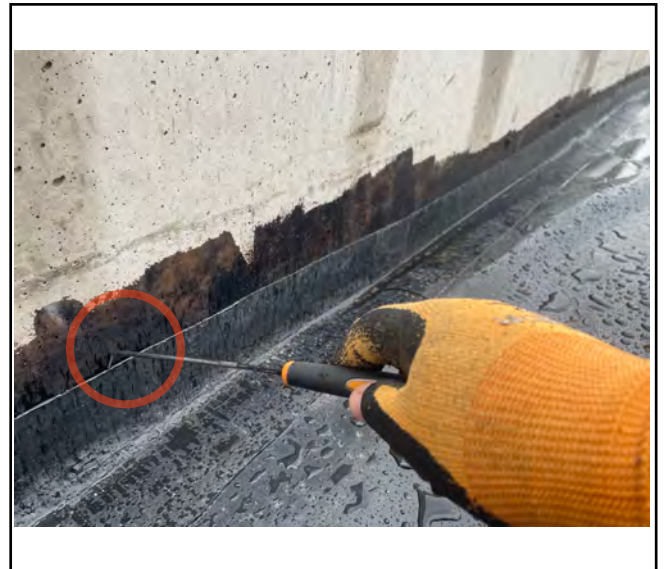
...to application to help aid in adherence of the 'Titan Tank' as highlighted on the left.

All Juta Titan Tank works have been thoroughly heated down with rolled pressure

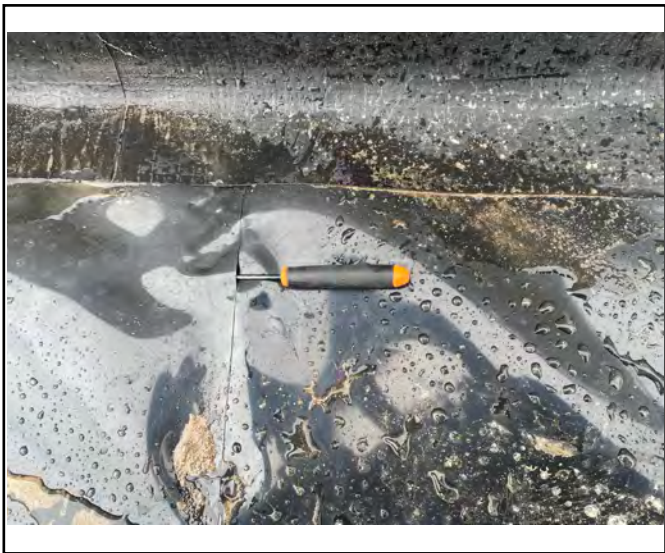
Faults identified.

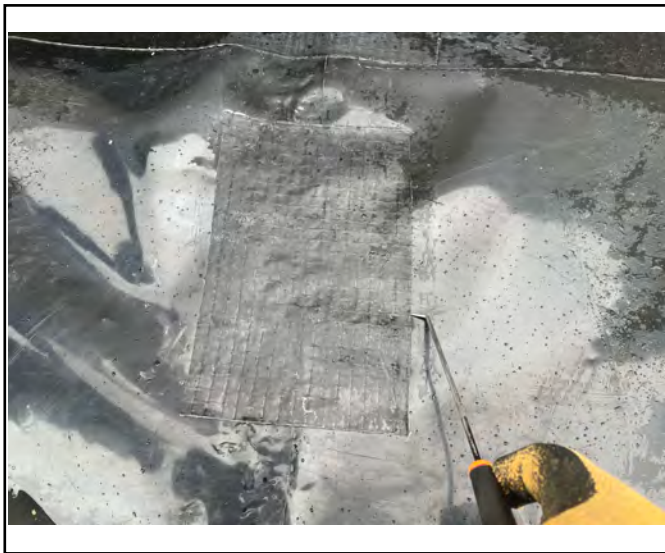
Faults remediated.

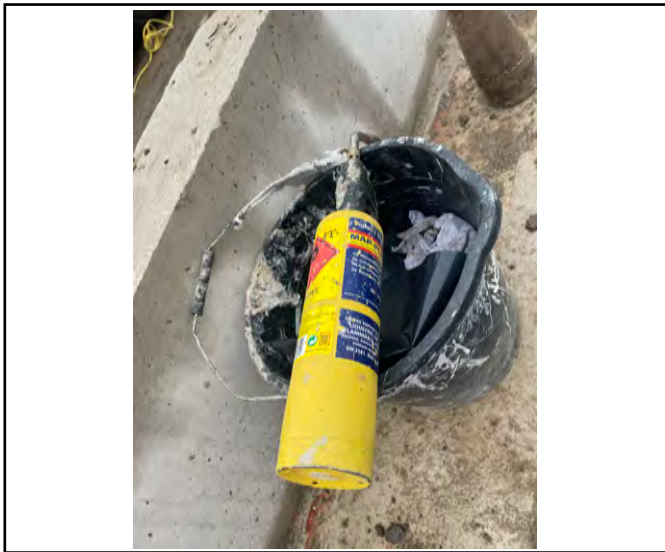
Hot air tool used on-site.

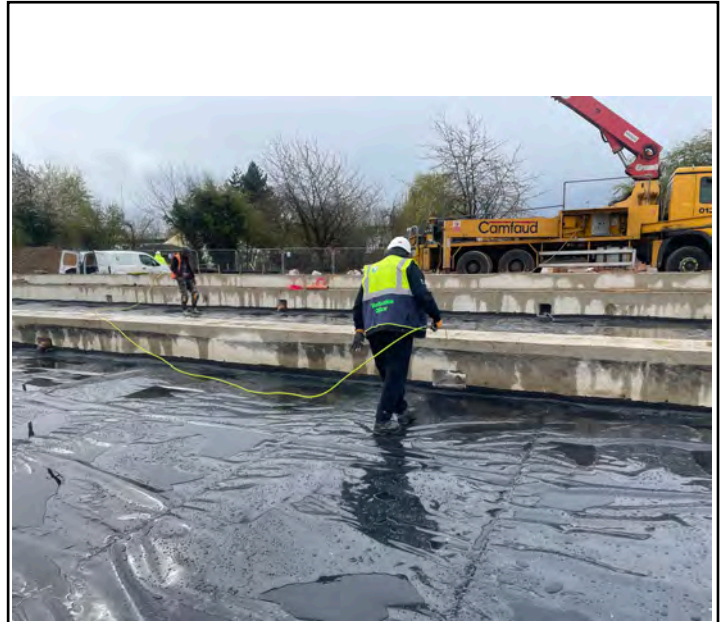
Airlance integrity testing to welded lap joint.

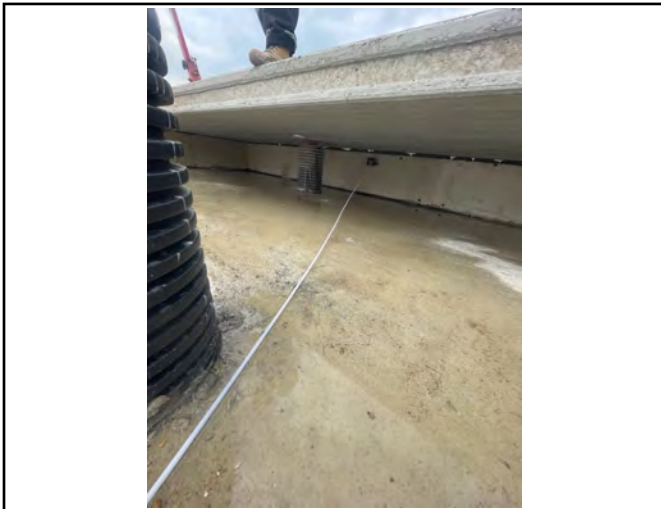
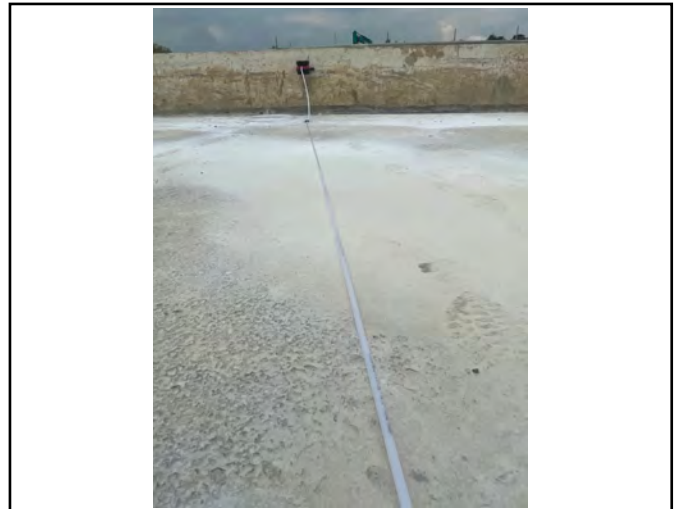
The probe pipe has been lined and installed as horizontally as possible, it has been lightly fixed upon the concrete blinding to reduce movements throughout the development. No sharp angles within the probe pipe routes were present.

A gradual gradient to each probe monitoring point was present eliminating any areas potentially creasing causing disruption during the post monitoring procedures.

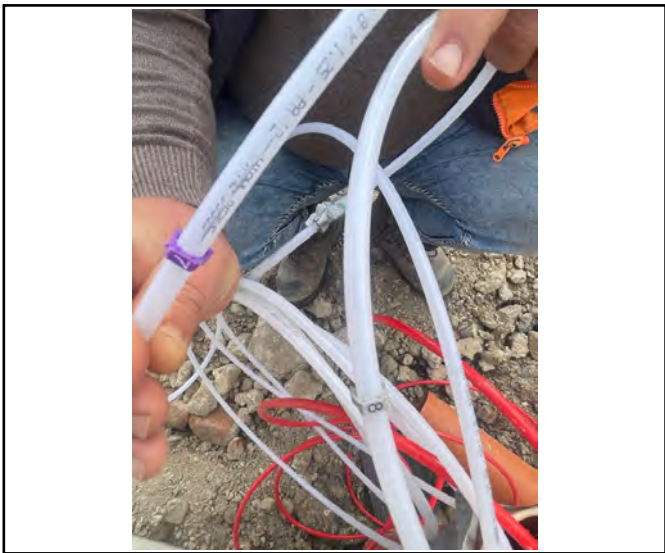
Probe pipe individually tagged.
