# GEOSHIELD Verification Report

PROJECT REFERENCE:

GEO103260

Riverside Academy

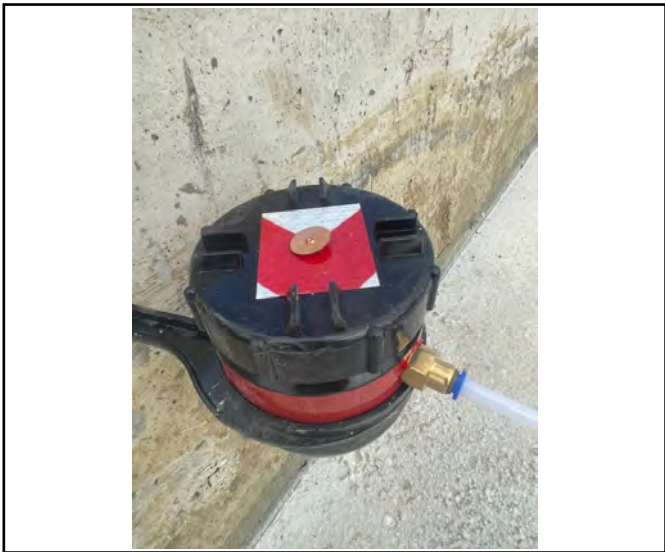
Ground gas monitor fixed.

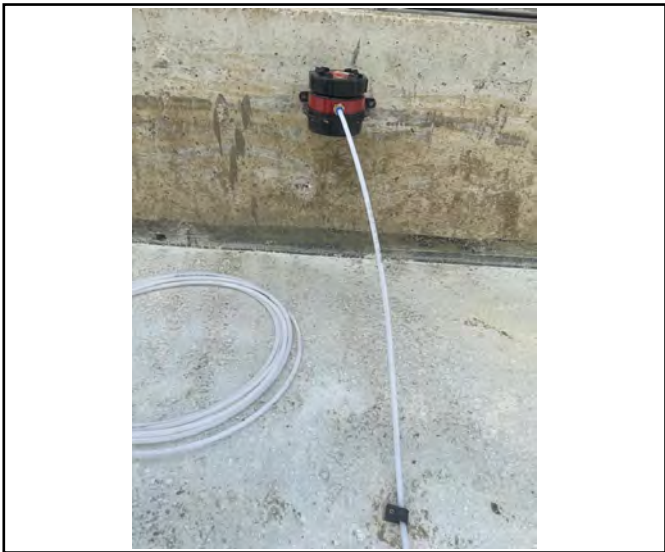
Ground gas monitor fixed.

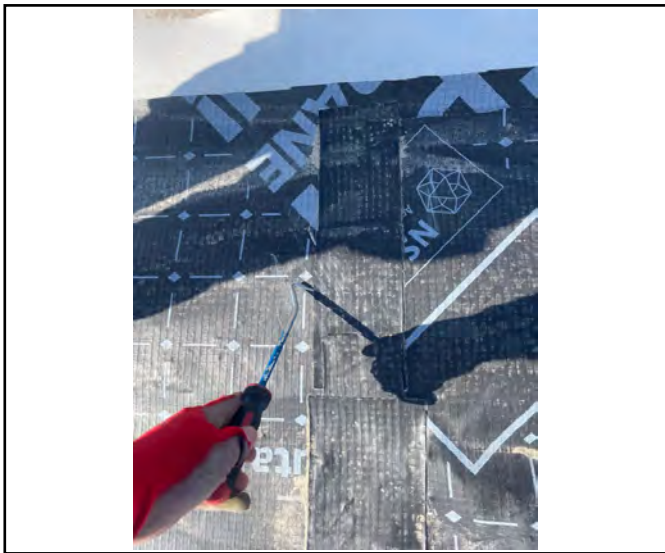
Mechanical point stress testing to

sealed overlap.

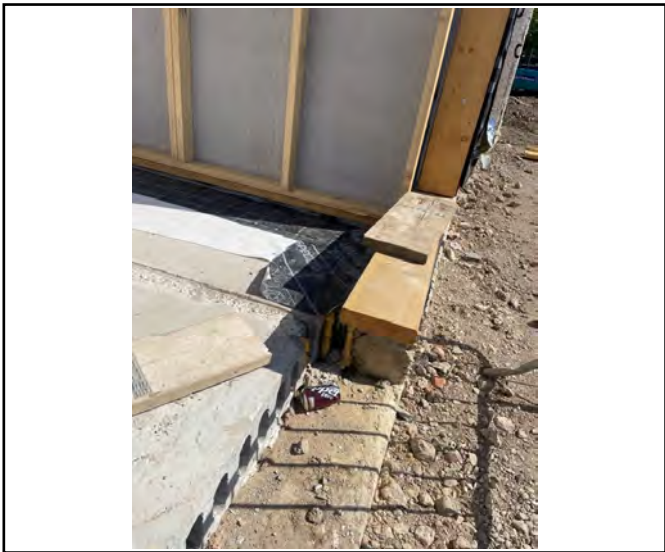
Outstanding threshold section.

Detail for this area to be issued.

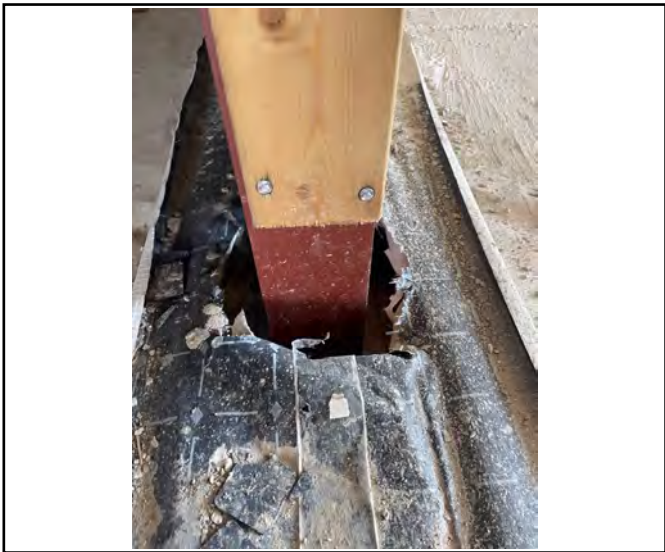
Outstanding steel stanchion.

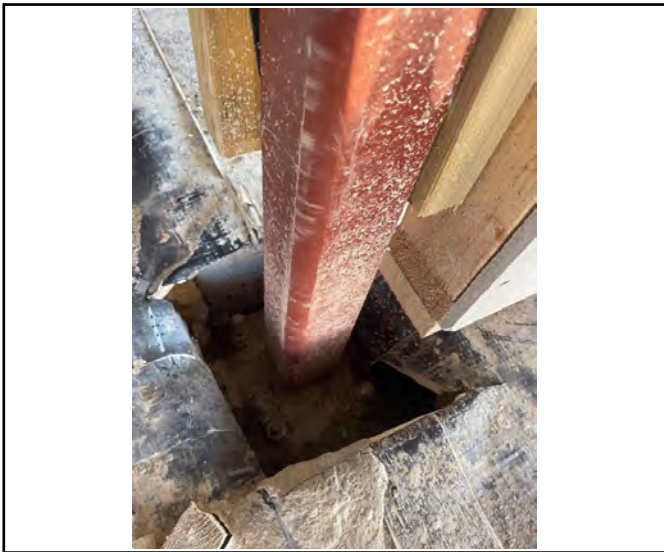
Outstanding steel stanchion.

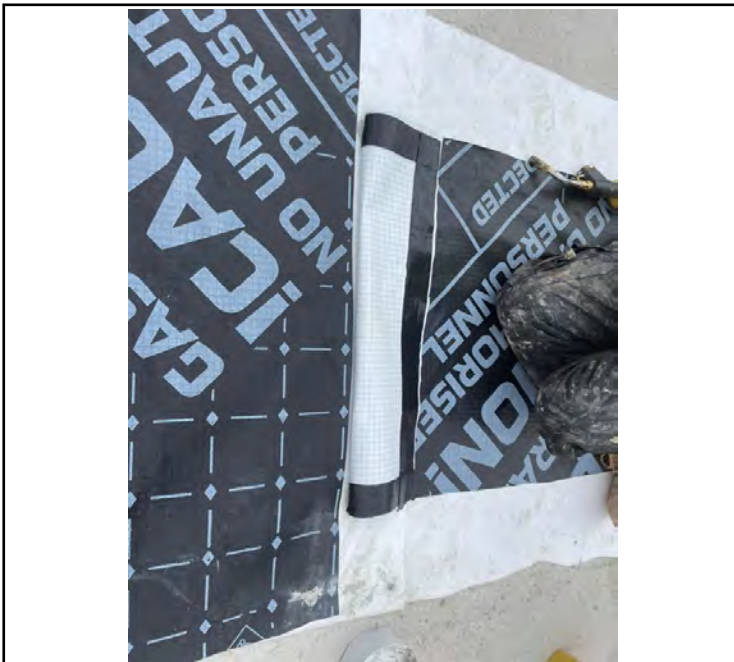
The photograph above on the left displays evidence of Juta Jointing tape in between sheets of Juta GP1 which have been lapped 100mm and over taped using Juta GPSAM.

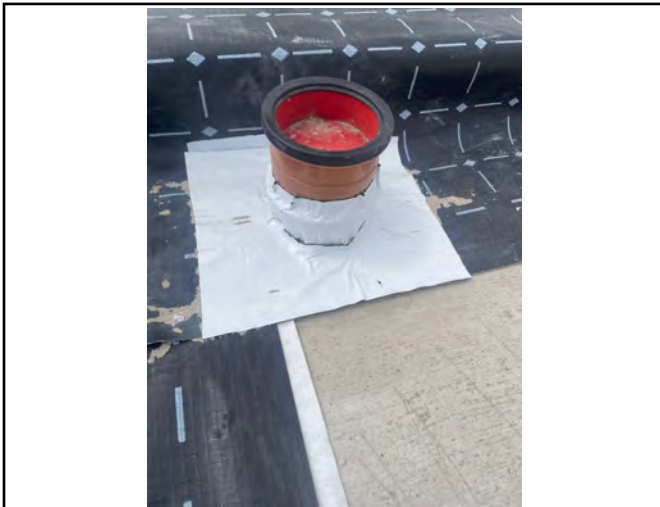
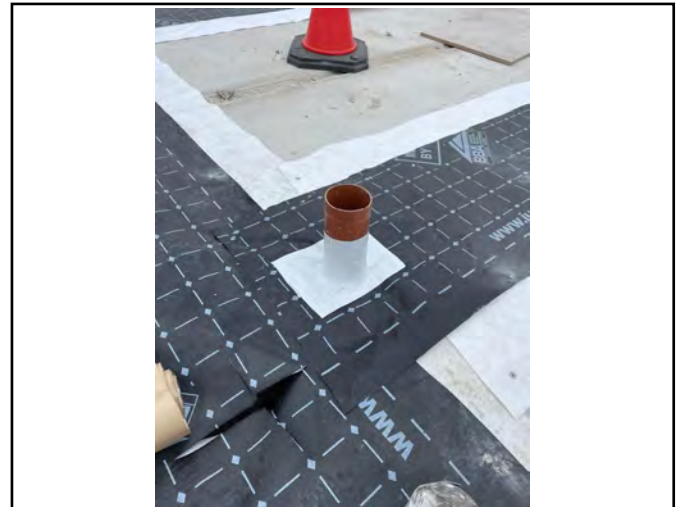
All pipe penetrations have been successfully sealed using Juta GPSAM which is a gas resistant self adhesive membrane. All have been successfully sealed in accordance to manufactures specification and to a good NVQ standard. All Juta GPSAM works have received adequate heat and rolled pressure ensuring the bituminous backing is activated and a continuous seal has been achieved.

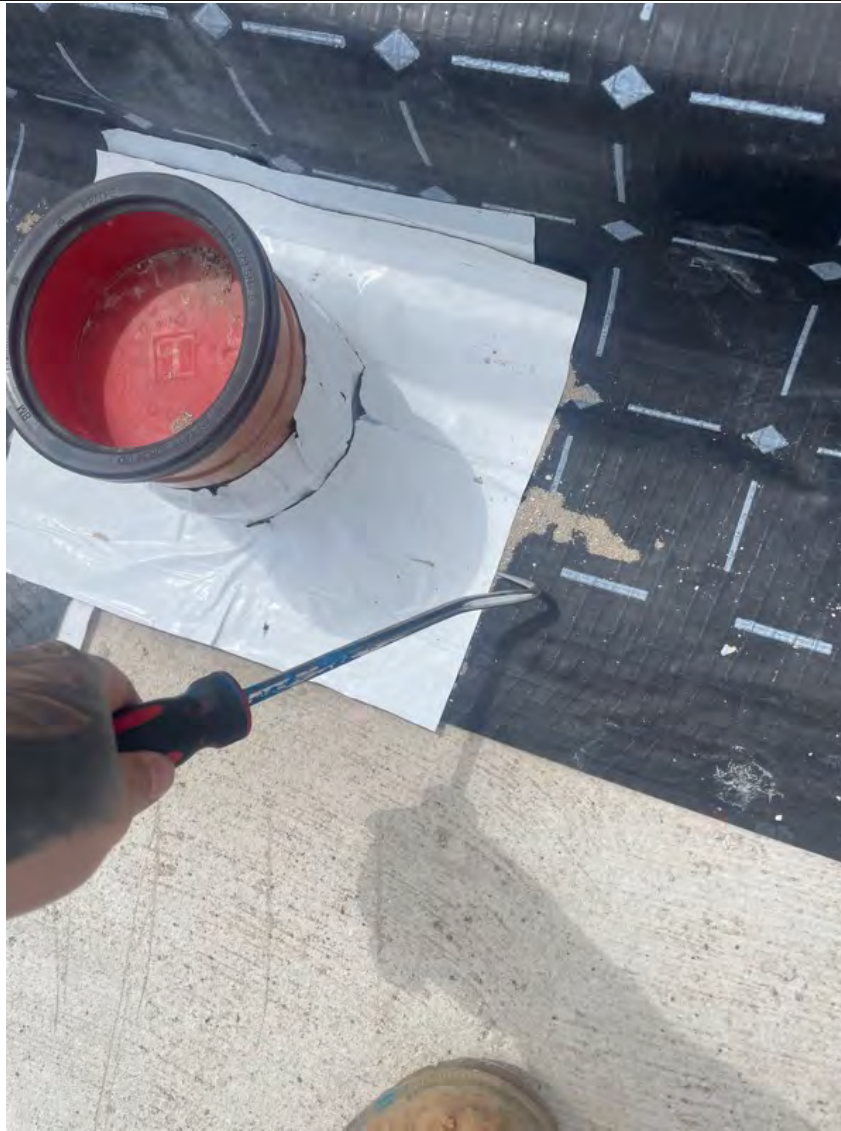
The above photograph displays a mechanical point stress test being carried out to a successfully sealed pipe penetration detail.

Complete adherence has been achieved throughout, with no faults identified.

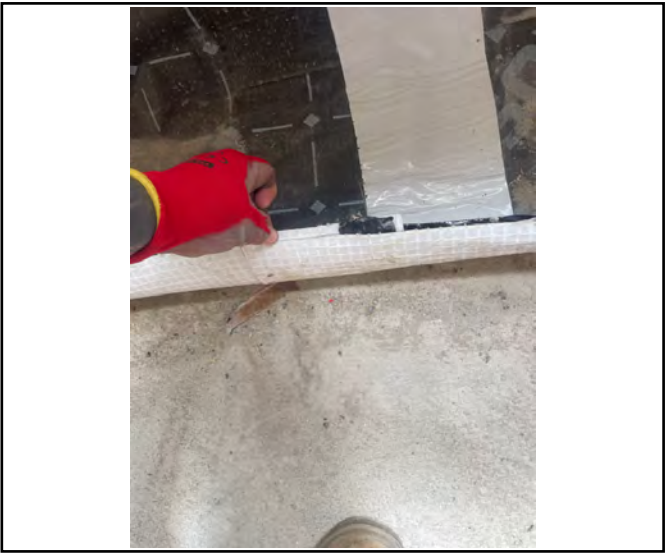
Dual taped lap joint evidence.

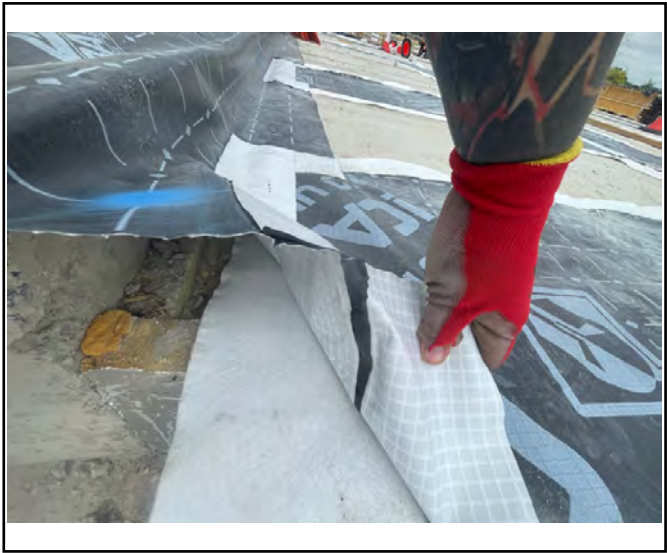
Dual taped lap joint evidence.

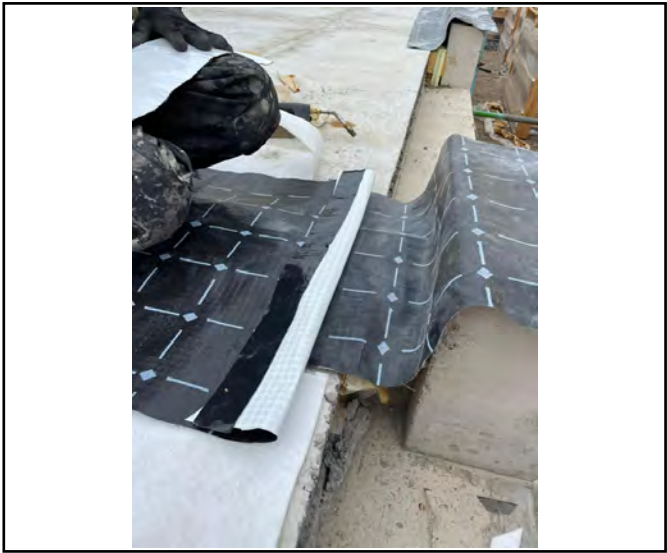
Evidence of butyl tape.

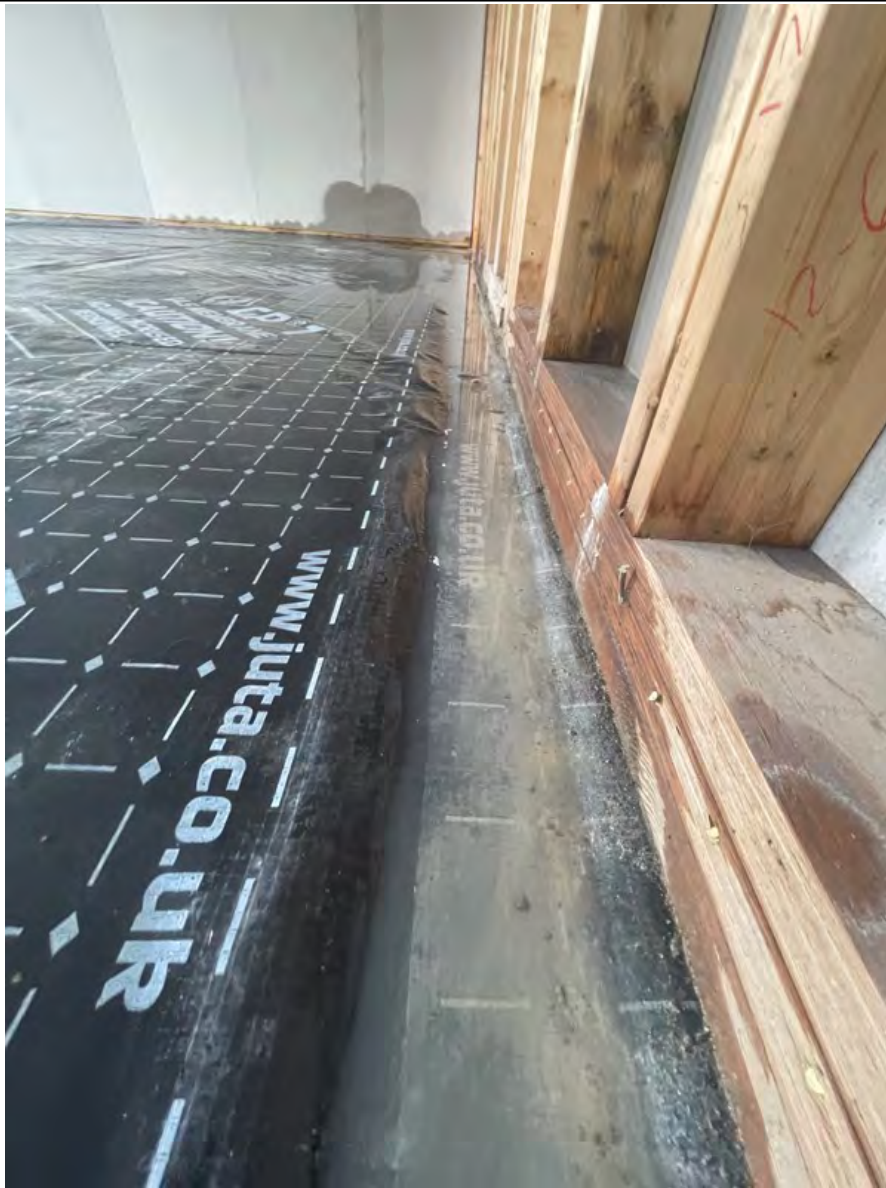
The Juta GP1 gas barrier has returned beneath the existing Juta GP1 gas barrier present around around the perimeter of the building and from beneath the internal stud walls. All Juta GP1 perimeter and internal works were verified on a previous visit.

As mentioned all membranes have been welded using a hot air tool & silicone roller.

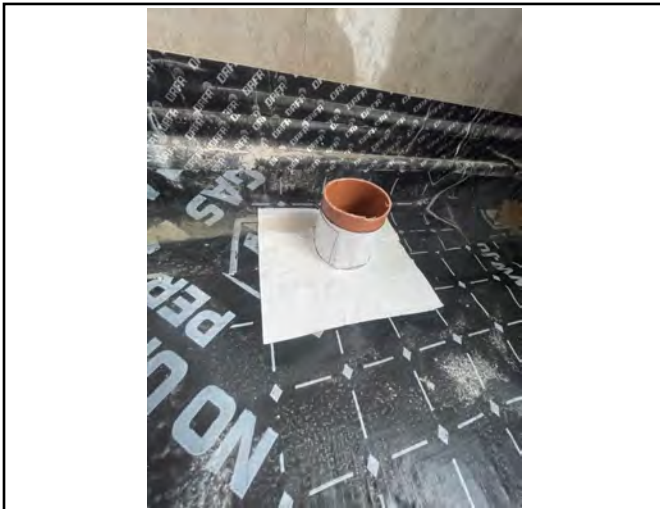
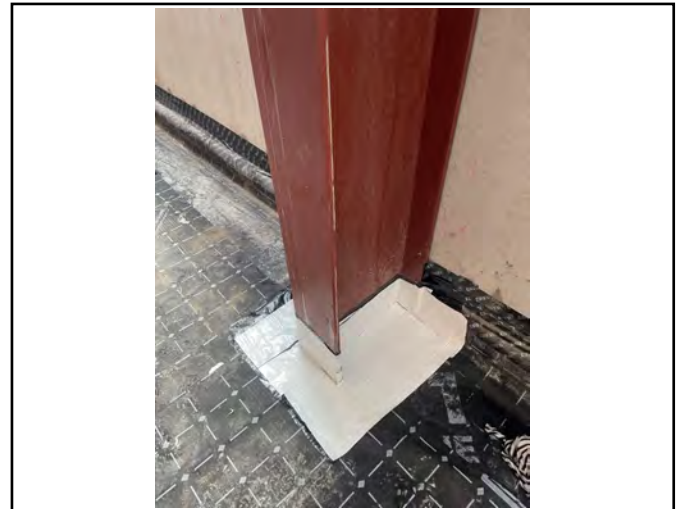
The photographs above displays a evidence of the details referenced which have been sealed to a good NVQ standard following the petal formation made up of a minimum of 4 150mm patches of GPSAM and finished off with a 300mm tophat to seal the pipes.

All GPSAM works have received adequate heat & rolled pressure to ensure the bituminous backing of the material is activated and a complete seal has been achieved.

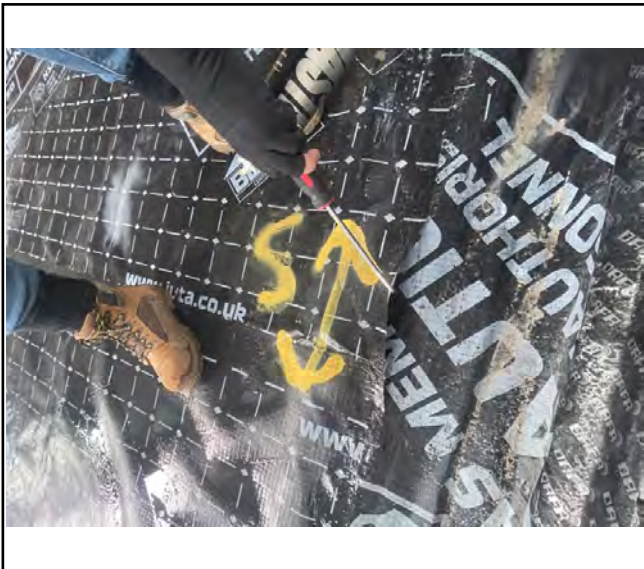
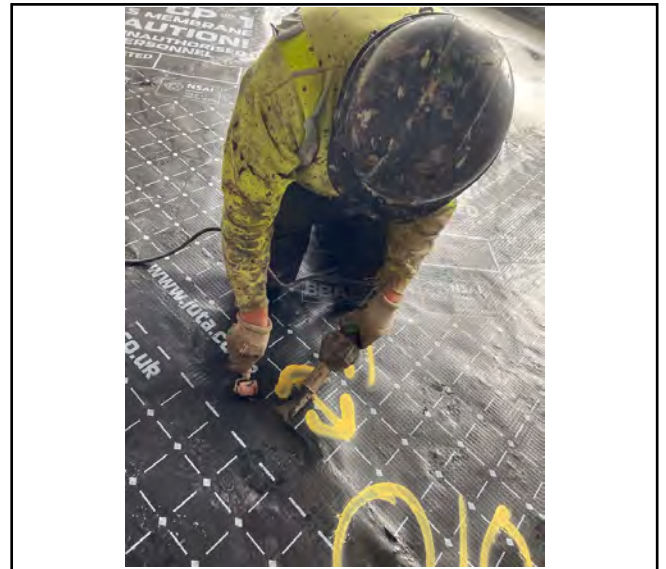
As mentioned within this report a number of faults were identified throughout the rooms referenced within the East Block . These were identified during the visual inspections supported by the mechanical point stress test in accordance with CIRIA 735.

The photograph above on the left displays the typical fault identified. Miswelded lap joints around the perimeter between the new and old sheets of Juta GP1. All faults were highlighted as shown and remediated on-site in the presence of Geoshield using patches of GPSAM or re-welded as shown above on the right.

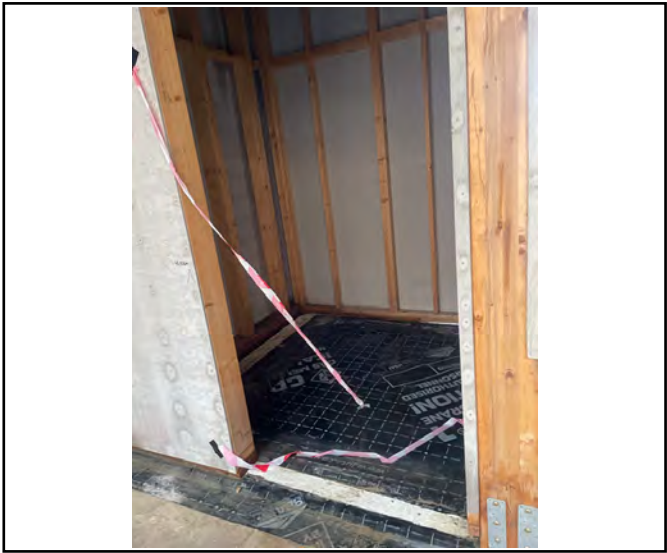
Internal overview photograph.

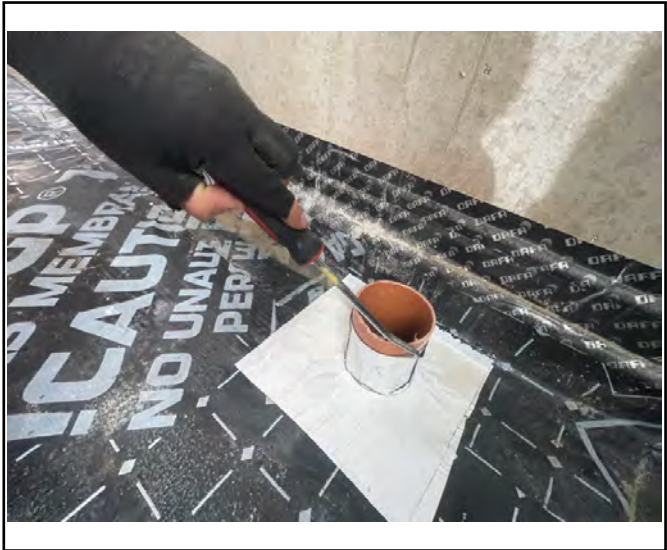
Mechanical point stress testing.
