***Project ref:TV230727***

# ***CCTV Survey Report***

**CLIENT: ACORN CARE AND EDUCATION LTD**

**SITE: Pheonix College**

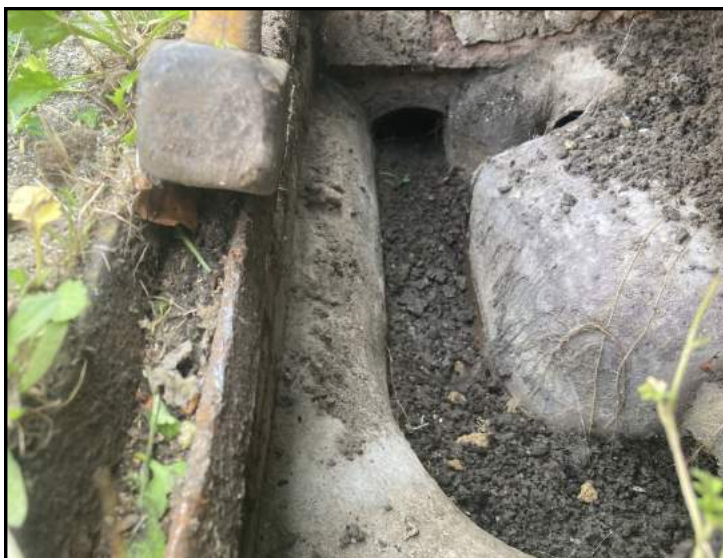
IC3. UNABLE TO FULLY LIFT.  
MANHOLE SILTED

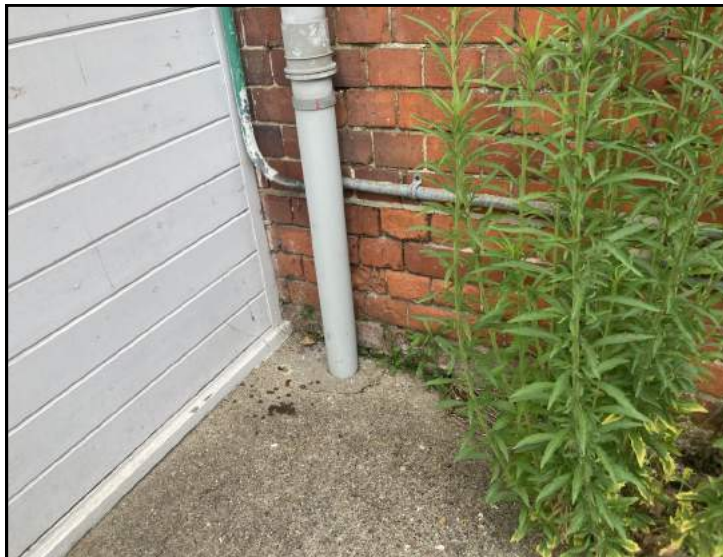
RWP 4 - INTO GROUND

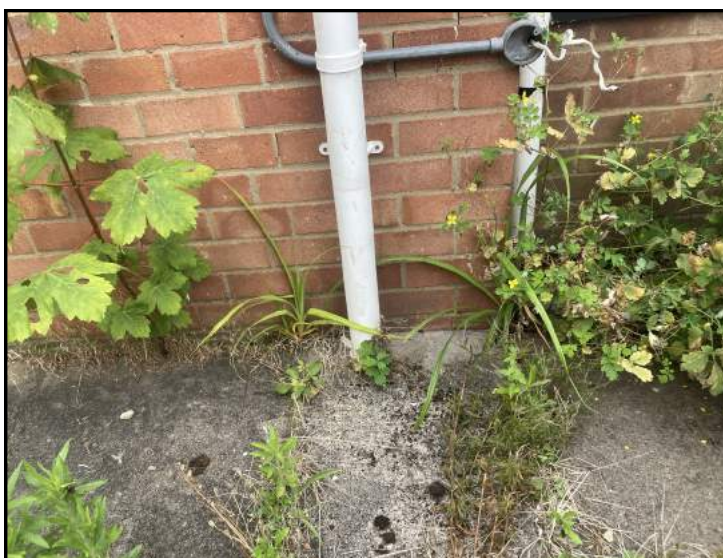
RWP 5 - INTO GROUND

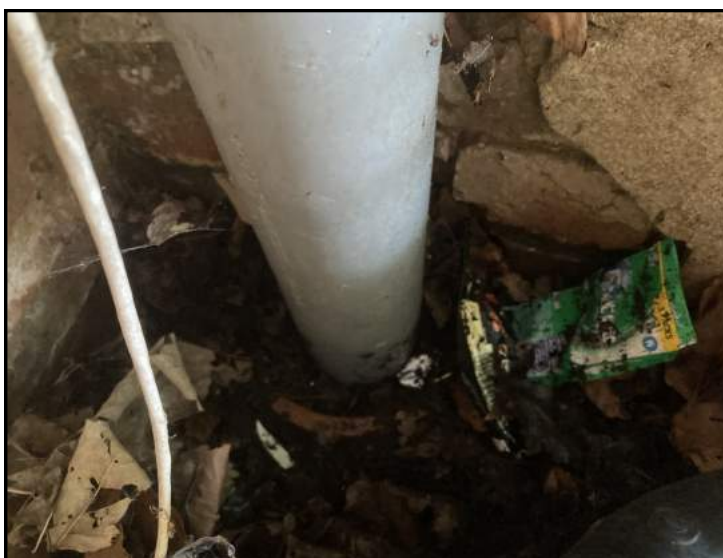
RWP 8 - INTO GROUND

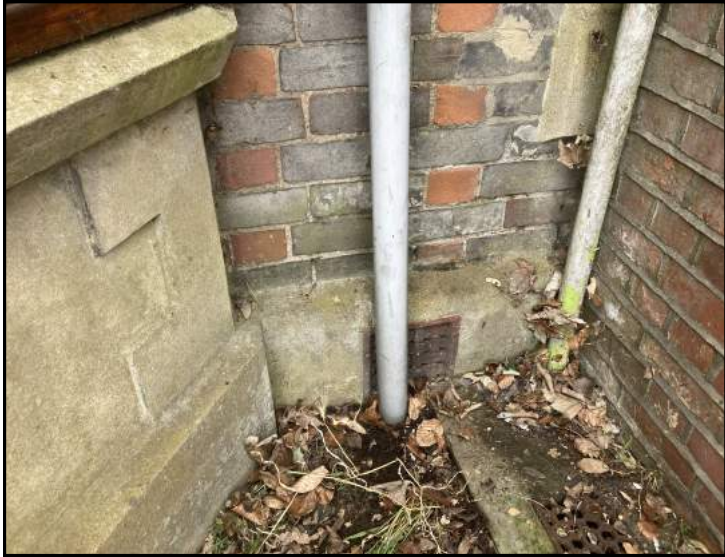
RWP 9 - INTO GROUND

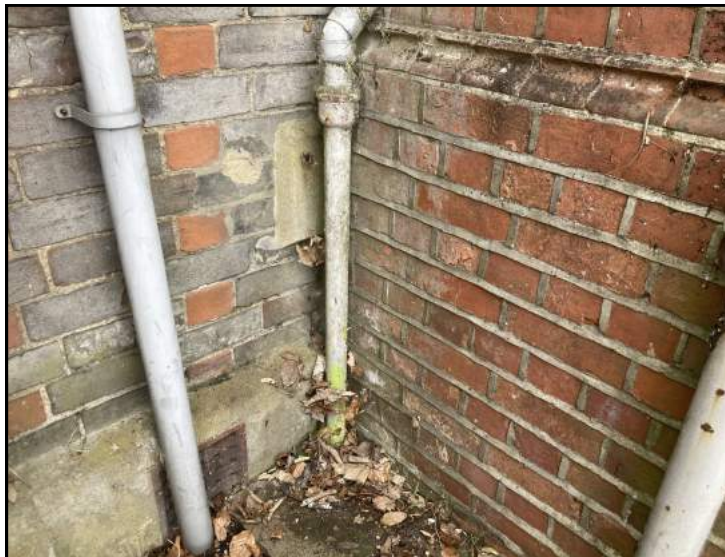
RWP 10 - INTO GROUND

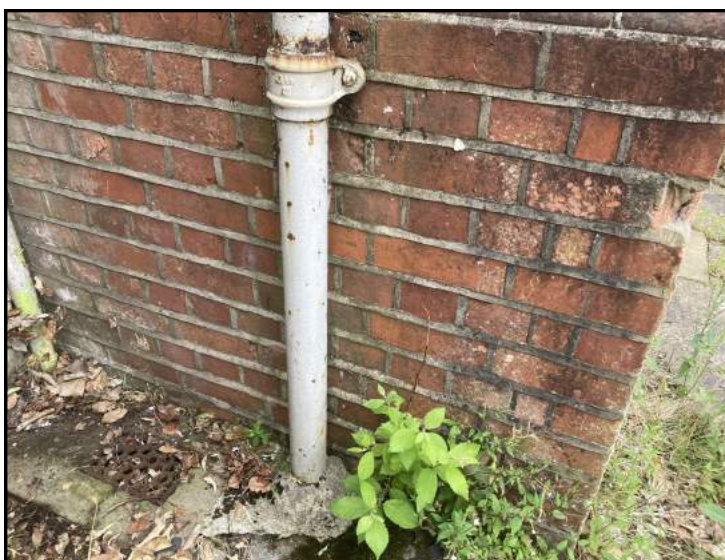
RWP 11 - INTO GROUND

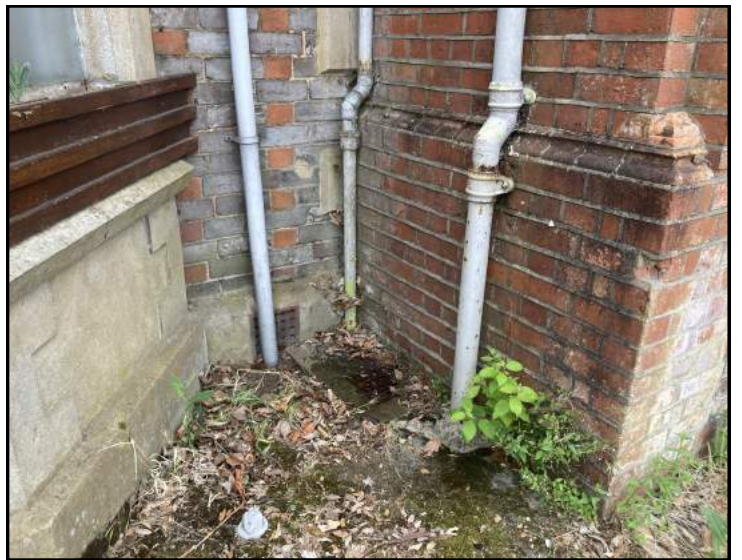
LOCATION OF RWP 11 (RIGHT)

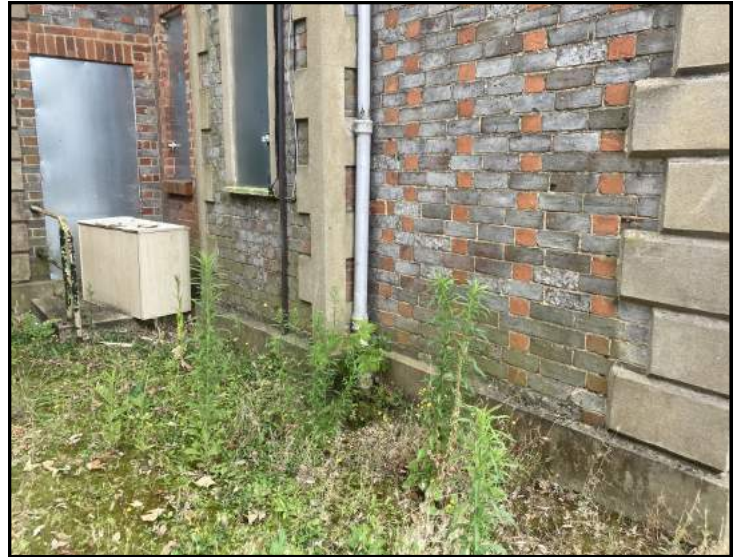
LOCATION OF RWP 12

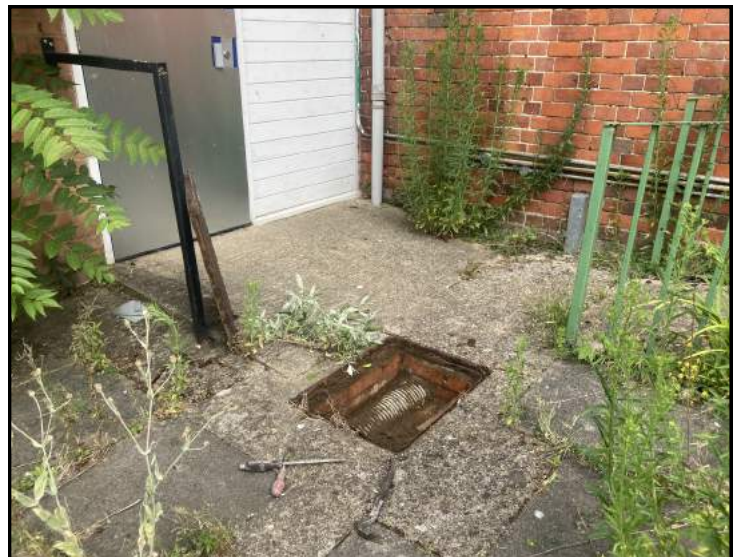
LOCATION OF MH1

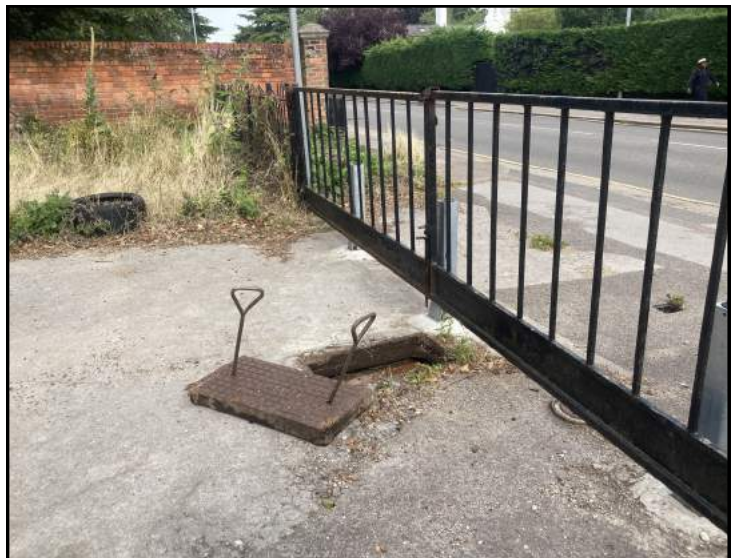
LOCATION OF MH2

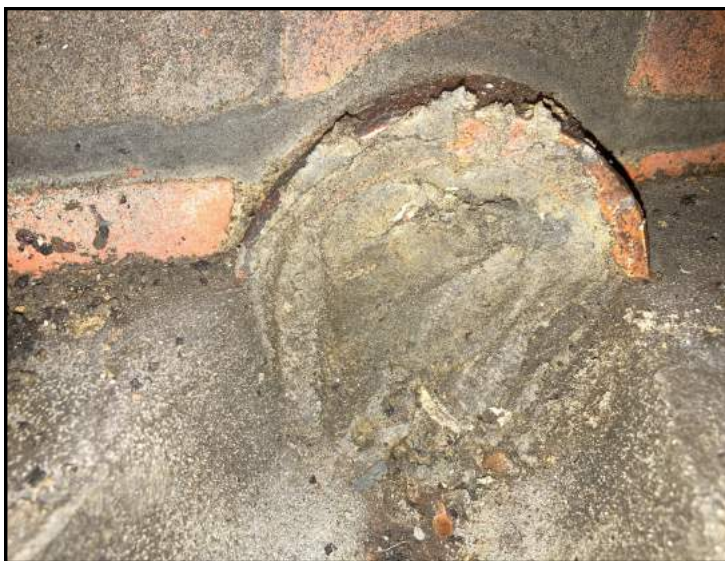
IC8-A.  
CAPPED

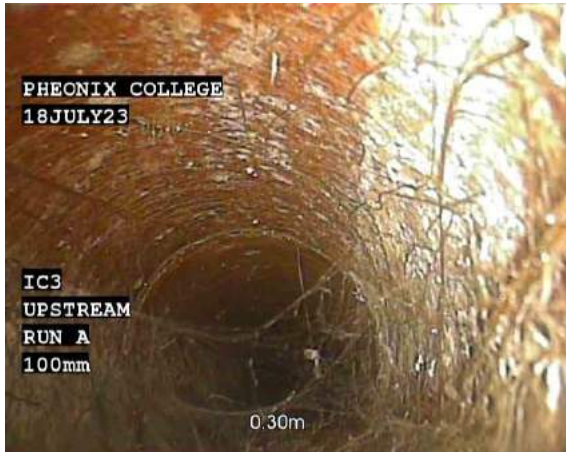
1, 00:00:00, 0.30 m  
Roots, fine, start

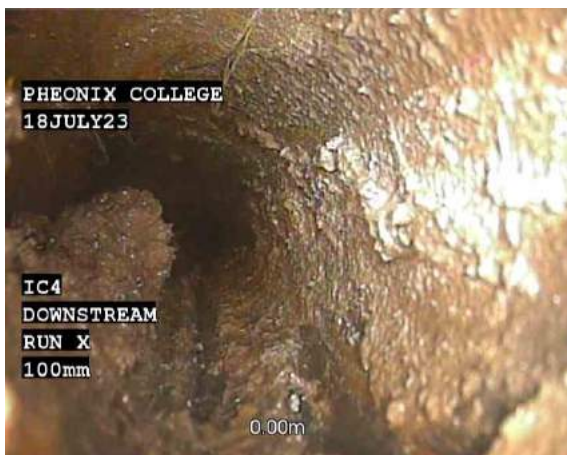
1, 00:00:00, 0.00 m  
Settled deposits, hard or compacted, 10% cross-sectional area loss, start

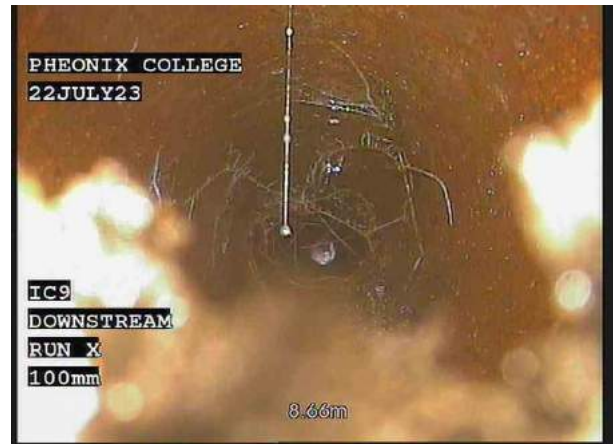
2, 00:01:08, 8.66 m  
Roots, fine, start

| Section number | Upstream manhole | Flow direction | Downstream manhole | Recommendations |
|---|---|---|---|---|
| 19 | IC9 | Downstream | IC10 | Repair defect(s) by lining |

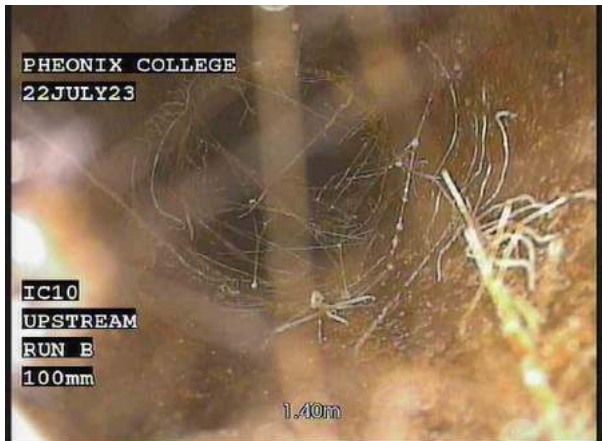
1, 00:00:25, 1.40 m  
Roots, fine

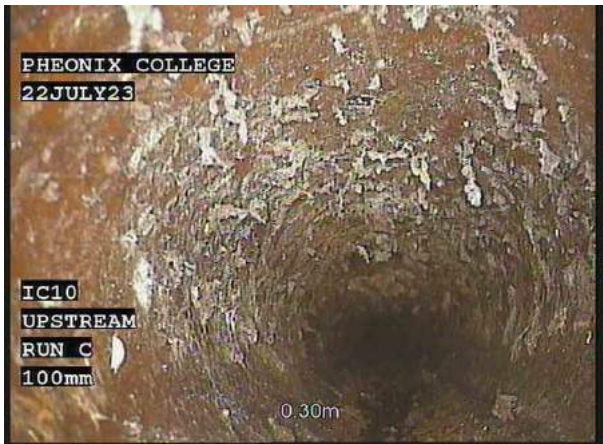
1, 00:00:04, 0.30 m  
Settled deposits, hard or compacted, 5% cross-sectional area  
loss, start

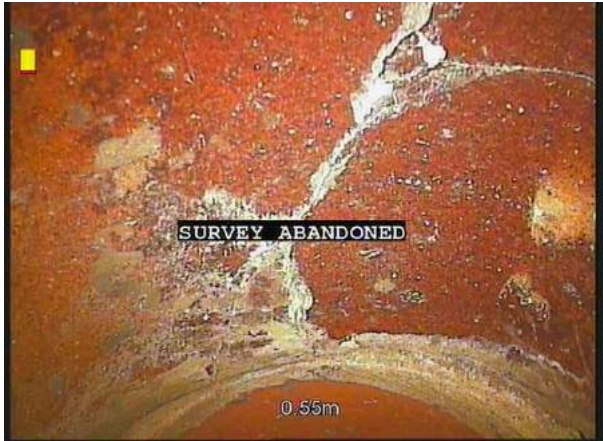
1, 00:00:22, 0.55 m  
Survey abandoned, Unable to continue - camera unable to round bend
