## Window Condition Survey at

189 Oxford Road  
Reading  
RG1 7UZ

### Metropolitan Thames Valley

Tel: [01689 885080](tel:01689885080)  
Email: [elliekeattch@effefftee.co.uk](mailto:elliekeattch@effefftee.co.uk)  
Date: 21/07/2025  
Project No: T1-7039

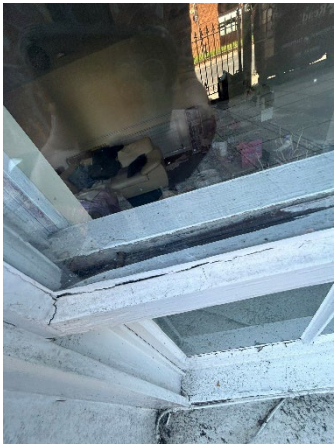
| Photo Name | Photograph |
|---|---|
| Rear sash window meeting rail condition. | |

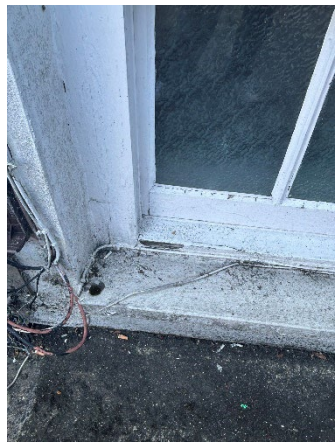
| Photo Name | Photograph |
|---|---|
| Box sash condition to front sash window. | |

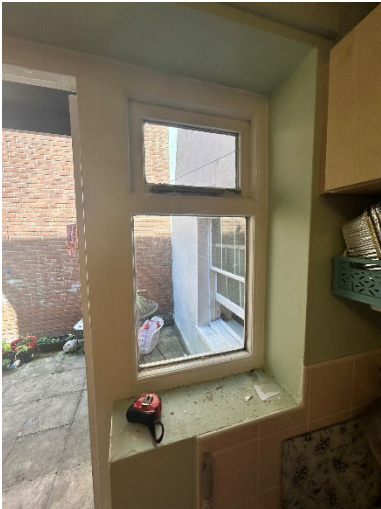
| Photo Name | Photograph |
|---|---|
| Internal view of rear casement window. | |

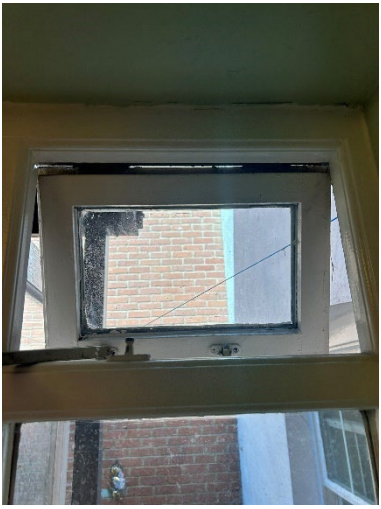
| Photo Name | Photograph |
|---|---|
| Internal view of rear casement window. | |

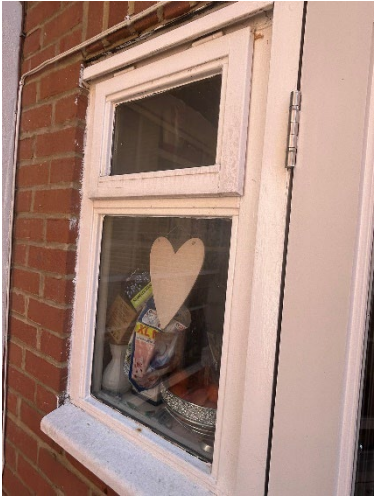
| Photo Name | Photograph |
|---|---|
| External condition of rear casement window. | |
