# Your survey report

122 Kidmore Road, Caversham  
Heights, Reading, Berkshire RG4  
7NB

10th March 2022

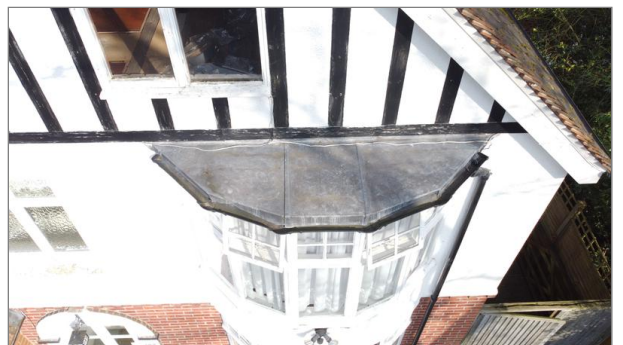
*Photo - 7 Bay*

There is a small flat roof over the front bay window which has been lined with lead, and was found to be in good condition. The flat roof is in adequate condition and appears fairly modern. Flat roofs have a lifespan of around 20 - 25 years and it is unlikely that any significant defects will occur soon.

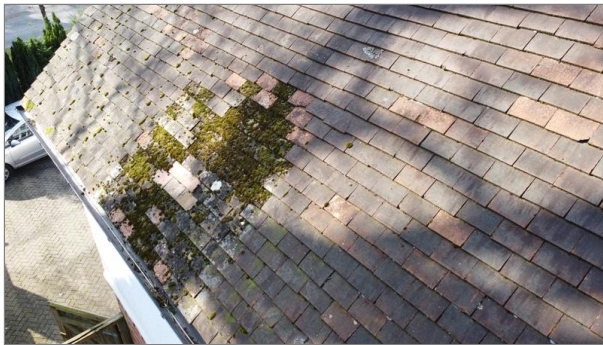
Where the chimneys have been removed in the past, on the right hand roof pitch when standing at the front, a different style of tiling has been installed. This has aged poorly and significant moss growth can be seen on the surface of the tile. This is not necessarily a defect, but moss does prematurely age a tile, as it tends to hold moisture against the surface of the tile for longer periods. These may require replacement soon.

*Photo - 8 Moss growth*

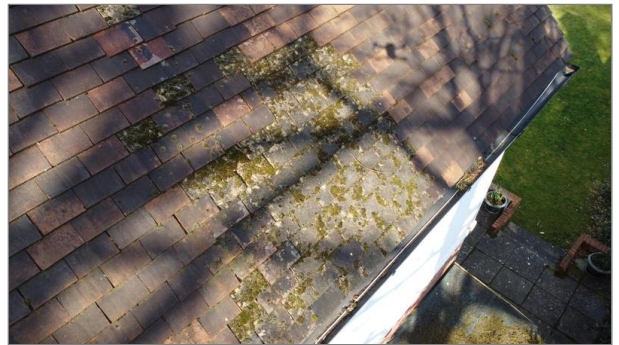
*Photo - 9 Moss growth*

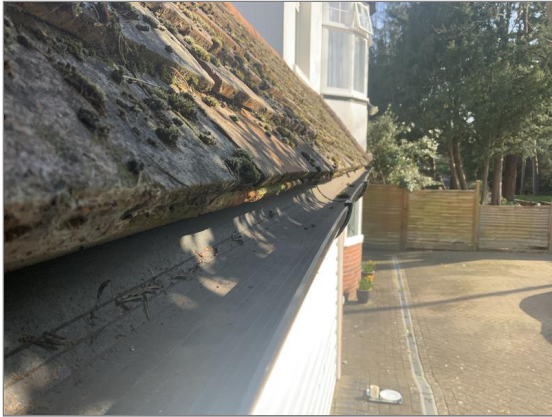
*Photo - 18 Clear*

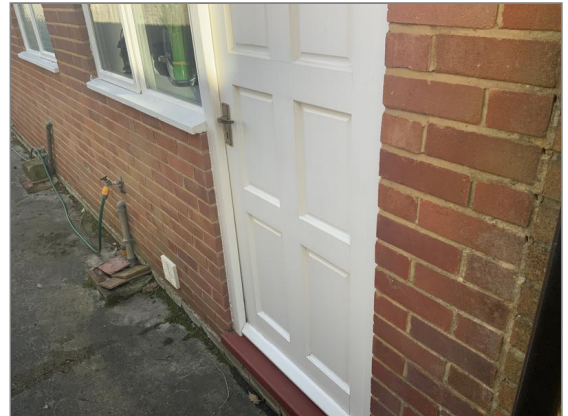
*Photo - 37 Side door*

The side door is of average quality and found to be functional.

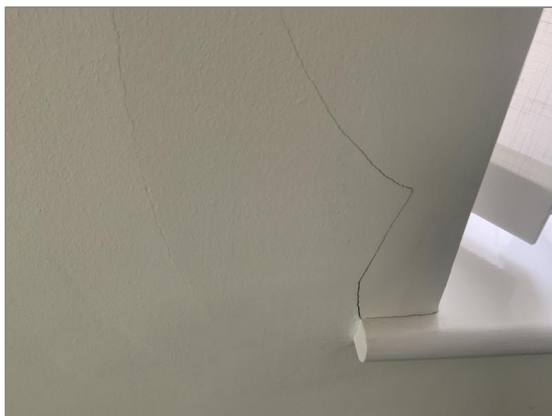
*Photo - 51 Hollow here*

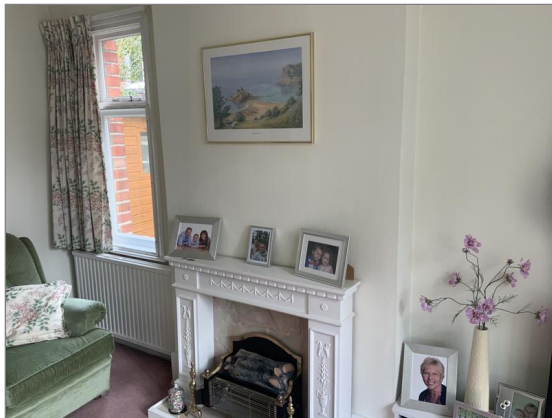
*Photo - 53 Not in use*

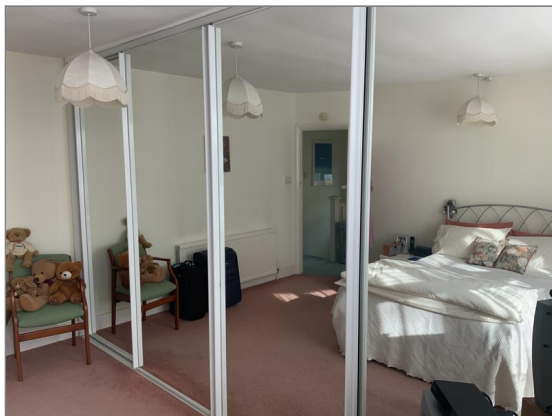
*Photo - 54 Large mirrored units*

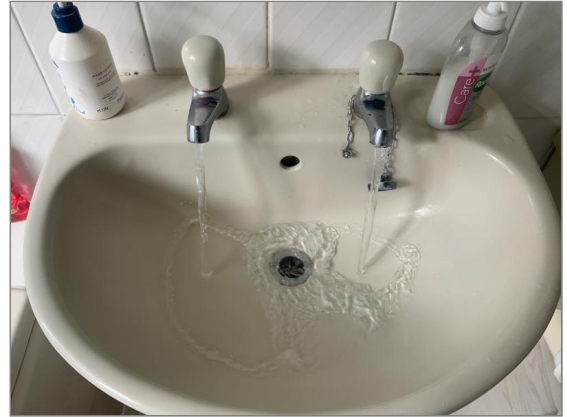
*Photo - 59 Good pressure*

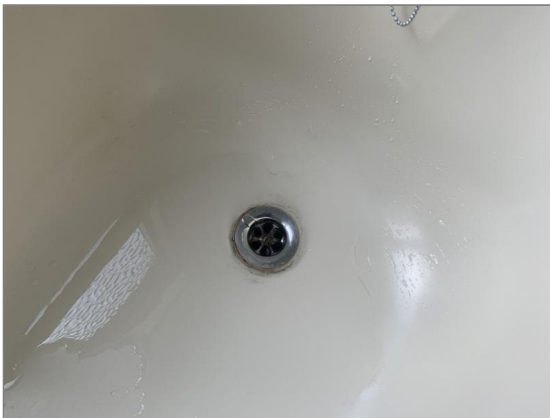
*Photo - 60 Ageing*

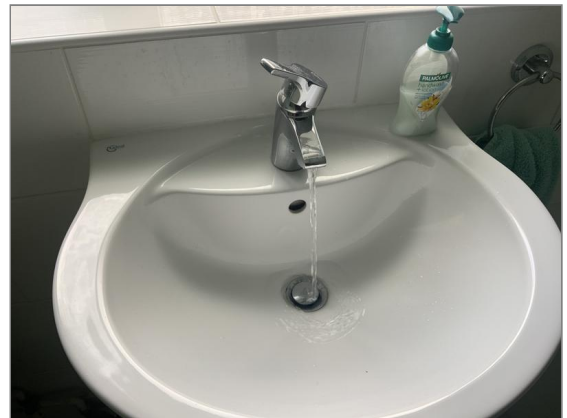
*Photo - 61 Lower pressure*

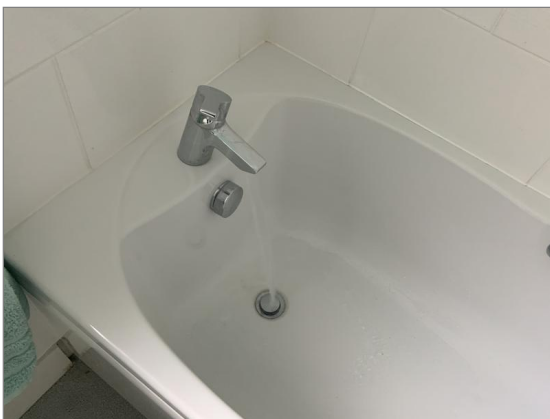
*Photo - 62 Higher pressure*

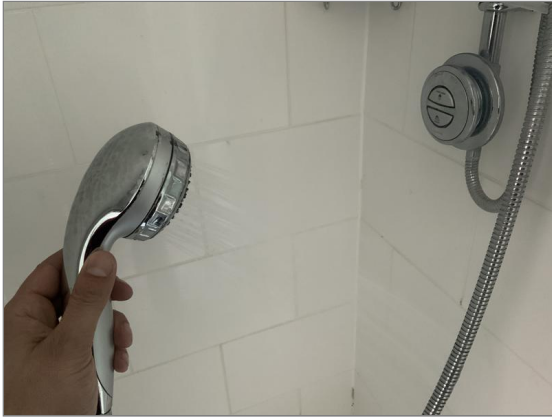
*Photo - 64 Functional*

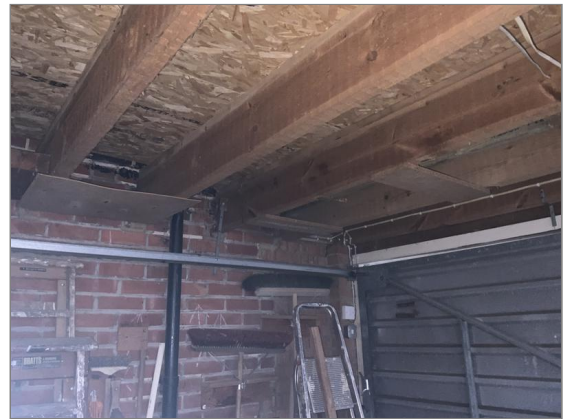
Photo - 74 General view

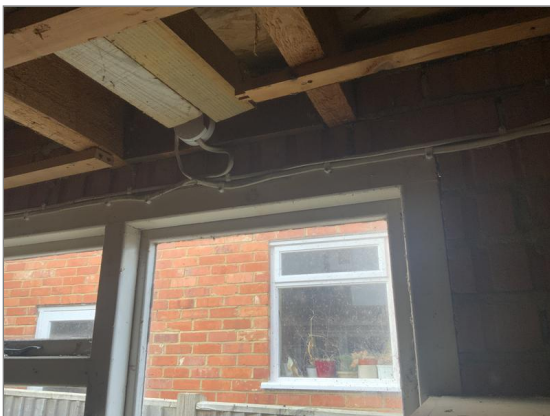
Photo - 75 Load bearing

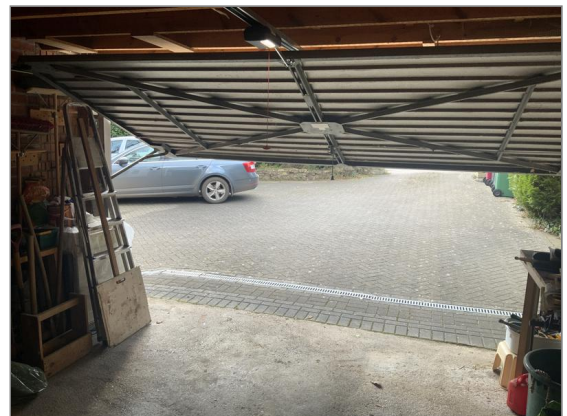
The property has a garage with an electric up and over door. The door was found to be fully functional and the garage was generally in good condition. Decoration is advisable to the front door of the garage, and it should be pointed out that the windows are load bearing. This means that the brickwork has been built up off of the windows, and if you change them, you must bear this in mind.

Photo - 76 Working

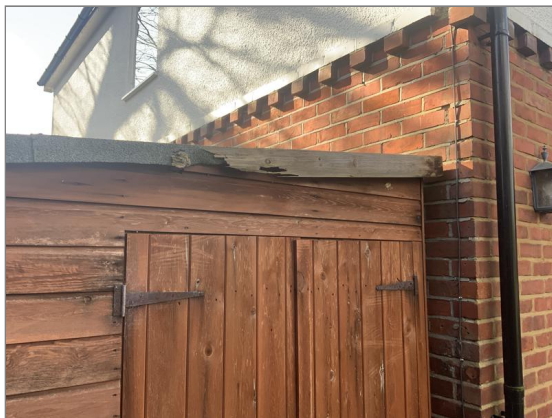
Photo - 79 Ageing

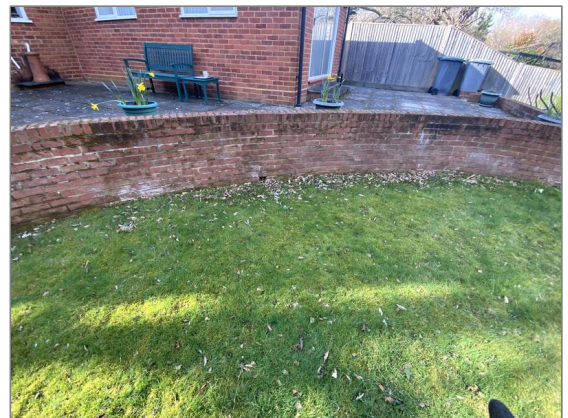
There is a large retaining wall, i.e. a wall which has been built to high level and is holding back the land of the patio. This was found to be in good condition.

Photo - 80 Good condition

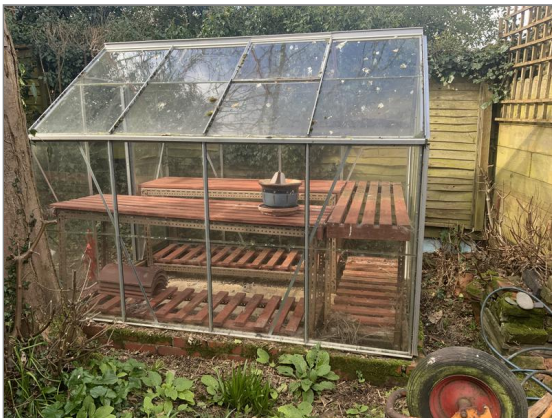
At the very rearmost part of the garden there is a further shed and greenhouse. The shed is in good condition, but the greenhouse has glass in it which will break into shards if impacted upon, and indeed, one element of glass is broken and has been taped up next to the door. Children should be kept away from this structure.

*Photo - 83 Greenhouse*

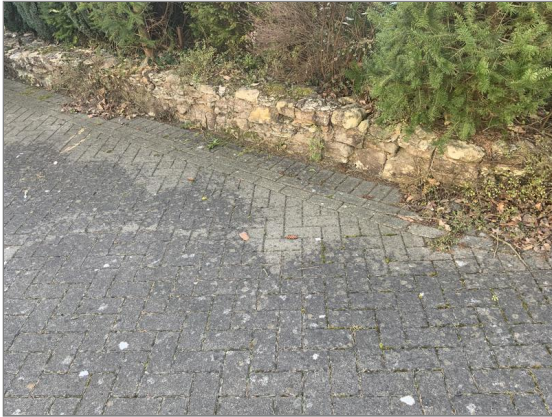
*Photo - 85 To front drive*

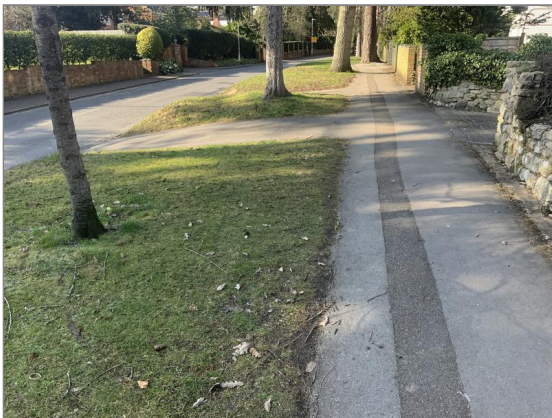
*Photo - 87 Crossover here*

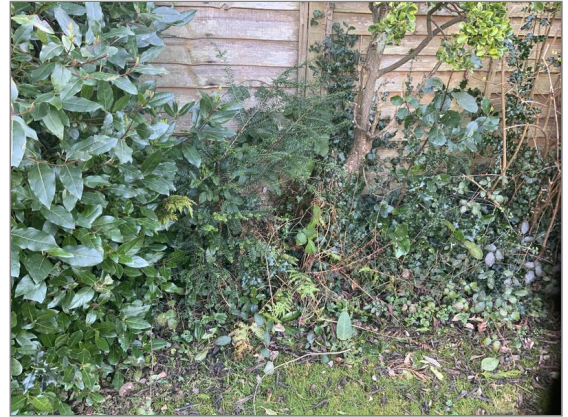
*Photo - 92 Yew*

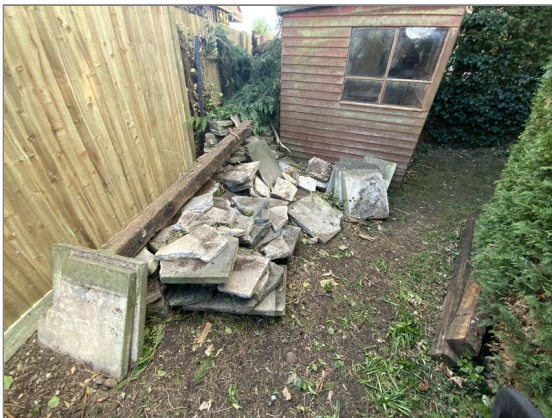
*Photo - 93 To rear*
